**Huyton Town Centre Regeneration**  
CCTV Condition Report

Project Ref: TS-2645 Huyton Town Centre Regeneration CCTV  
Report\_303\_Issue01

**Dominic White – Tower Surveys CCTV Ltd**  
**23/05/2025**

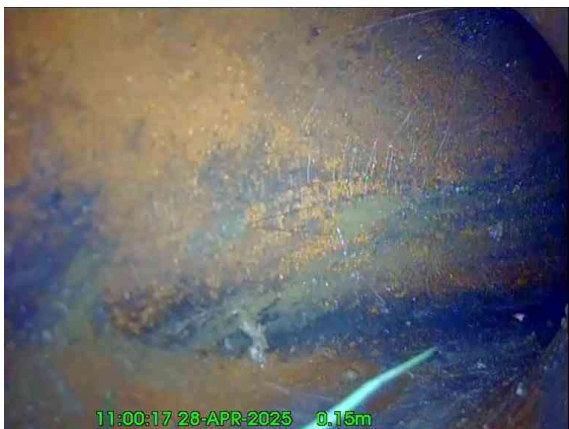
1, 00:00:09, 0.15 m  
Line deviates right

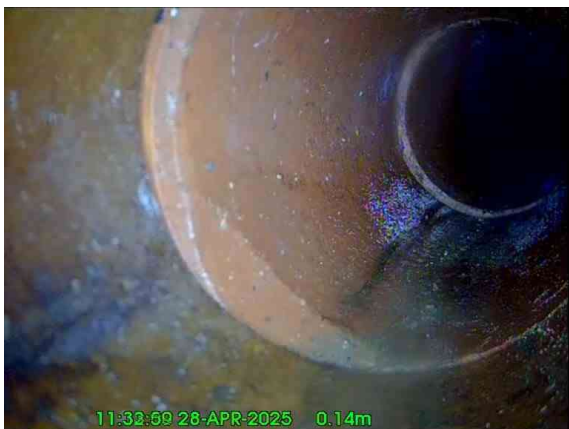
1, 00:00:06, 0.14 m  
Line deviates right

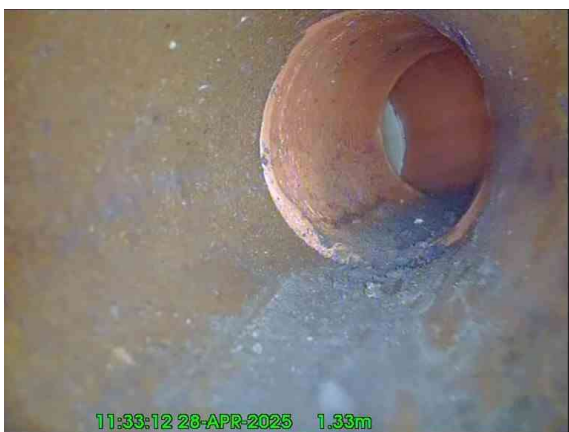
3, 00:00:19, 1.33 m  
Line deviates right

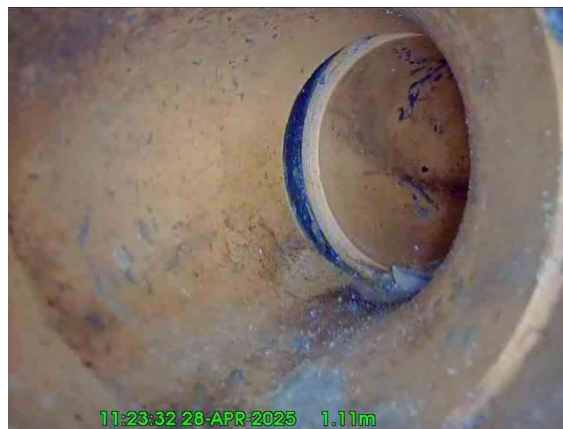
2, 00:00:16, 1.11 m  
Line deviates right

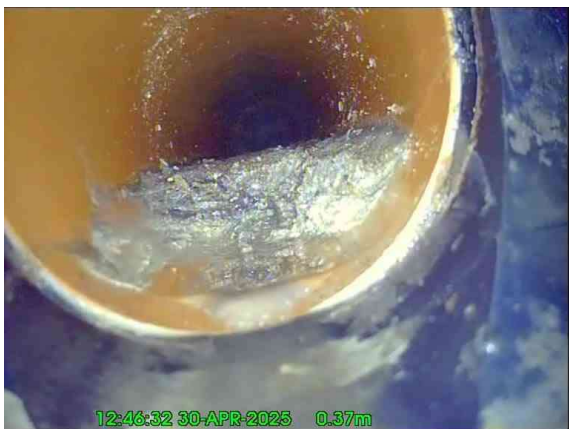
1, 00:00:11, 0.37 m

Settled deposits, hard or compacted, 20% cross-sectional area loss, start, Solid set debris remained in sewer following jetting

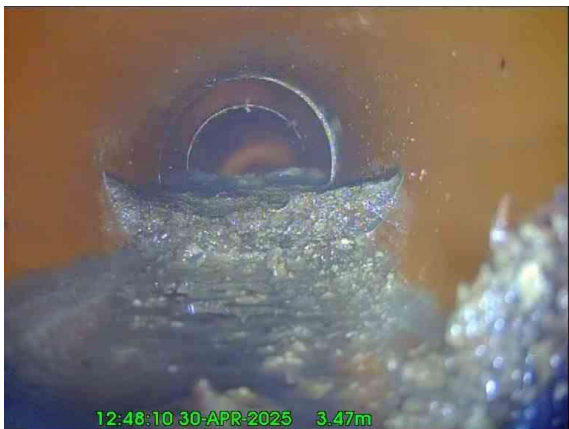
3, 00:01:49, 3.47 m

Settled deposits, hard or compacted, 20% cross-sectional area loss, start, Solid set debris remained in sewer following jetting

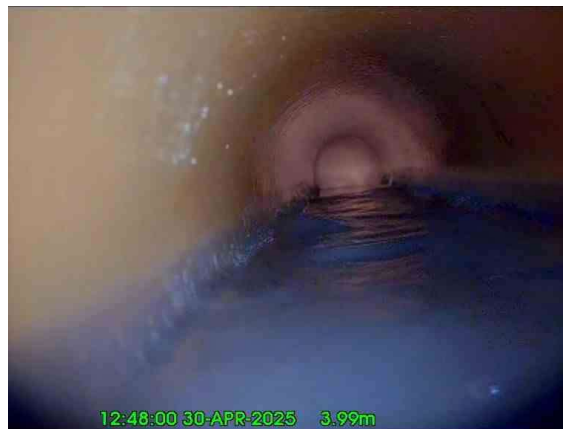
4, 00:01:40, 3.99 m

Settled deposits, hard or compacted, 20% cross-sectional area loss, finish, Solid set debris remained in sewer following jetting

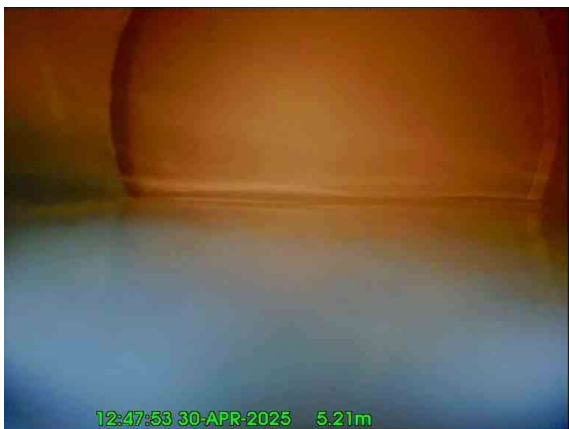
5, 00:01:32, 5.21 m  
Line deviates left

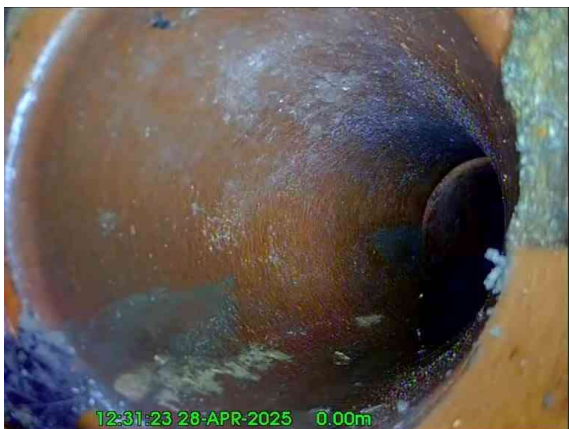
1, 00:00:02, 0.00 m  
Line deviates right

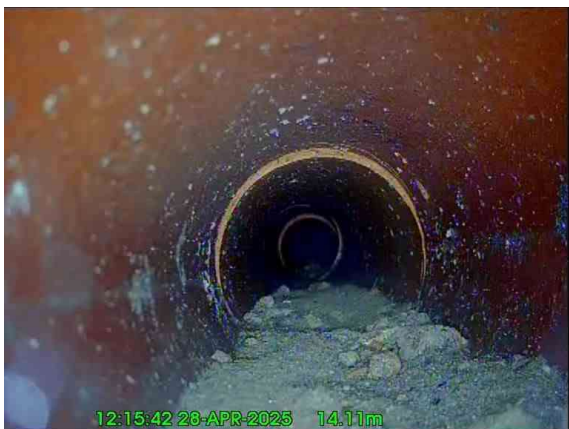
13, 00:01:58, 14.11 m

Settled deposits, coarse, 5% cross-sectional area loss, start

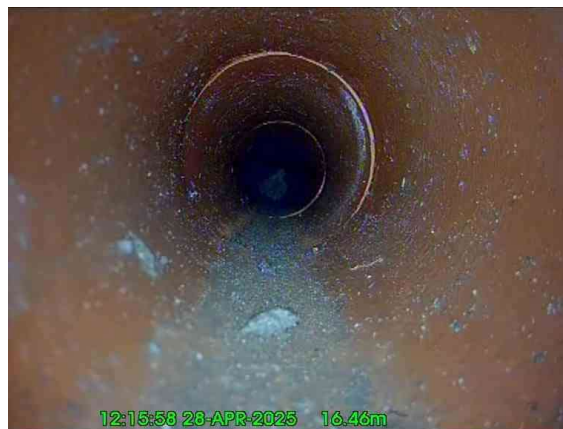
14, 00:02:14, 16.46 m

Settled deposits, coarse, 5% cross-sectional area loss, finish

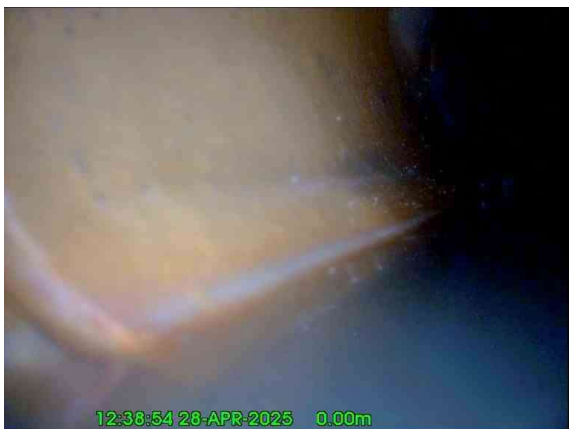
1, 00:00:03, 0.00 m  
Line deviates right

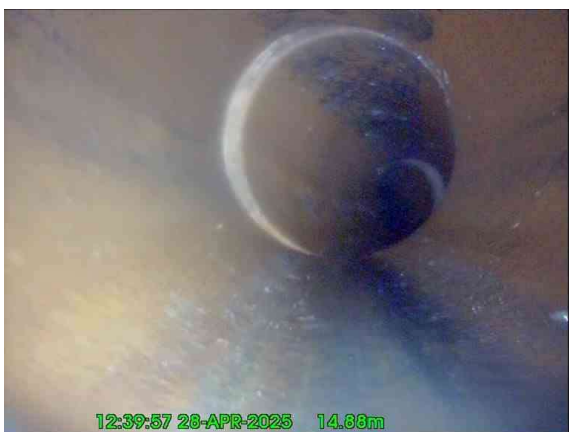
3, 00:01:07, 14.88 m  
Line deviates right

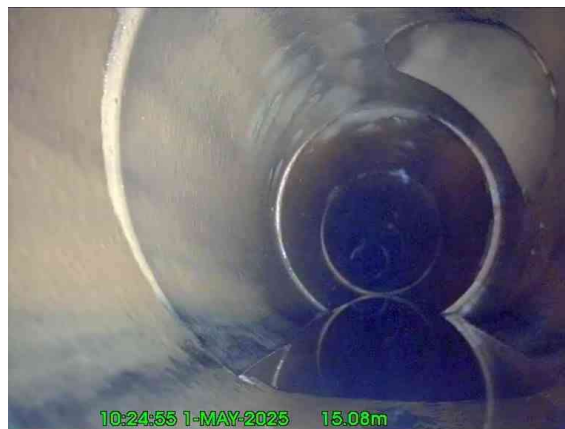
5, 00:00:53, 14.08 m

| Section | PLR | Grade | Description |
|---|---|---|---|
| 14 | MH10 X | 3 | Fracture, circumferential at joint from 8 o'clock to 4 o'clock |

<table><tr><th>Position [m]</th><th>Code</th><th>Observation</th><th>MPEG</th><th>Photo</th><th>Grade</th></tr><tr><td>14.08</td><td>FCJ</td><td>Fracture, circumferential at joint from 8 o'clock to 4 o'clock</td><td>00:00:53</td><td>5</td><td>3 / 2</td></tr></table>

Fracture, circumferential at joint from 8 o'clock to 4 o'clock

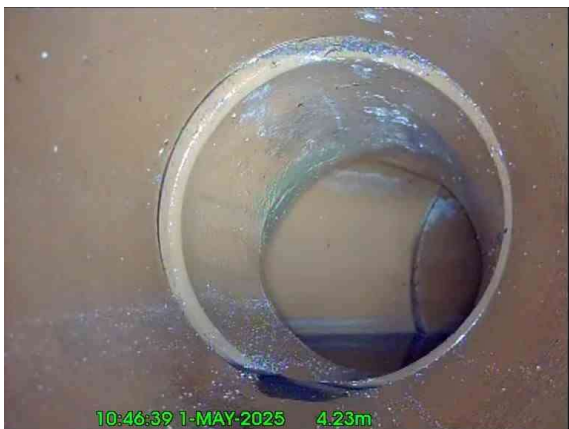
5, 00:00:38, 4.23 m  
Open joint, medium

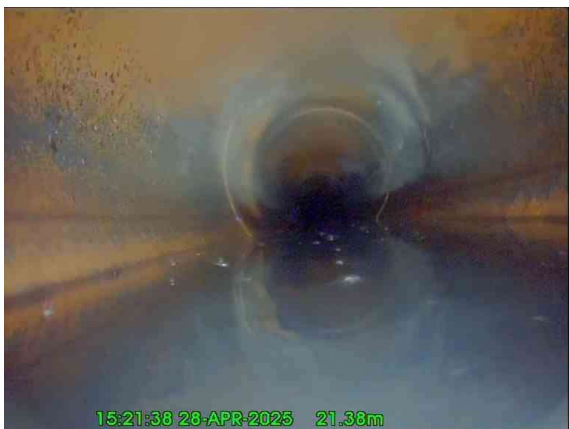
5, 00:03:29, 21.38 m  
General photograph taken at this point

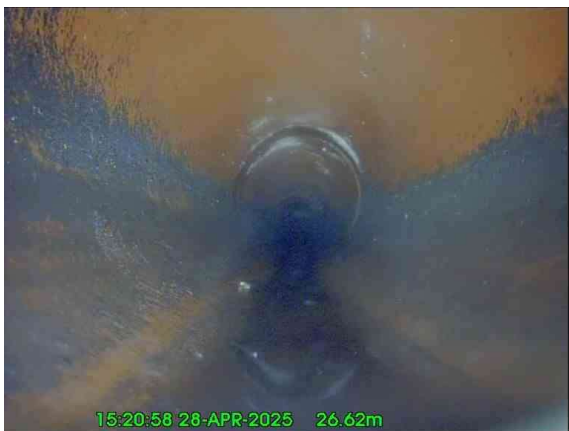
7, 00:02:50, 26.62 m  
Water level, 5% of the vertical dimension

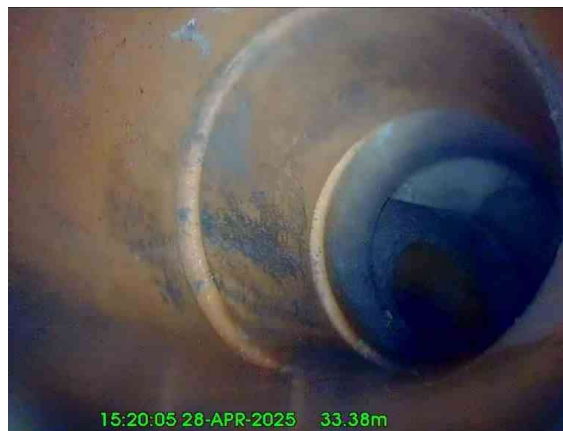
8, 00:01:56, 33.38 m  
Line deviates right

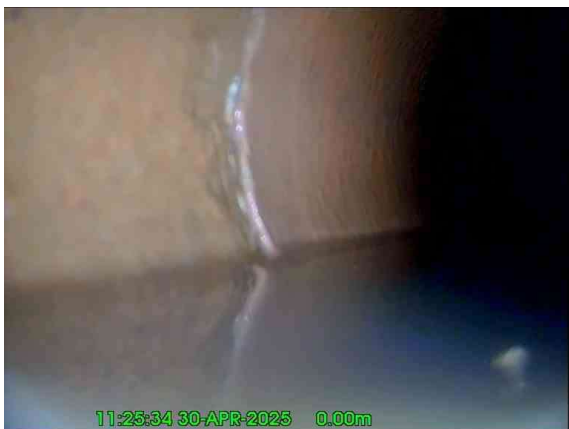
1, 00:00:02, 0.00 m  
Line deviates right

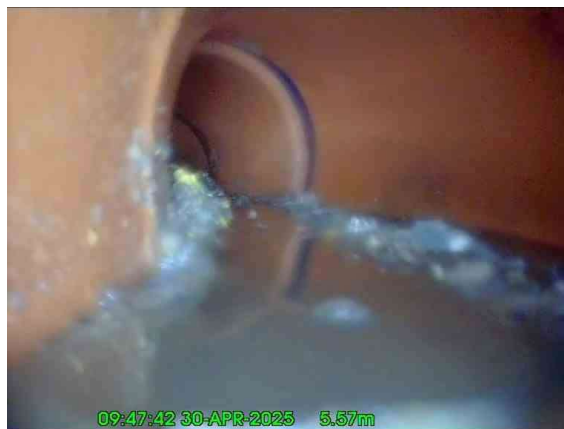
2, 00:02:44, 5.57 m  
Settled deposits, hard or compacted, 10% cross-sectional area loss, start, Solid set debris remained in sewer following jetting

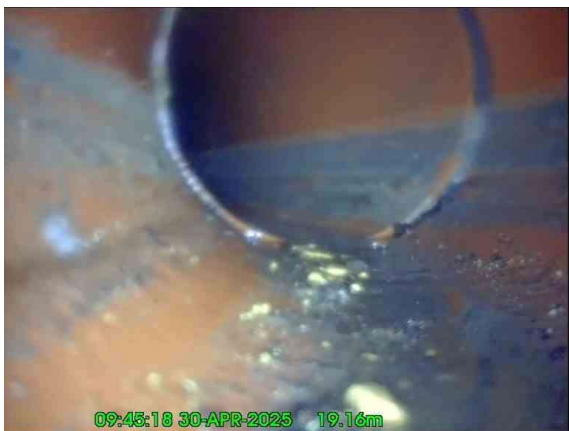
11, 00:00:20, 19.16 m  
Open joint, medium

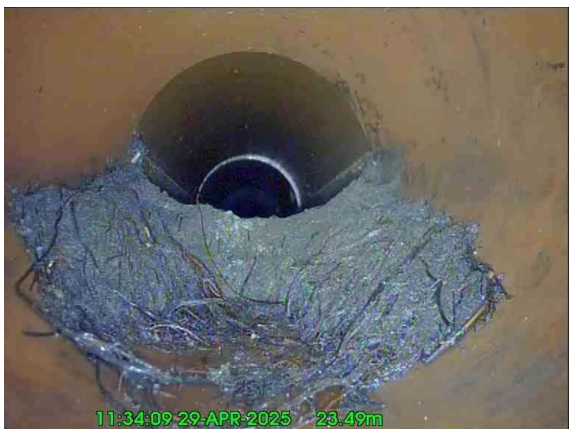
9, 00:01:11, 23.49 m

Roots, mass at joint, 50% cross-sectional area loss

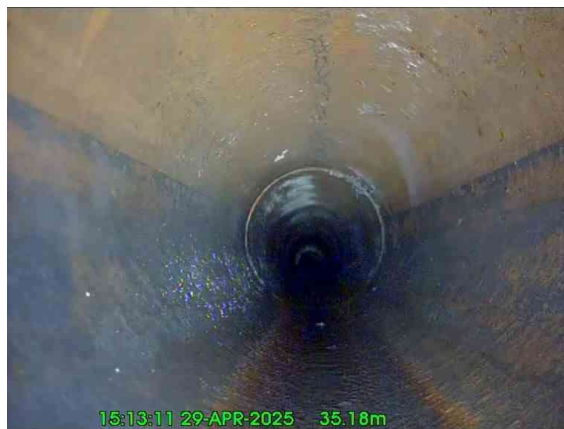
15:13:11 29-APR-2025 35.18m

6, 00:02:55, 35.18 m  
Survey abandoned, Remaining section of sewer surveyed from  
MH39 A downstream

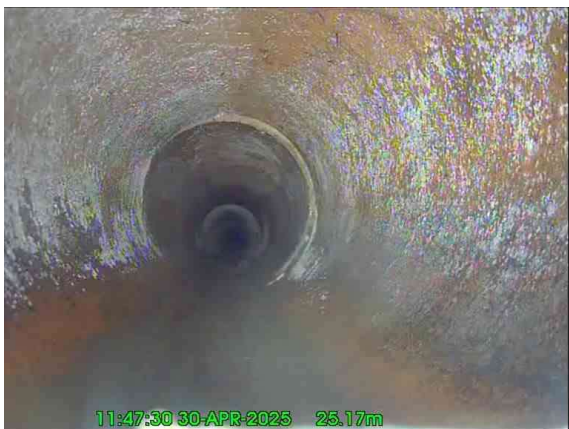
5, 00:01:36, 25.17 m

Survey abandoned, Remaining section of sewer surveyed from  
MH37 X upstream

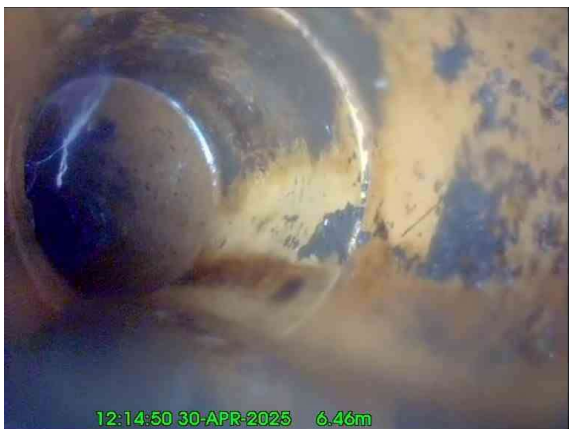
5, 00:00:35, 6.46 m  
Line deviates left

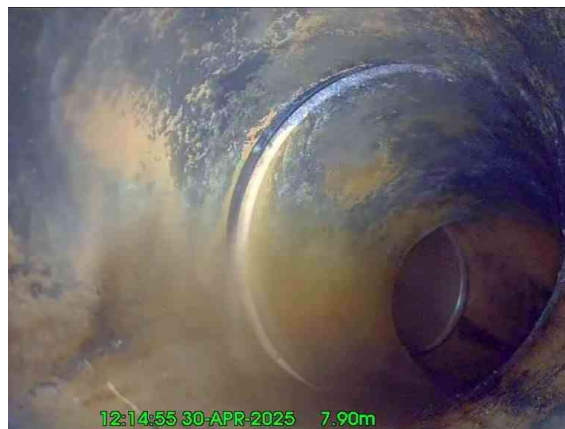
6, 00:00:40, 7.90 m  
Line deviates right

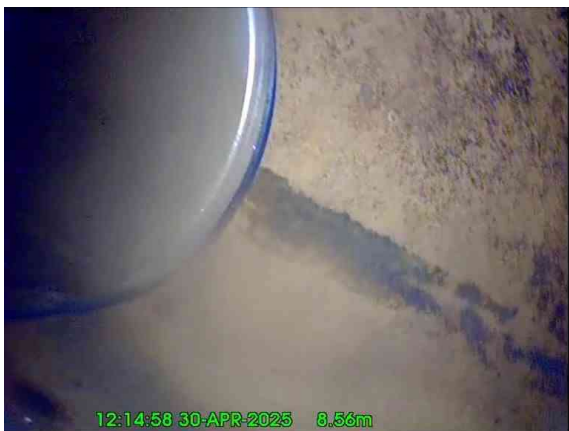
7, 00:00:43, 8.56 m  
Line deviates left

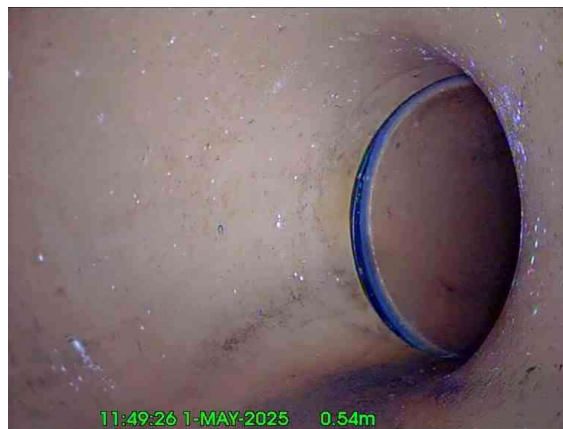
2, 00:00:11, 0.54 m  
Line deviates right

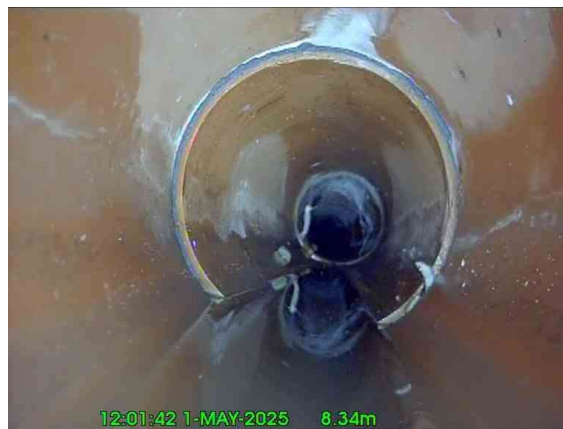
2, 00:00:32, 8.34 m  
Open joint, medium

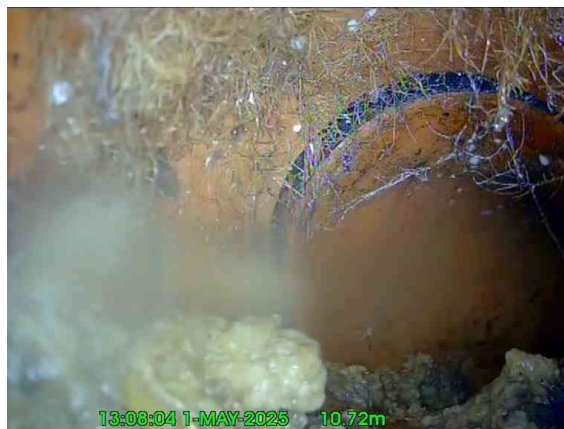
6, 00:00:57, 10.72 m  
Line deviates right

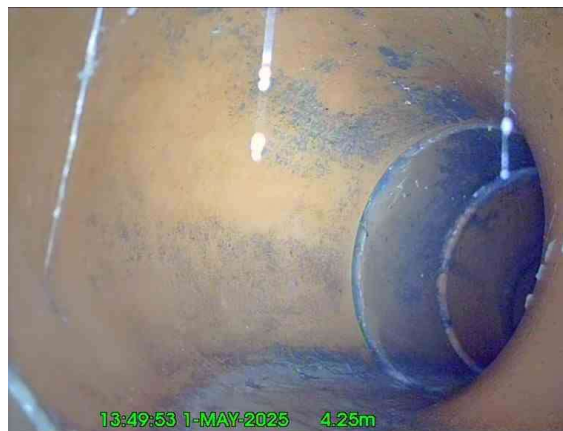
4, 00:00:53, 4.25 m  
Line deviates right

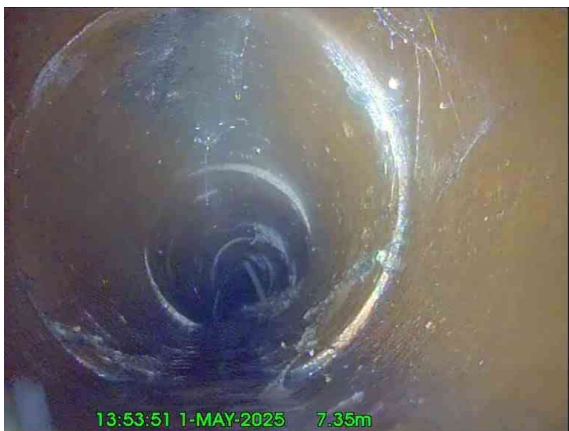
7, 00:02:48, 7.35 m

Roots, fine at joint

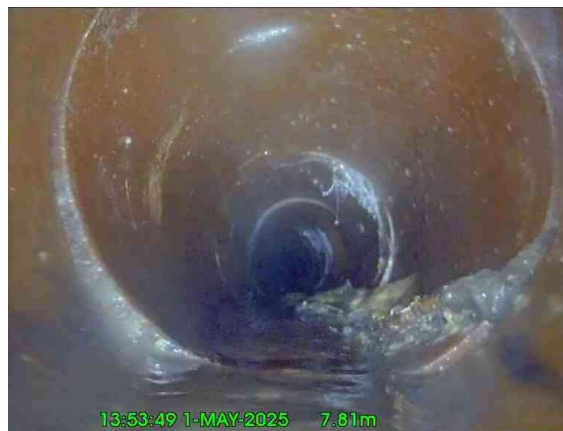
8, 00:02:46, 7.81 m

Roots, mass at joint, 5% cross-sectional area loss

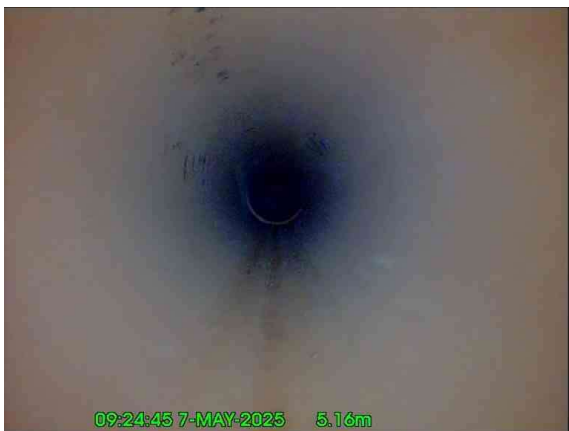
3, 00:00:21, 5.16 m  
General photograph taken at this point

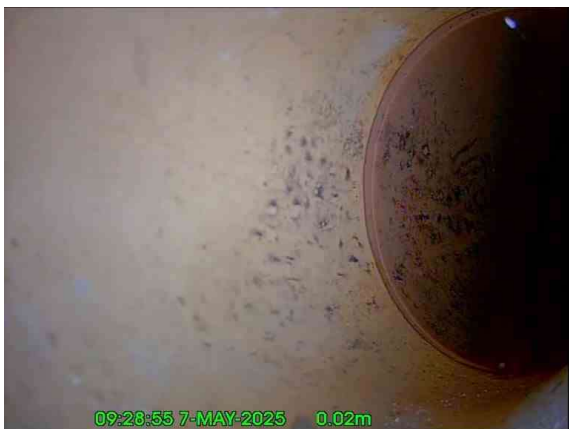
1, 00:00:01, 0.02 m  
Line deviates right

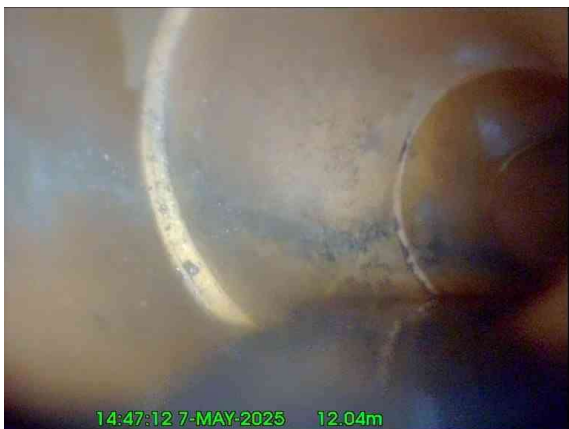
5, 00:01:06, 12.05 m  
Line deviates right

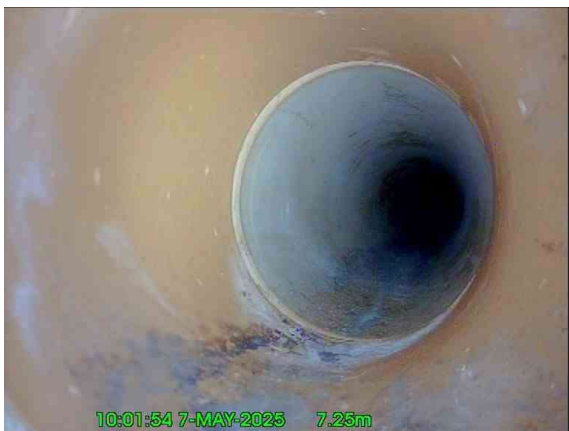
3, 00:00:47, 7.25 m  
Line deviates right

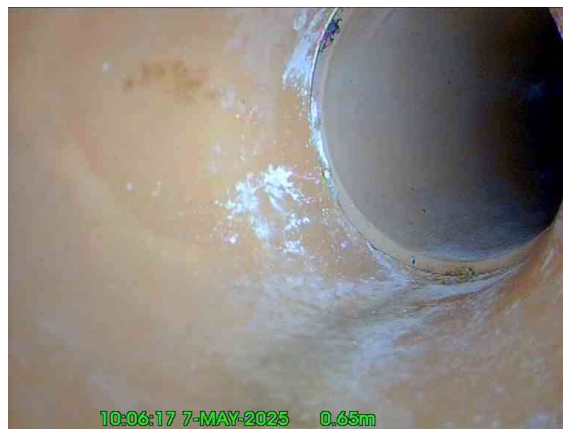
2, 00:00:10, 0.65 m  
Line deviates right

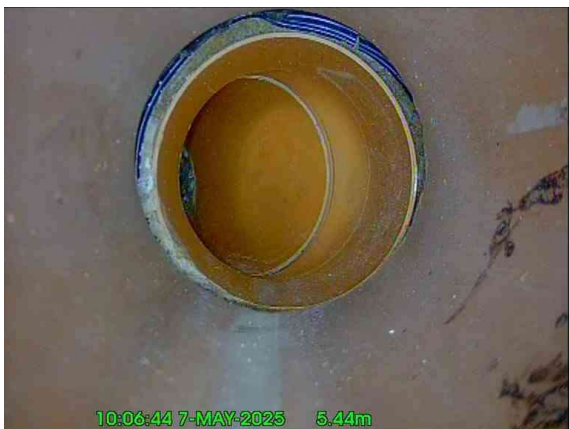
5, 00:00:36, 5.44 m

Pipe material changes to polyvinyl chloride at this point

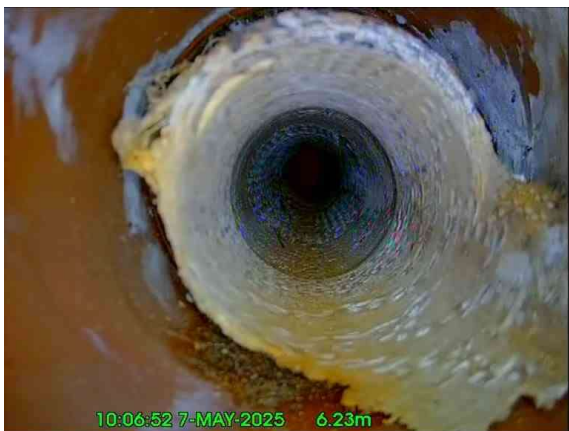
6, 00:00:38, 5.58 m

Line deviates left

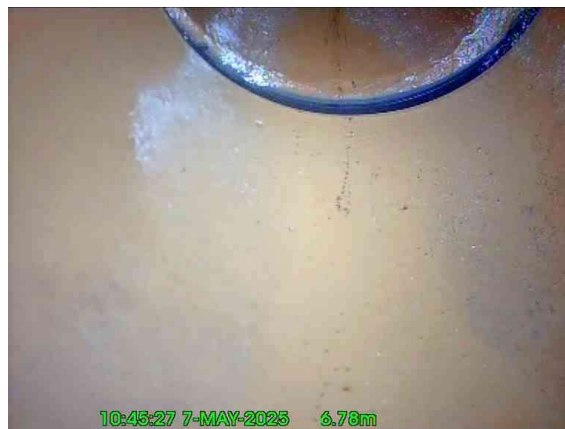
6, 00:00:38, 6.78 m  
Open joint, medium

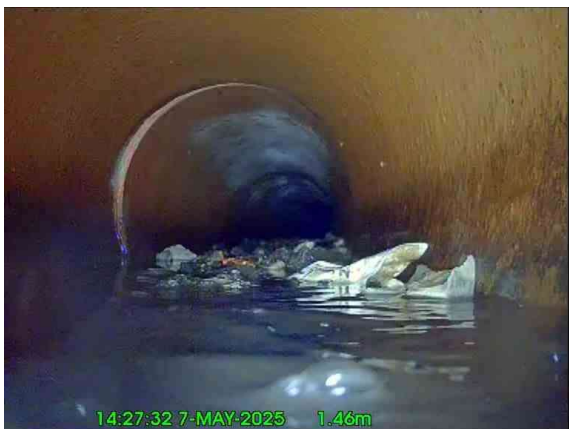
1, 00:01:34, 1.46 m

Settled deposits, coarse, 10% cross-sectional area loss, start

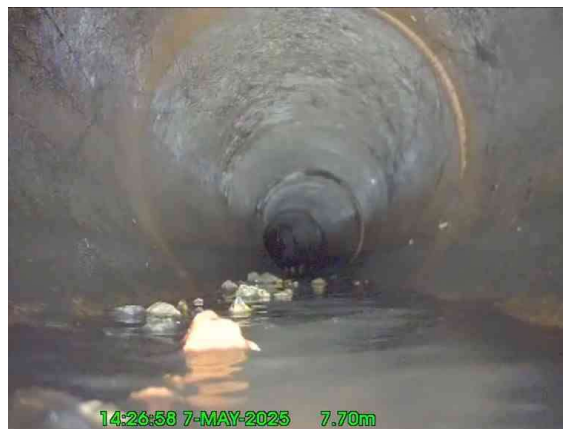
2, 00:00:59, 7.70 m

Settled deposits, coarse, 5% cross-sectional area loss, change

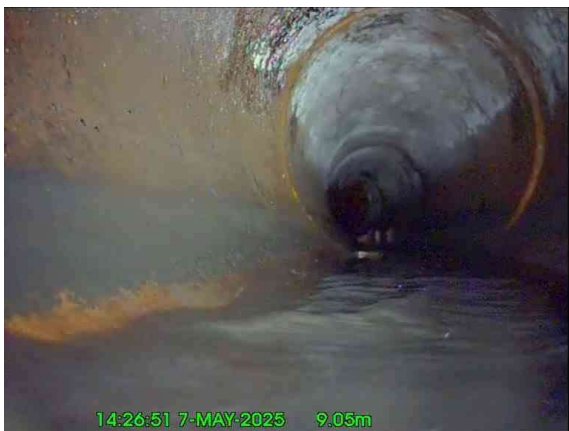
3, 00:00:52, 9.05 m

Settled deposits, coarse, 5% cross-sectional area loss, finish

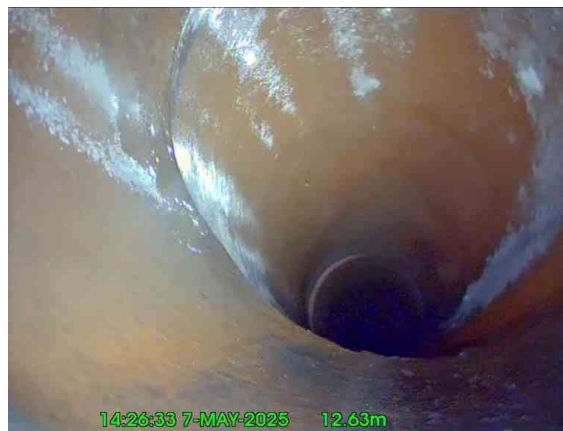
4, 00:00:34, 12.63 m

Line deviates down

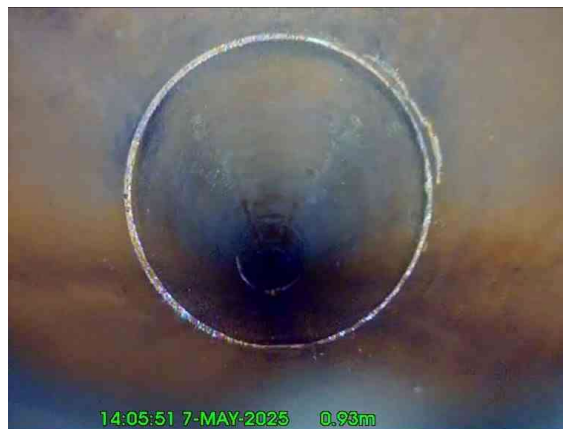
2, 00:00:07, 0.93 m  
General photograph taken at this point

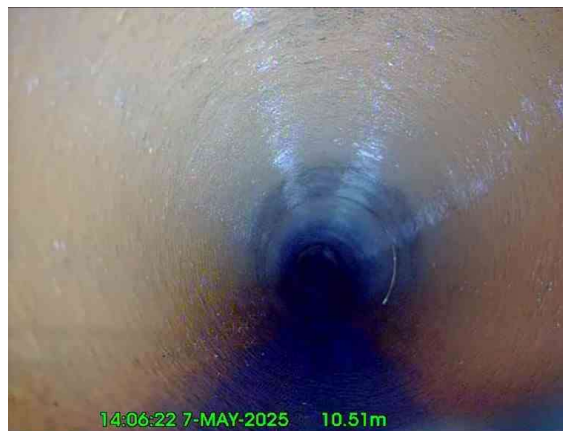
4, 00:00:38, 10.51 m  
General photograph taken at this point

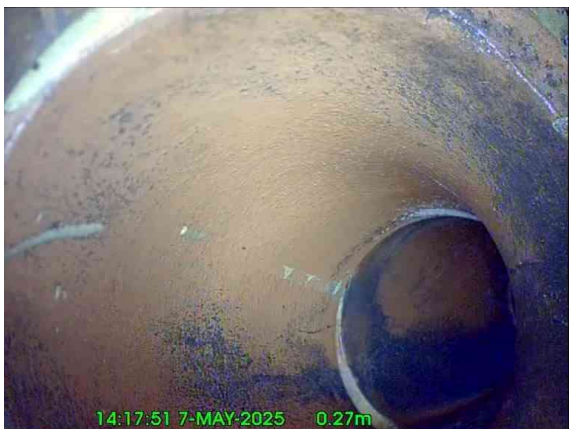
1, 00:00:06, 0.27 m  
Line deviates right

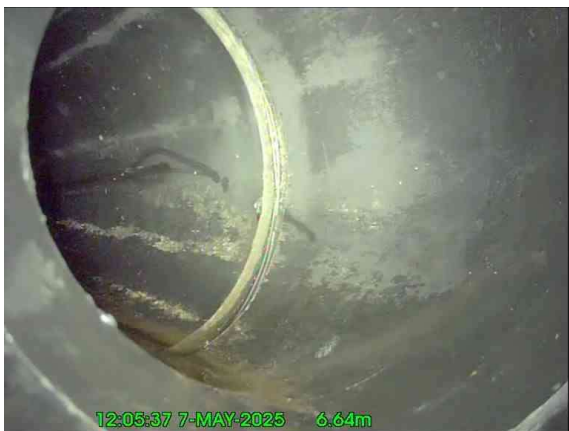
12:05:37 7-MAY-2025 6.64m

Line deviates left

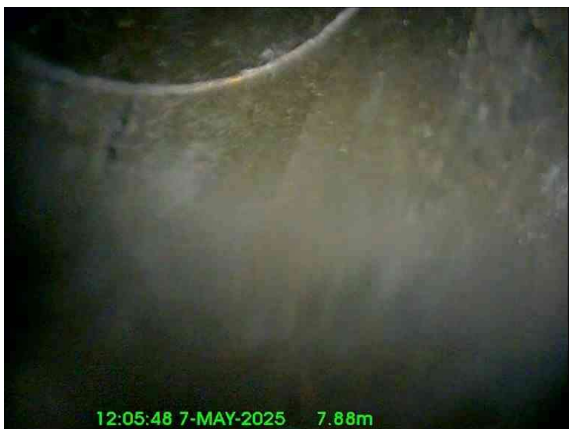
5, 00:00:45, 7.88 m

Finish node, other special chamber, reference: Downpipe,  
Internal downpipe reached

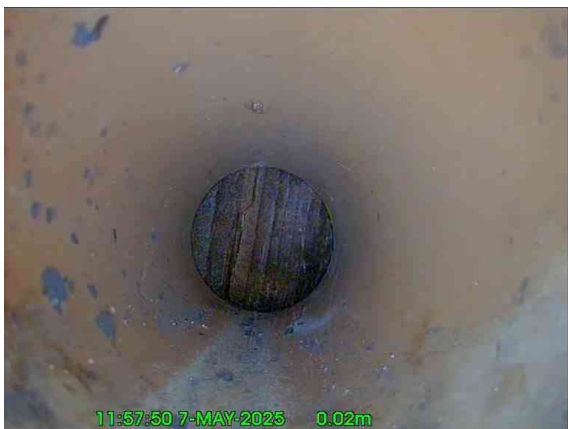
1, 00:00:03, 0.02 m  
General photograph taken at this point

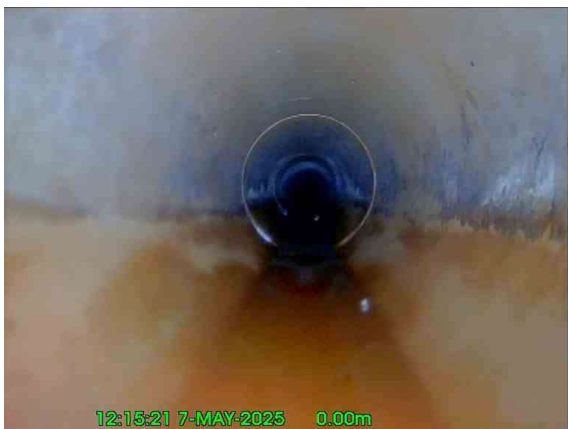
1, 00:00:03, 0.00 m  
General photograph taken at this point

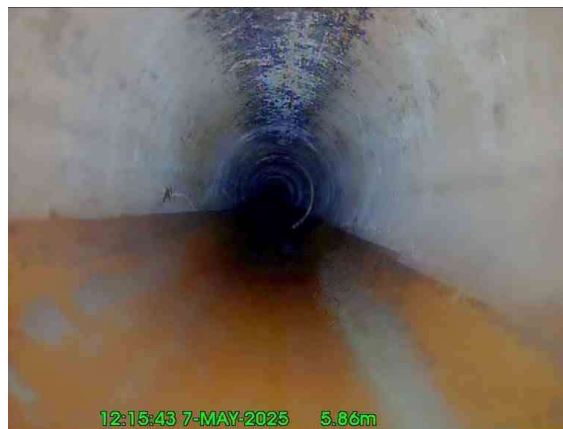
2, 00:00:24, 5.86 m  
General photograph taken at this point

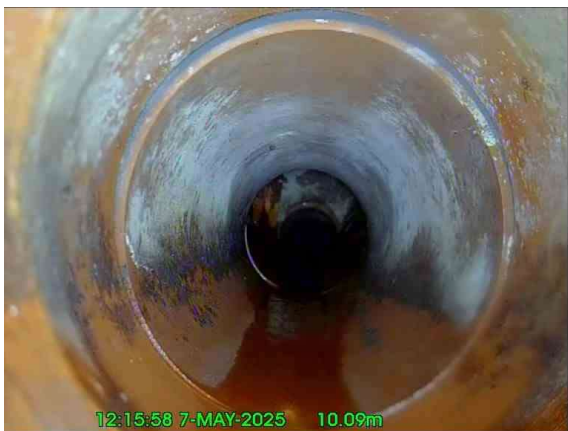
3, 00:00:40, 10.09 m  
Pipe size changes, new size(s), 150mm high

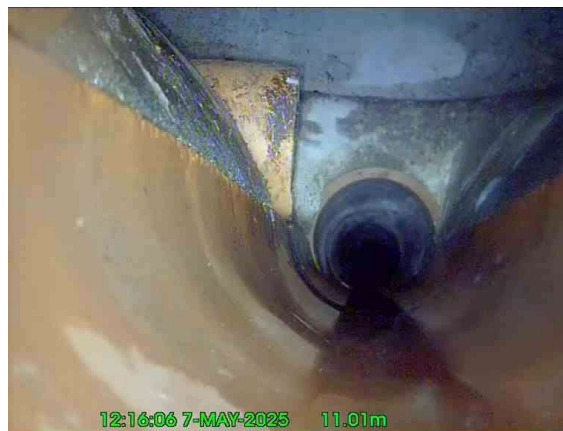
4, 00:00:48, 11.01 m  
Finish node, manhole, reference: MH56 reached

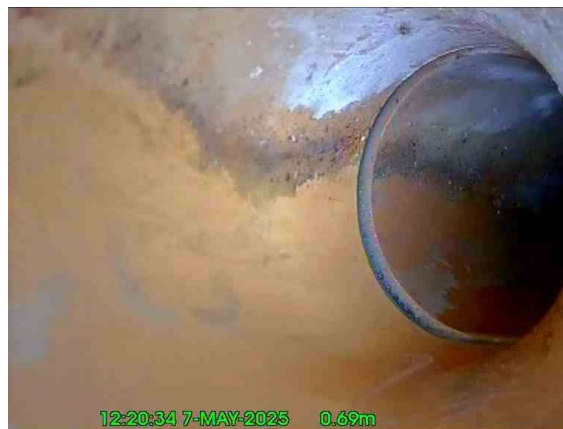
2, 00:00:11, 0.69 m  
Line deviates right

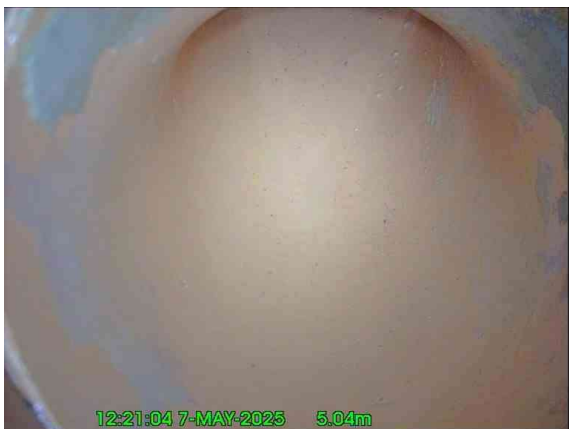
5, 00:00:41, 5.04 m

Finish node, other special chamber, reference: Downpipe,  
Internal downpipe reached

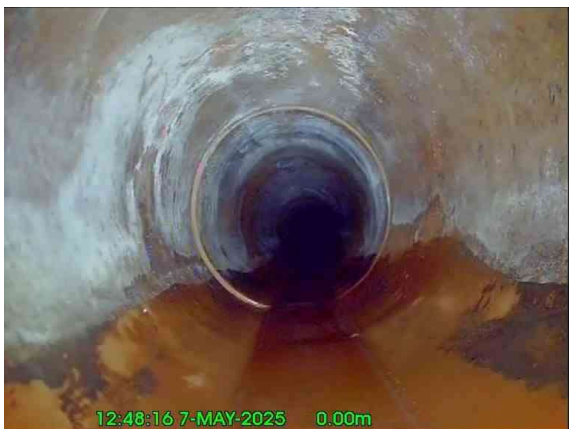
1, 00:00:01, 0.00 m  
General photograph taken at this point

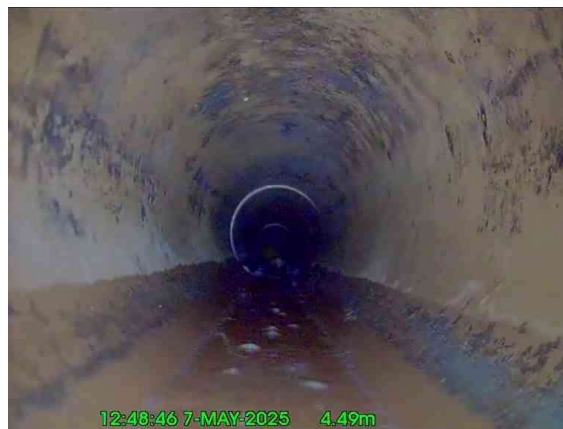
2, 00:00:32, 4.49 m  
General photograph taken at this point

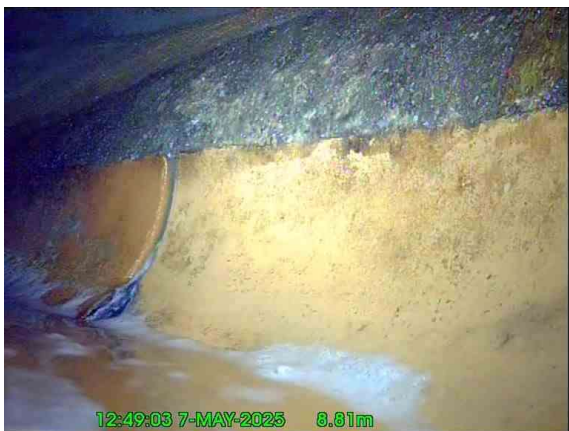
3, 00:00:49, 8.81 m  
Finish node, manhole, reference: MH63 reached

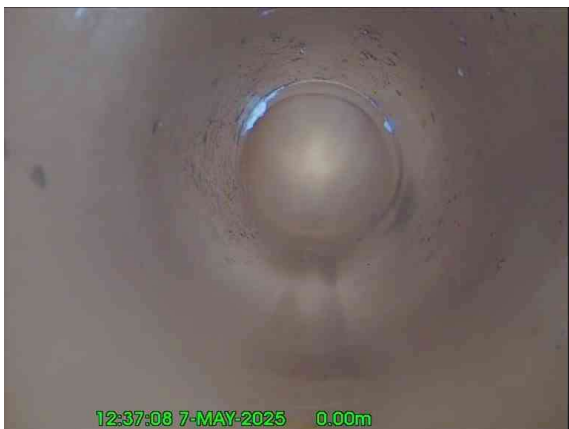
1, 00:00:02, 0.00 m  
General photograph taken at this point

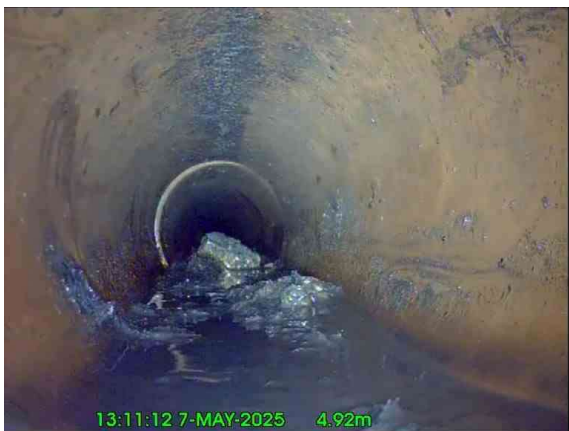
3, 00:00:27, 4.92 m  
General photograph taken at this point

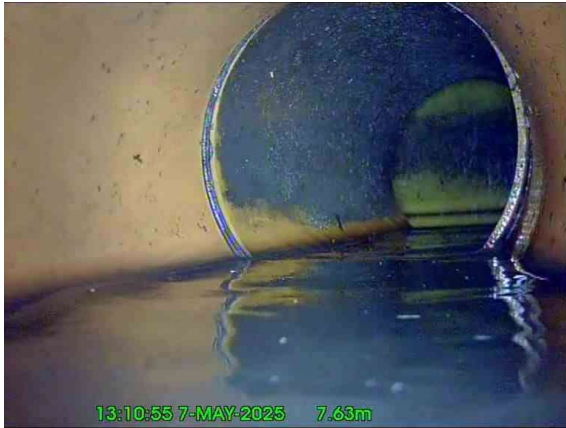
5, 00:00:10, 7.63 m  
Line deviates right

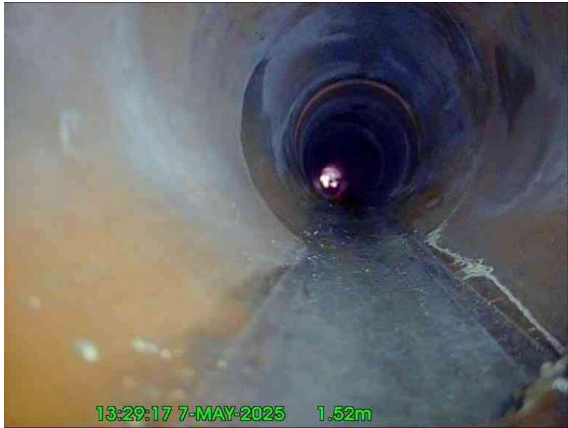
1, 00:00:15, 1.52 m  
General photograph taken at this point

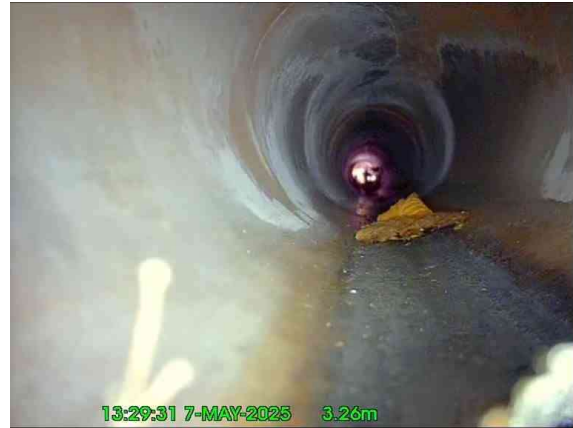
2, 00:00:29, 3.26 m  
General photograph taken at this point

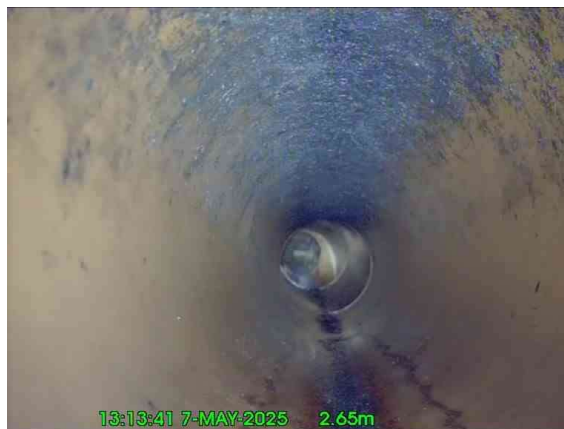
2, 00:00:23, 2.65 m  
General photograph taken at this point

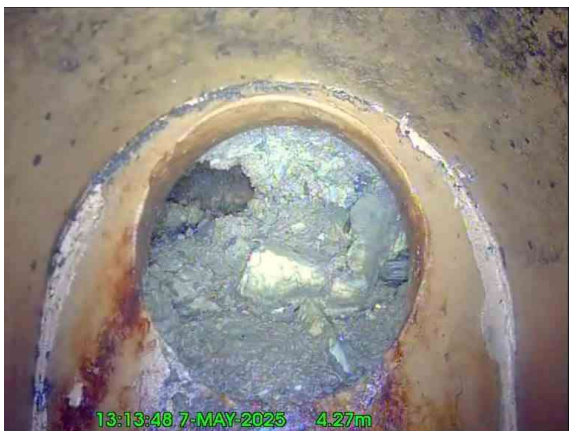
3, 00:00:30, 4.27 m  
Finish node, gully, reference: Buried Gully reached

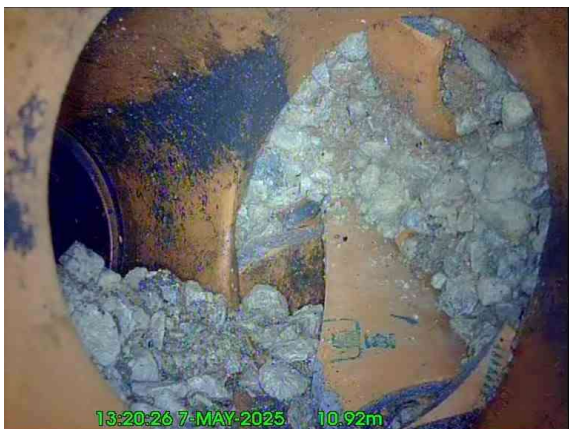
5, 00:00:44, 10.92 m

Finish node, other special chamber, reference: Capped,  
Capped pipe reached

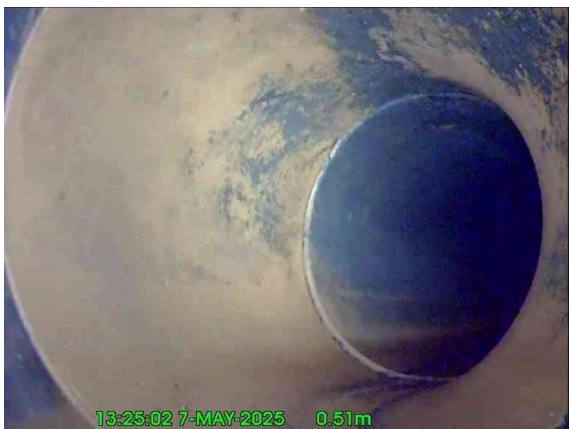
1, 00:00:08, 0.51 m  
Line deviates right

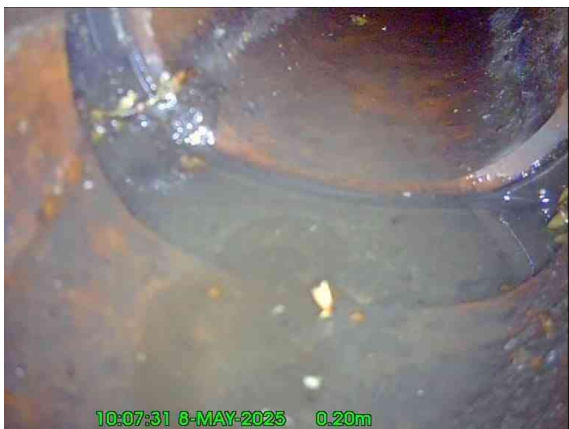
1, 00:00:05, 0.20 m  
Joint displaced, large

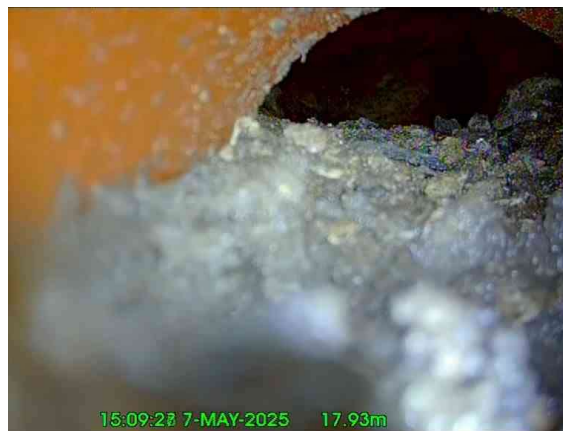
4, 00:01:22, 17.93 m  
Finish node, manhole, reference: MH62 reached

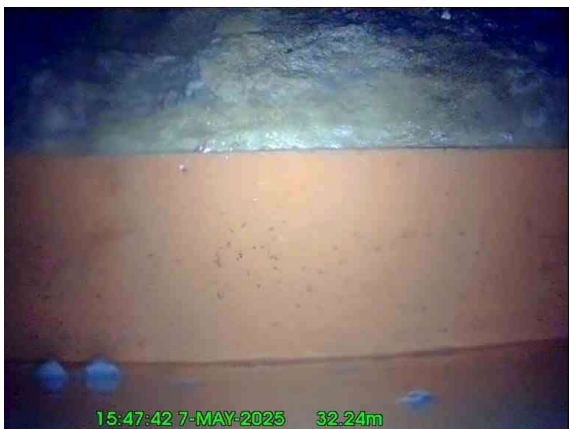
9, 00:02:32, 32.24 m

Finish node, manhole, reference: MH64 reached, UU MH Ref:  
2902

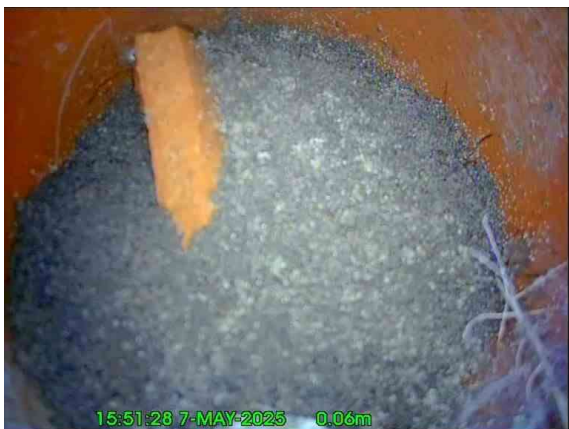
1, 00:00:04, 0.06 m

Finish node, other special chamber, reference: Capped,  
Capped pipe reached

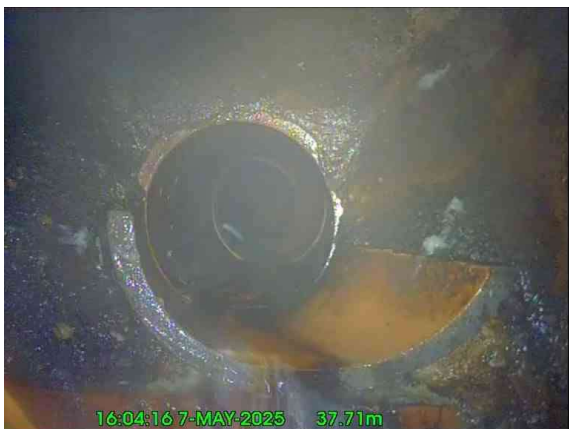
5, 00:02:04, 37.71 m

Finish node, manhole, reference: MH65 reached

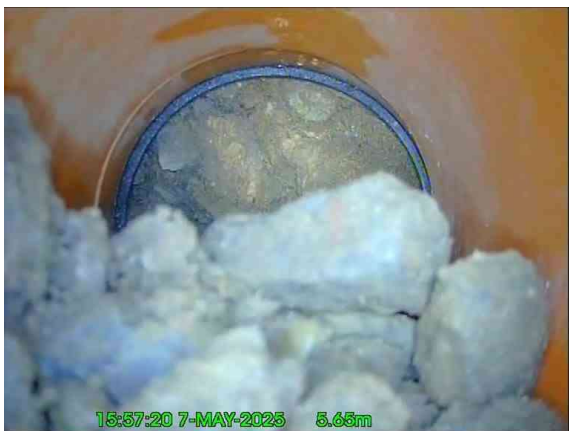
3, 00:00:25, 5.65 m  
Finish node, other special chamber, reference: Capped,  
Capped pipe reached

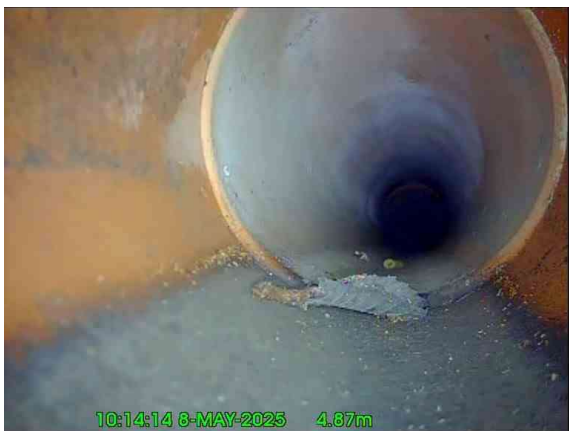
3, 00:00:21, 4.87 m  
Line deviates right

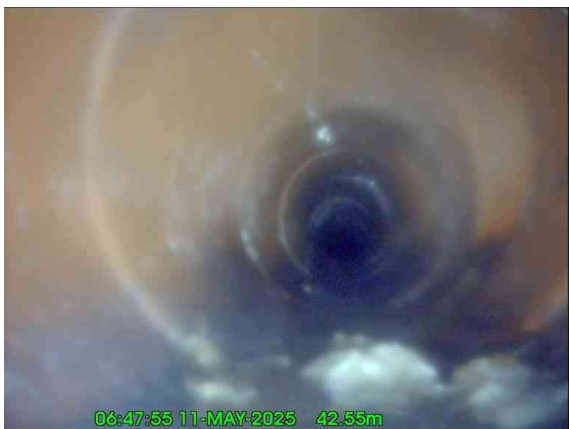
9, 00:03:43, 42.55 m  
Junction at 3 o'clock, 150mm dia, from MH46 X, Junction  
visible downstream of this point

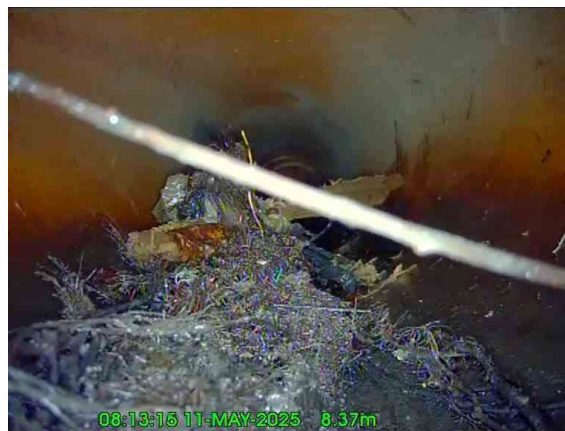
4, 00:01:41, 8.37 m  
Roots, mass, 25% cross-sectional area loss

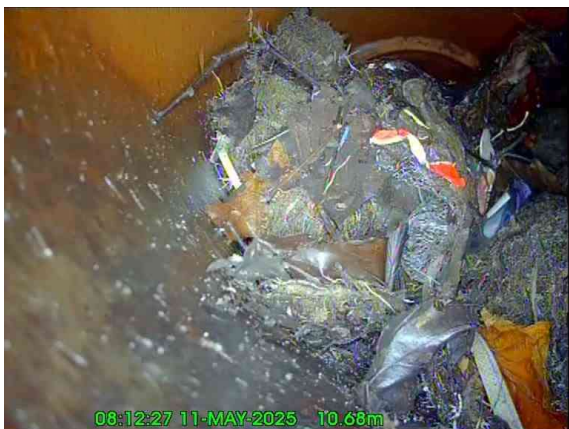
5, 00:00:52, 10.68 m

Roots, mass at joint, 80% cross-sectional area loss
