# Validation Completion Report

Site: Sonnet Gate, Prescott

Reference:15-292-R1

Date: July 2025

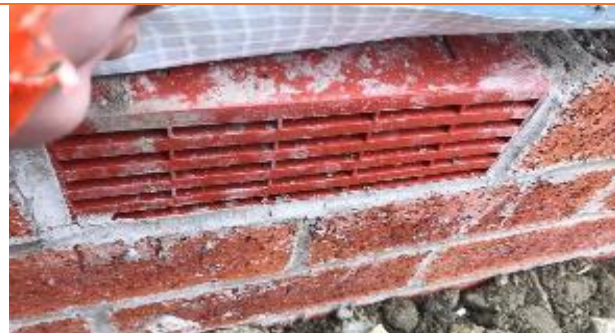
**Verification of Ventilation-Good Condition**

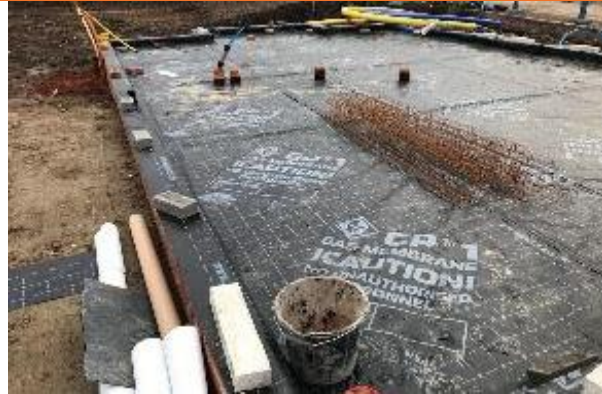
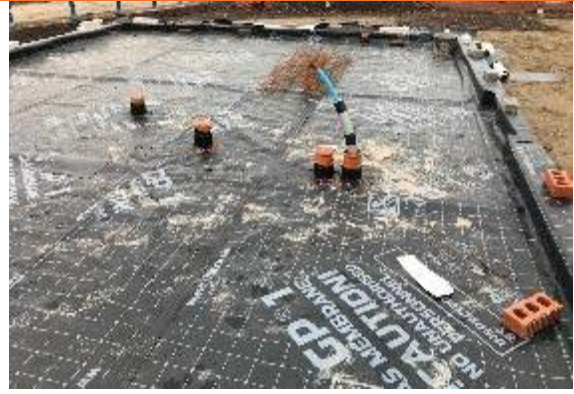
**Plot - 3**

**General Condition of Membrane-Good Condition**

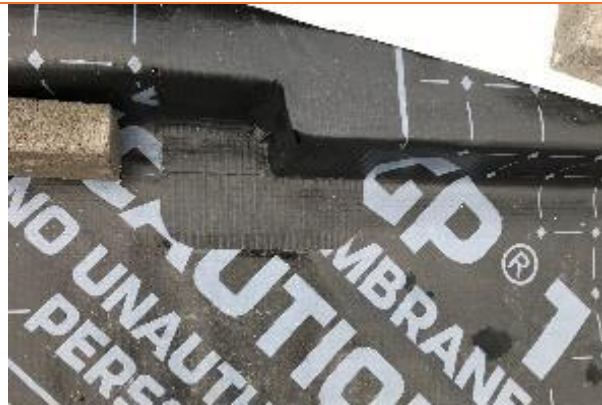
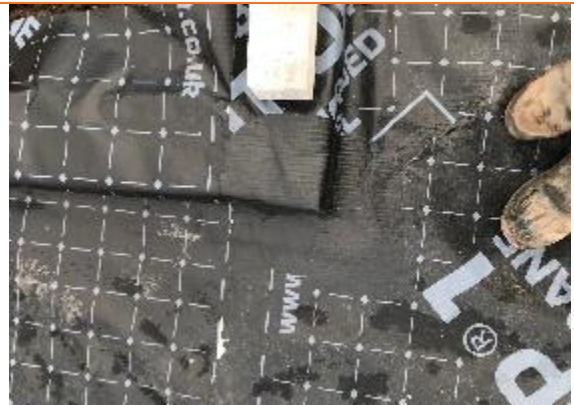
**Verification of Joints and Seals-Good Condition**

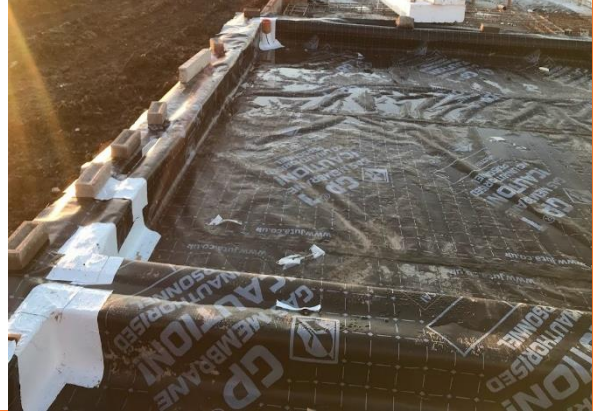
**Plot - 8**

**General Condition of Membrane-Good Condition**

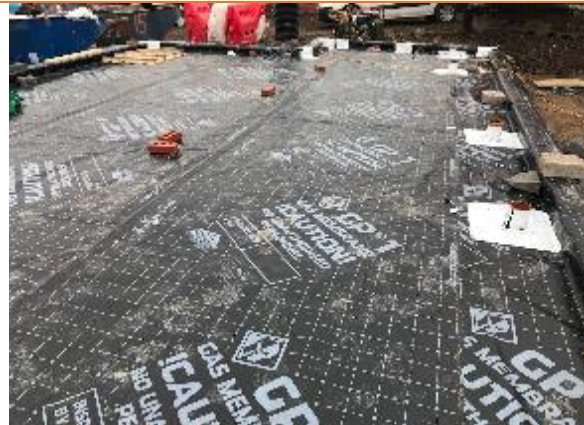
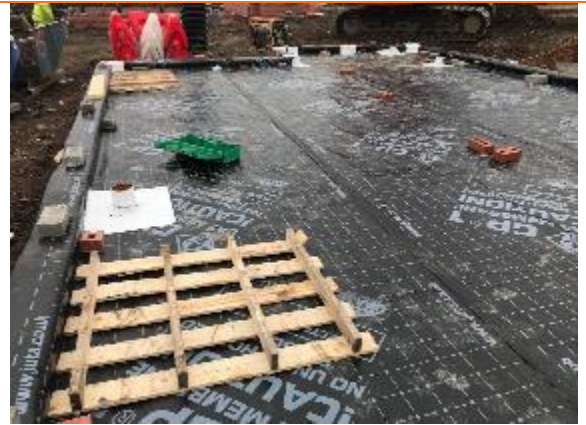
**Plot - 19**

**General Condition of Membrane-Good Condition**

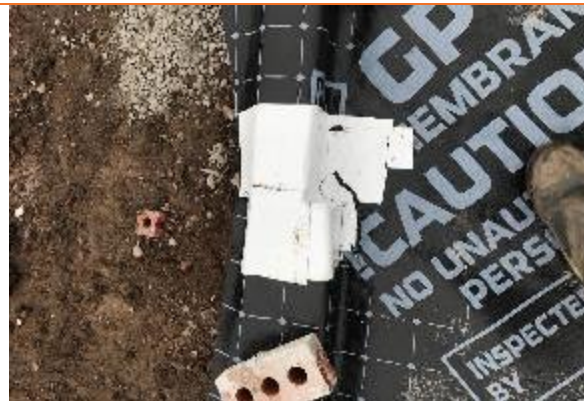
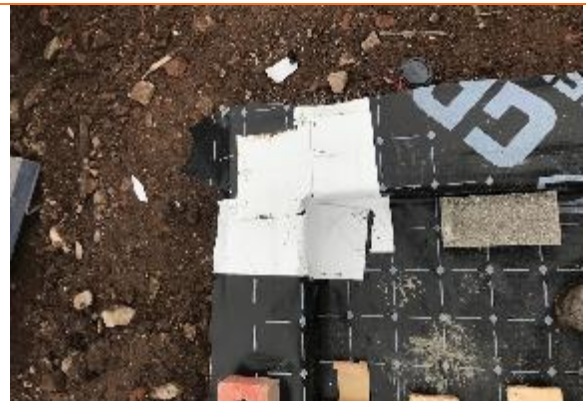
**Verification of Joints and Seals-Good Condition**

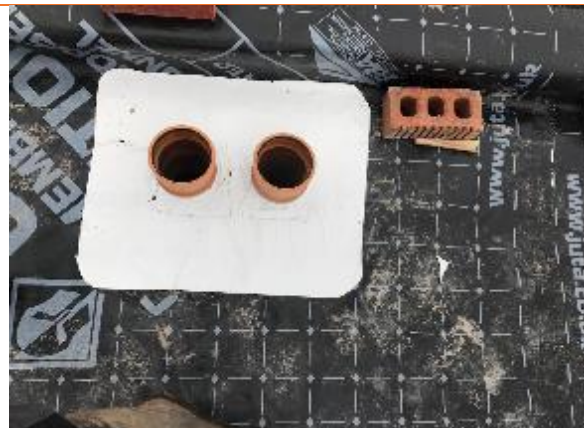
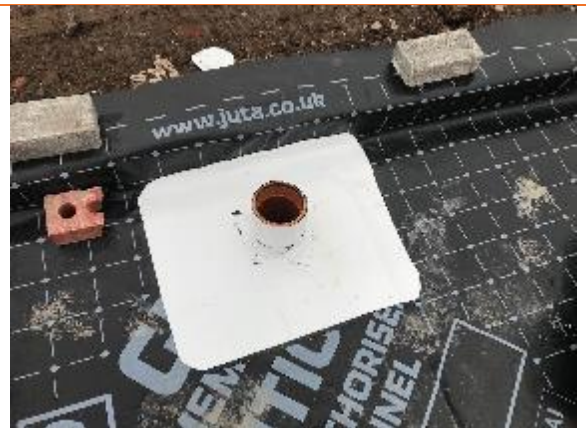
**Verification of Service Penetrations-Good Condition**

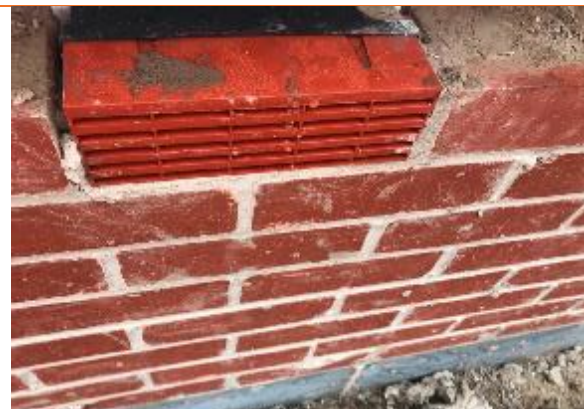
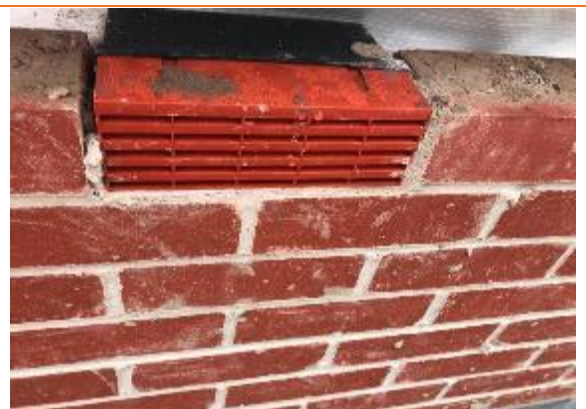
**Verification of Ventilation- Good Condition**

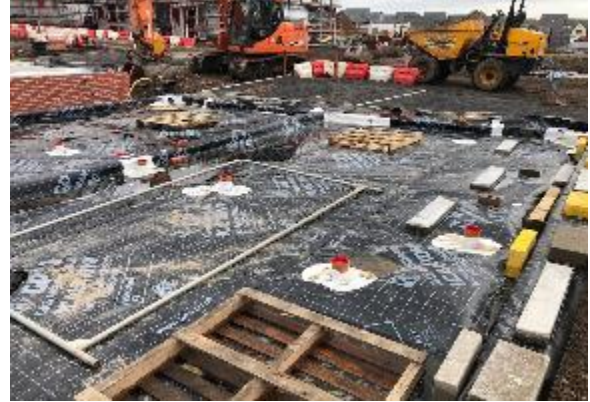
**Plot - 12**

**General Condition of Membrane-Good Condition**

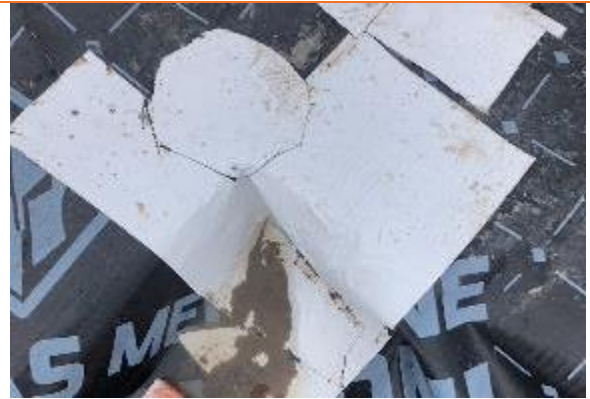
**Verification of Joints and Seals-Good Condition**

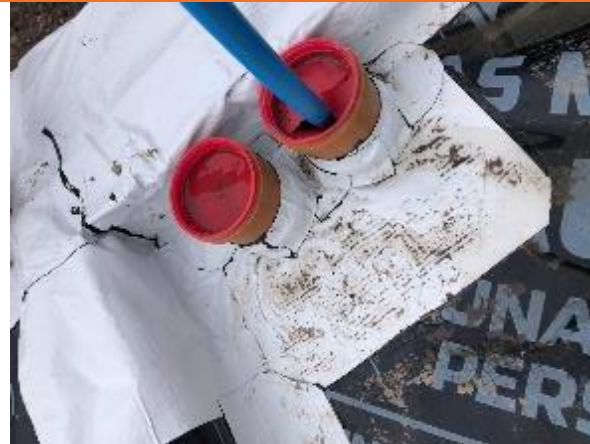
**Verification of Service Penetrations-Good Condition**

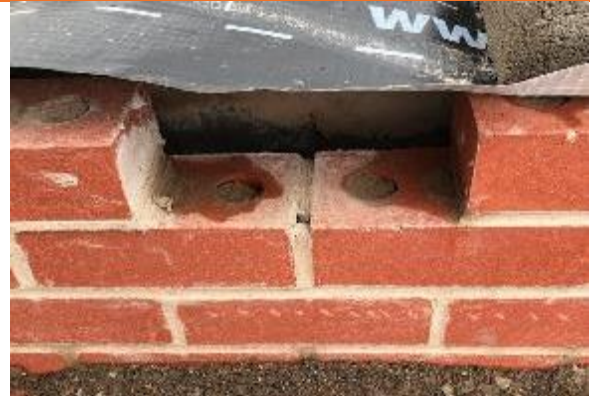
**Verification of Service Penetrations-Good Condition**

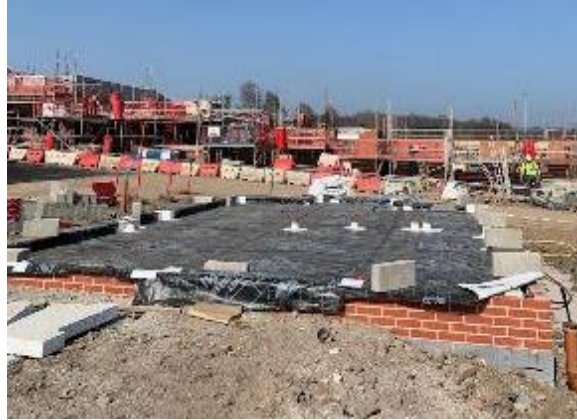
**Plot - 34**

**General Condition of Membrane-Good Condition**

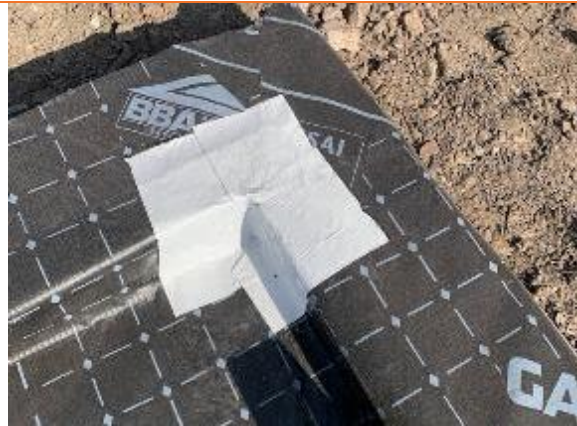
**Verification of Joints and Seals-Good Condition**

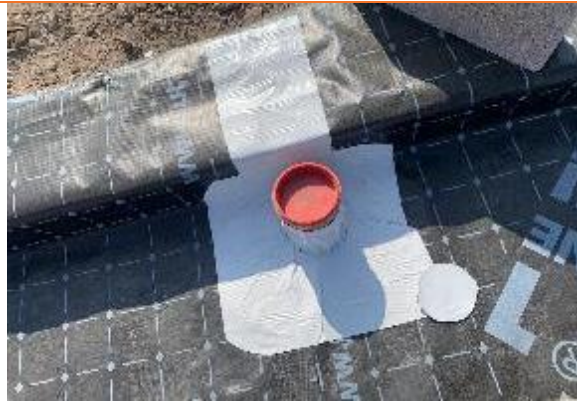
**Verification of Service Penetrations-Good Condition**

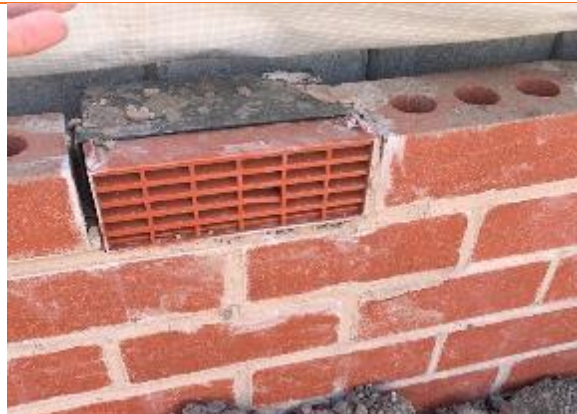
**Verification of Service Penetrations-Good Condition**

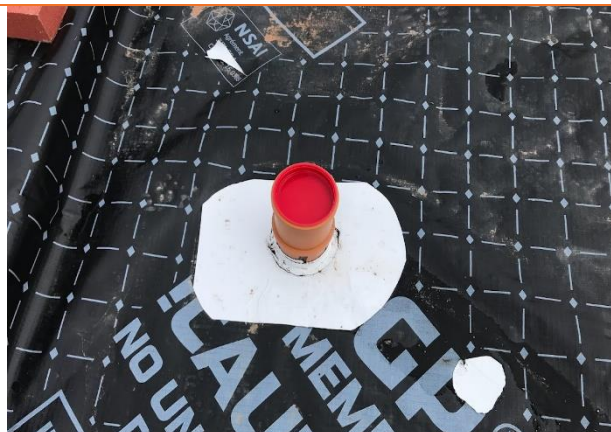
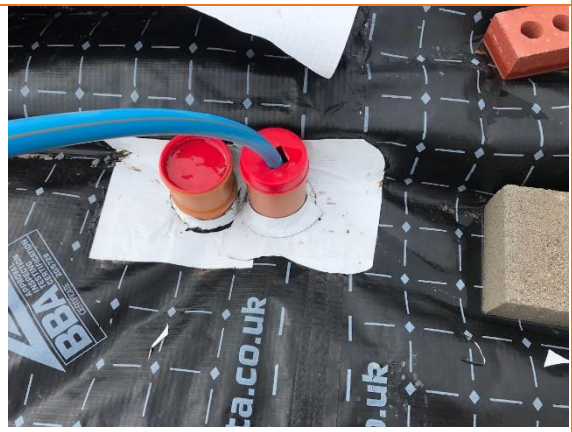
Plot - 32

Verification of Service Penetrations-Good Condition

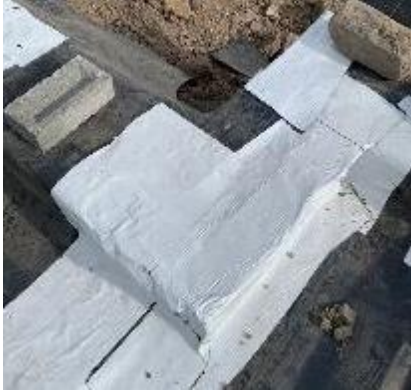
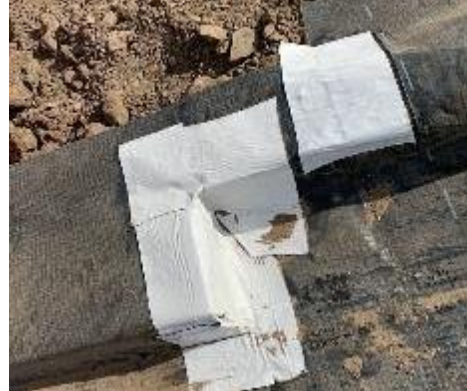
**Plot - 27**

**Verification of Joints and Seals-Good Condition**

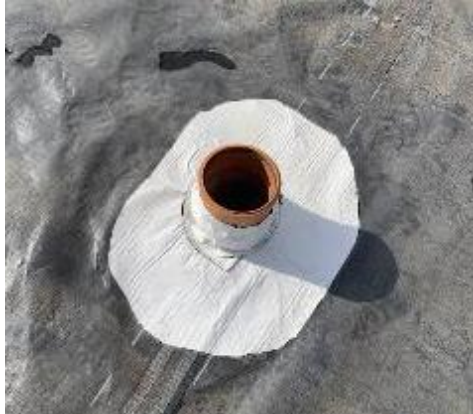
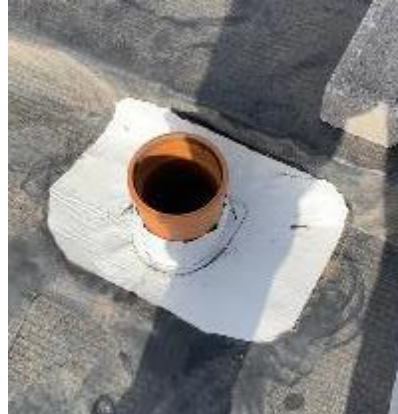
**Verification of Service Penetrations-Good Condition**

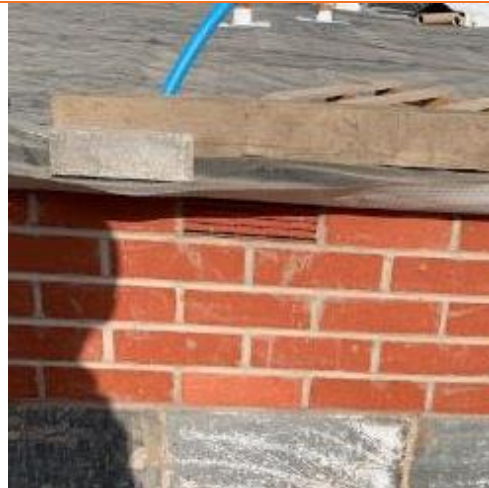
**Verification of Service Penetrations-Good Condition**

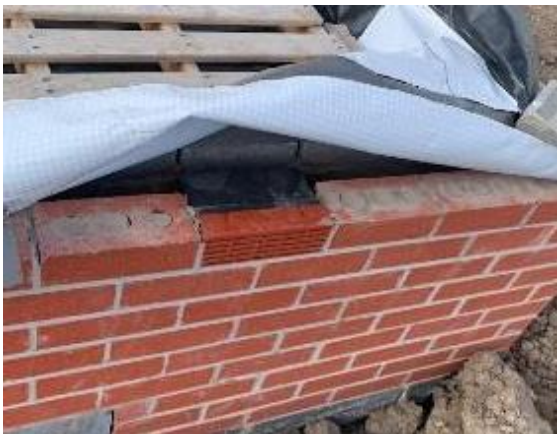
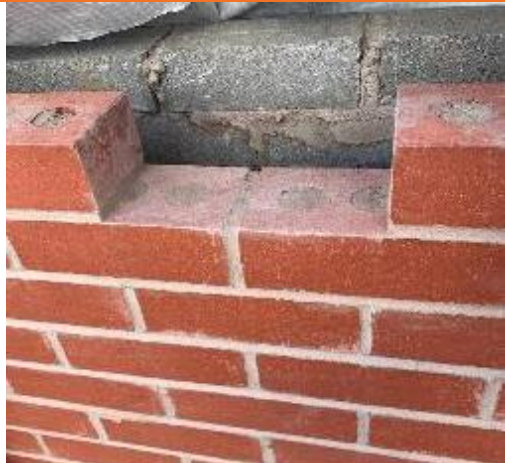
**Plot - 29**

**Verification of Service Penetrations-Good Condition**

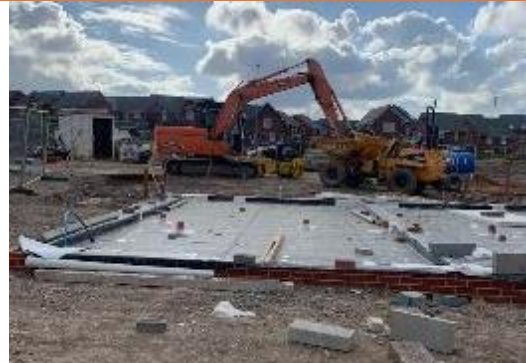
**Plot - 31**

**General Condition of Membrane-Good Condition**

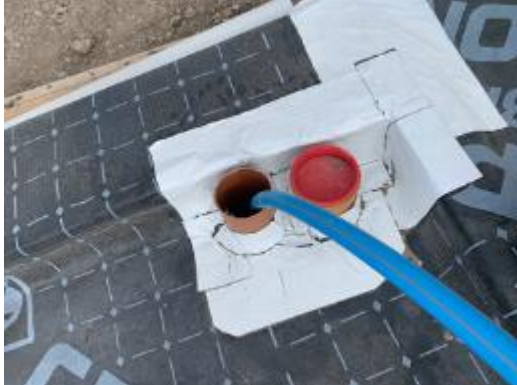
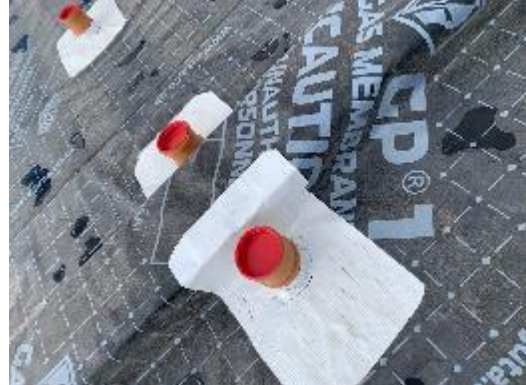
**Verification of Service Penetrations-Good Condition**

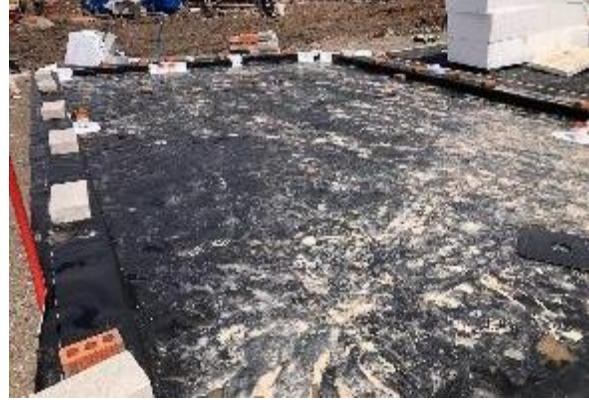
**Plot - 20**

**General Condition of Membrane-Good Condition**

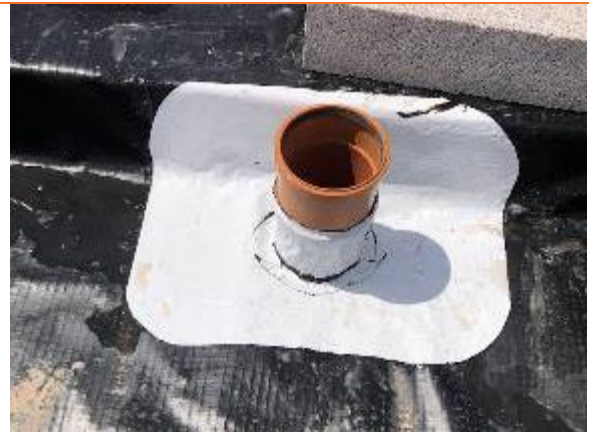
**Verification of Service Penetrations-Good Condition**

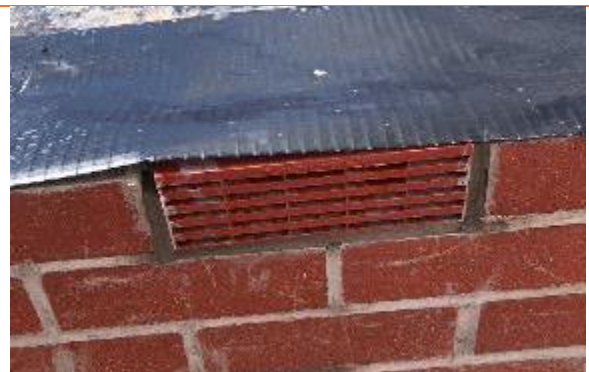
**Verification of Service Penetrations-Good Condition**

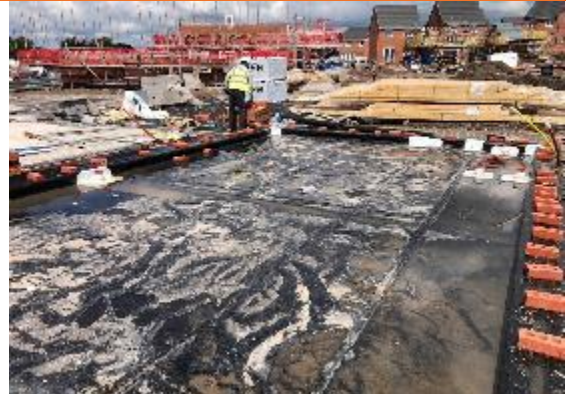
**Plot - 26**

**General Condition of Membrane-Good Condition**

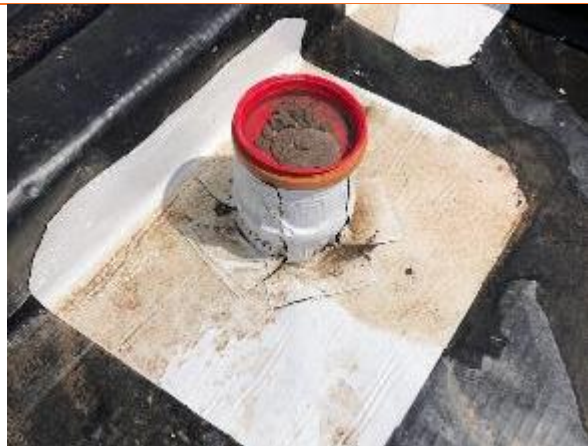
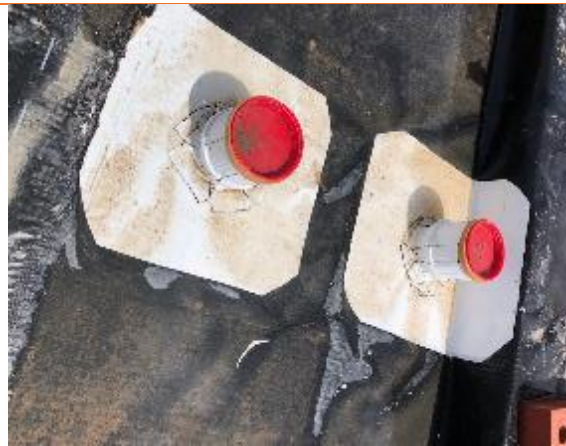
**Verification of Service Penetrations-Good Condition**

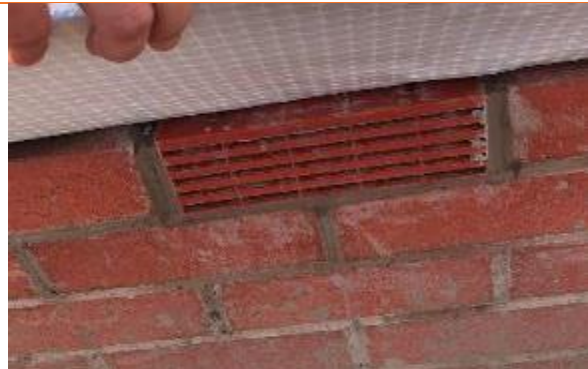
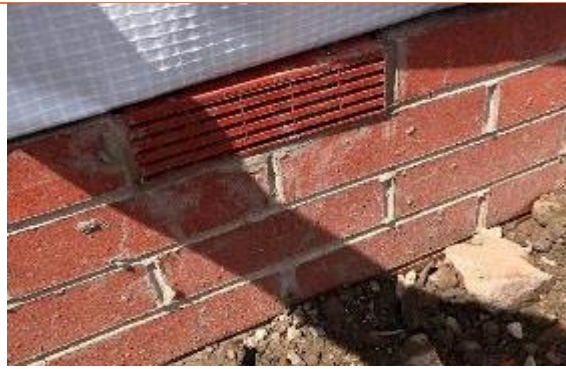
**Verification of Service Penetrations-Good Condition**

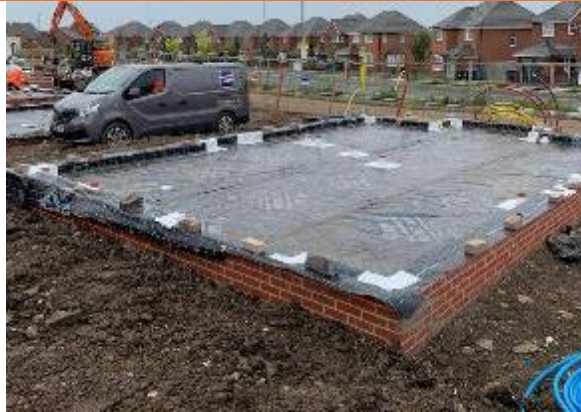
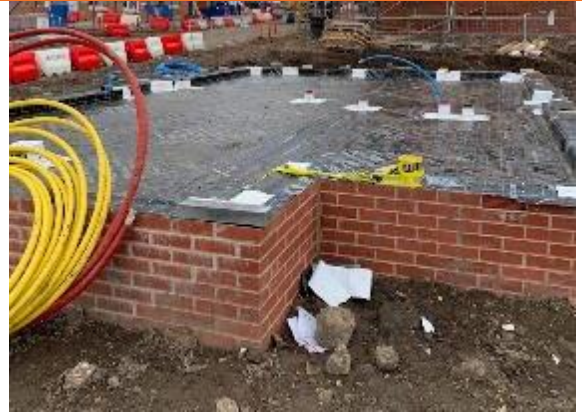
**Plot - 36**

**General Condition of Membrane-Good Condition**

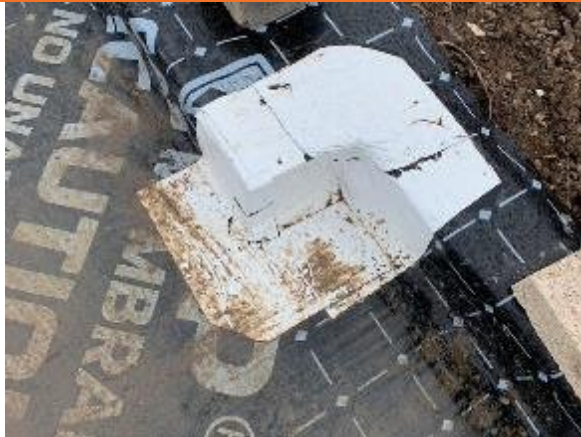
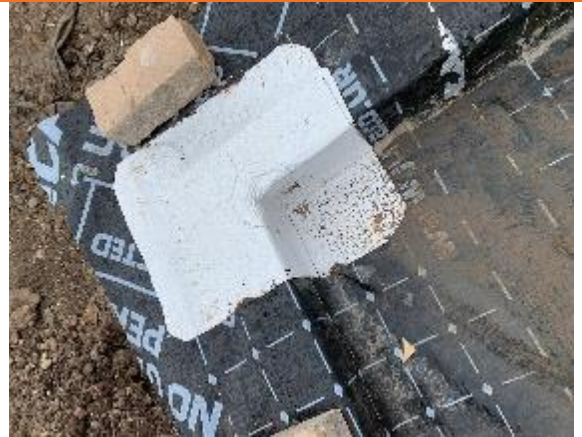
**Verification of Joints and Seals-Good Condition**

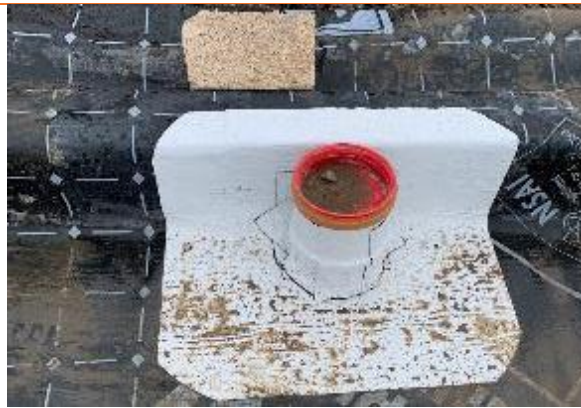
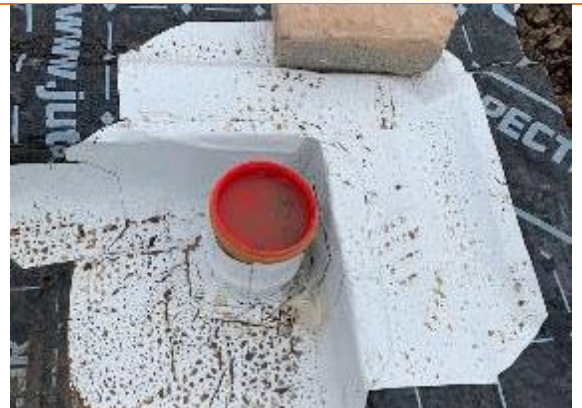
**Verification of Service Penetrations-Good Condition**

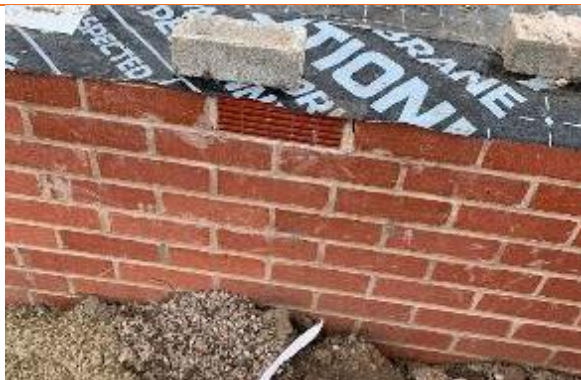
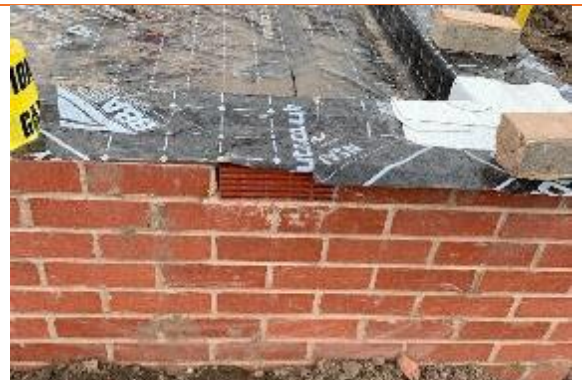
**Verification of Service Penetrations-Good Condition**

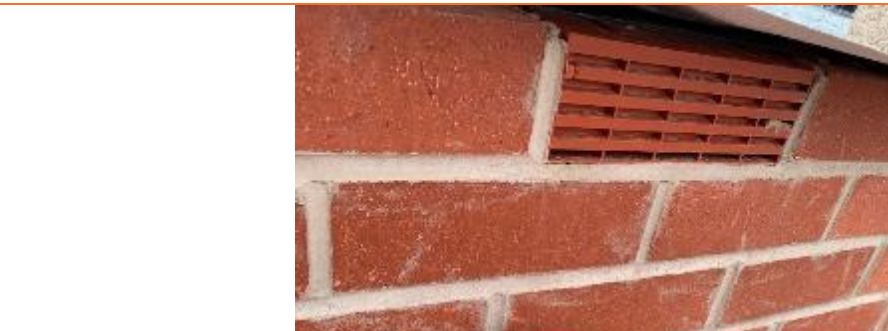
**Plot - 38**

**Verification of Service Penetrations-Good Condition**

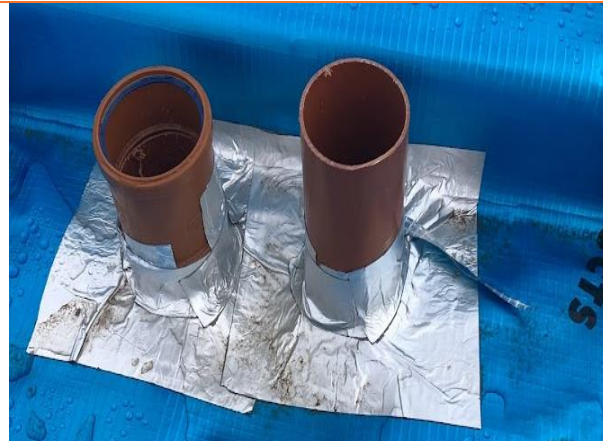
**Plot - 47**

**Verification of Service Penetrations-Good Condition**

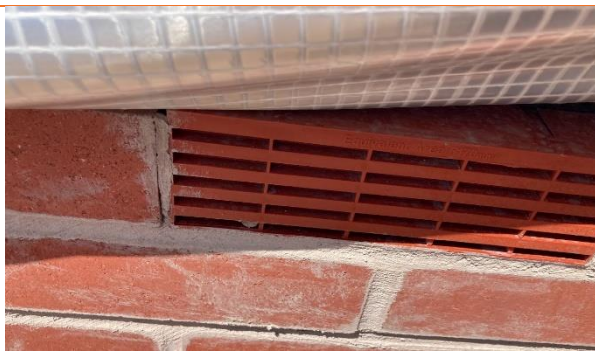
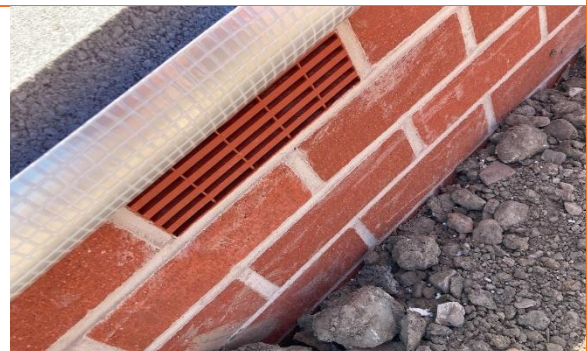
**Plot – 45**

**Verification of Service Penetrations-Good Condition**

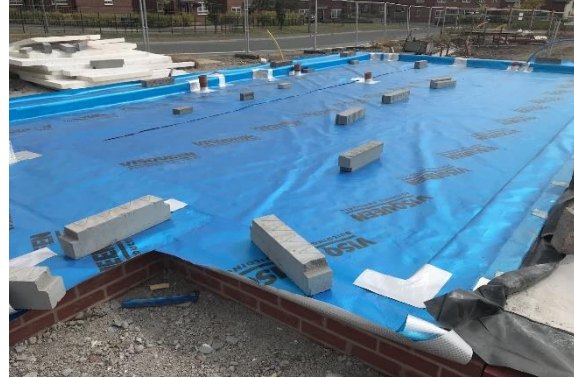
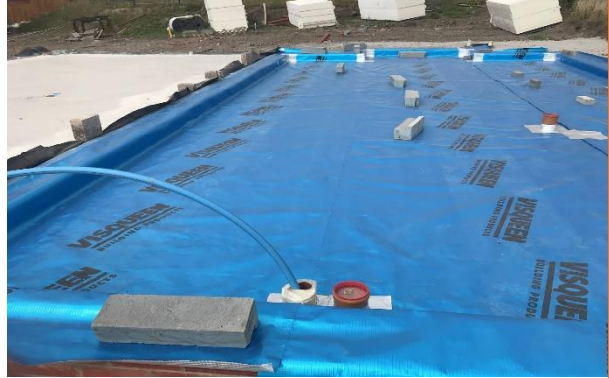
**Plot - 22**

**General Condition of Membrane-Good Condition**

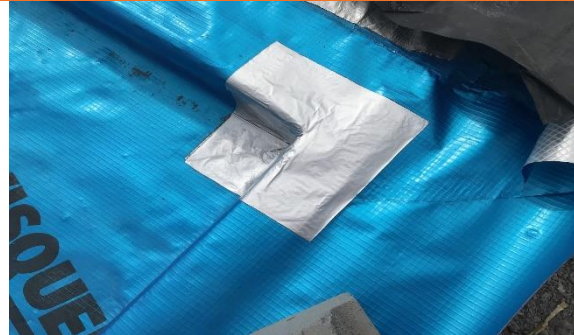
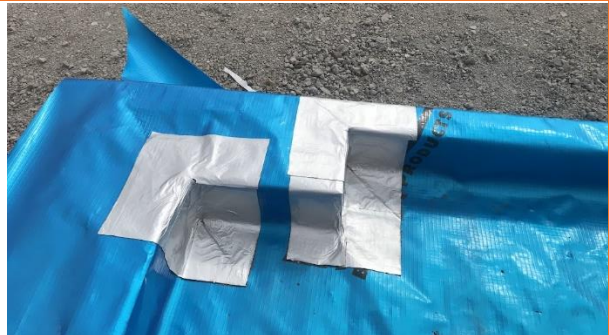
**Verification of Joints and Seals-Good Condition**

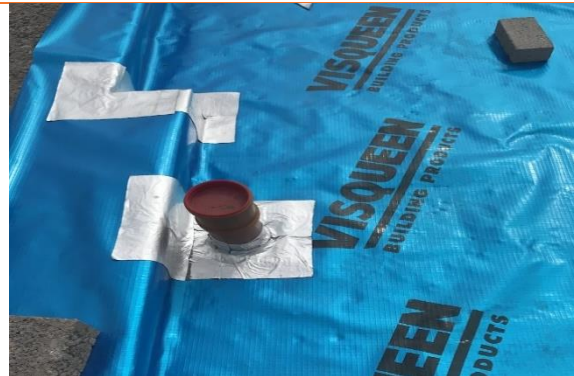
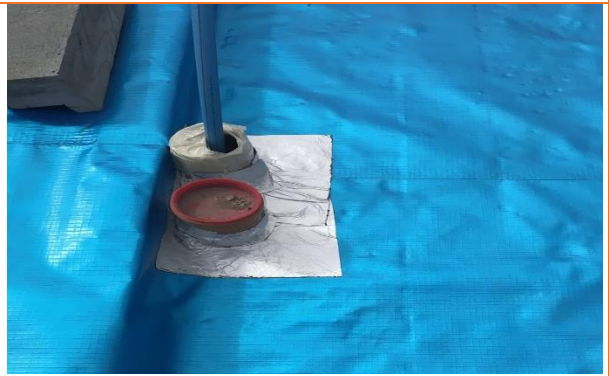
**Verification of Service Penetrations-Good Condition**

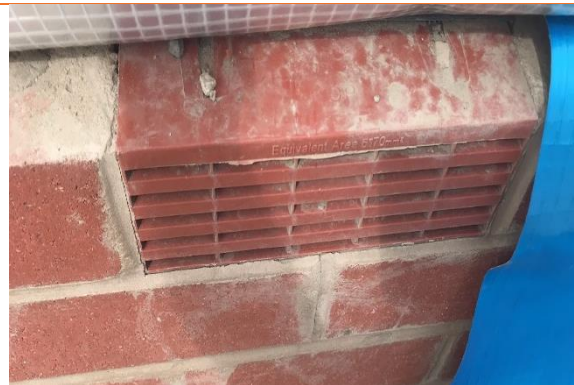
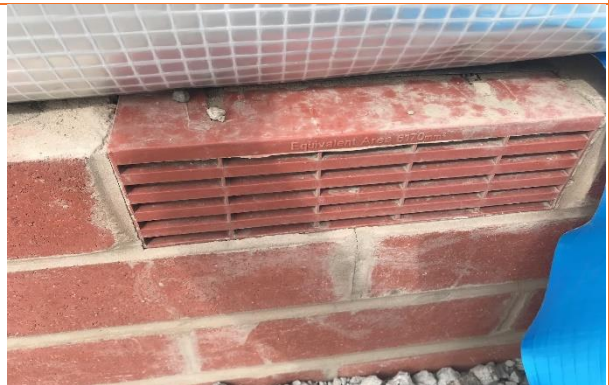
**Verification of Service Penetrations-Good Condition**

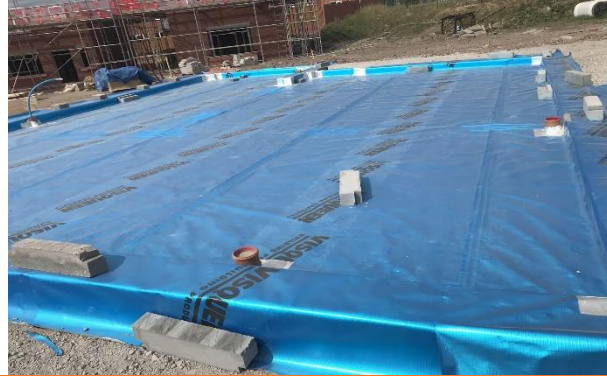
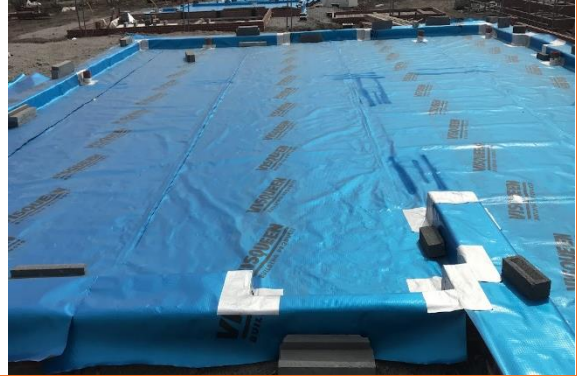
**Plot – 24**

**General Condition of Membrane-Good Condition**

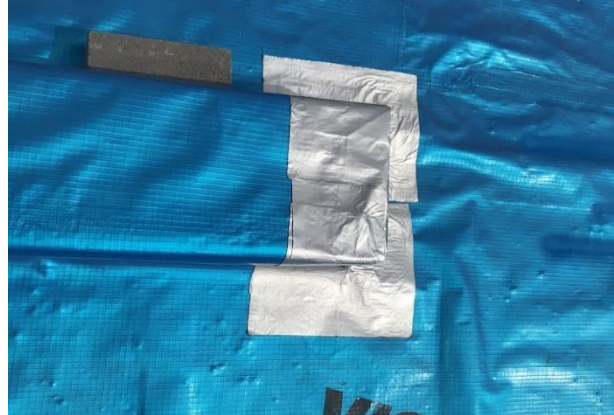
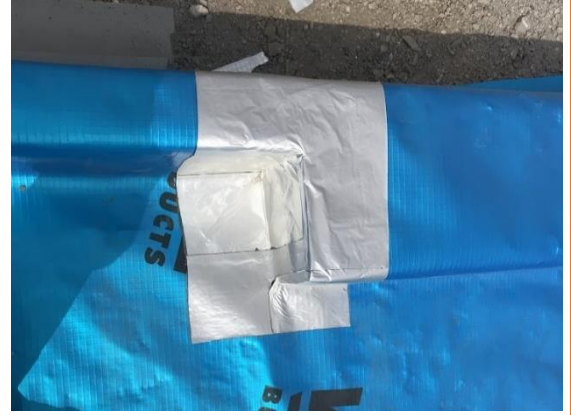
**Verification of Joints and Seals-Good Condition**

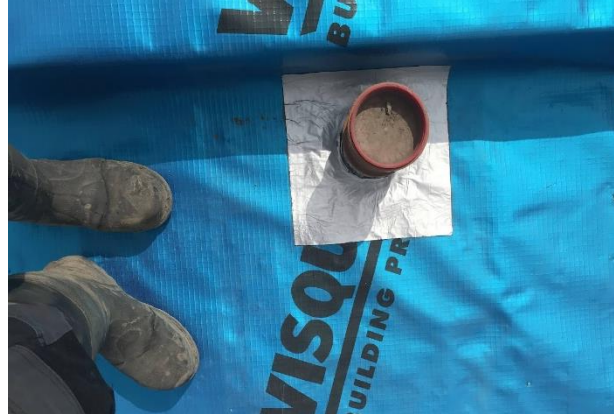
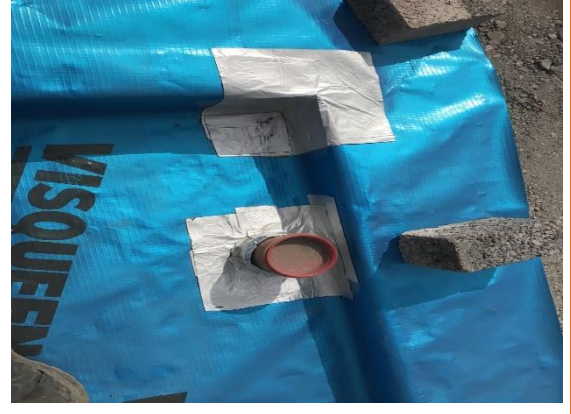
**Verification of Service Penetrations-Good Condition**

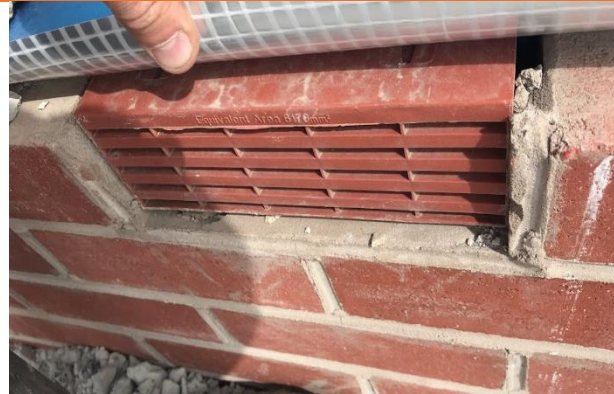
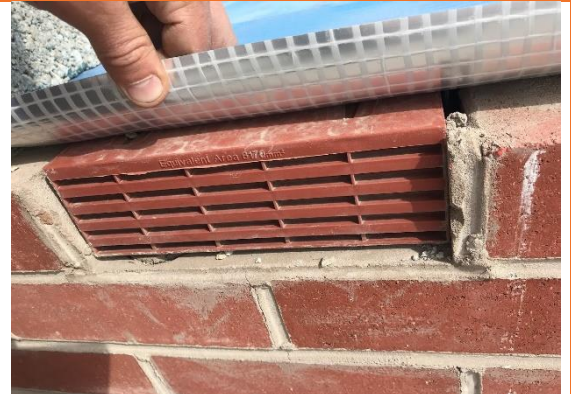
**Verification of Service Penetrations-Good Condition**

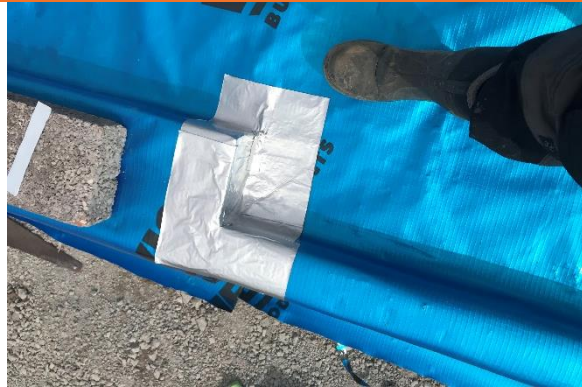
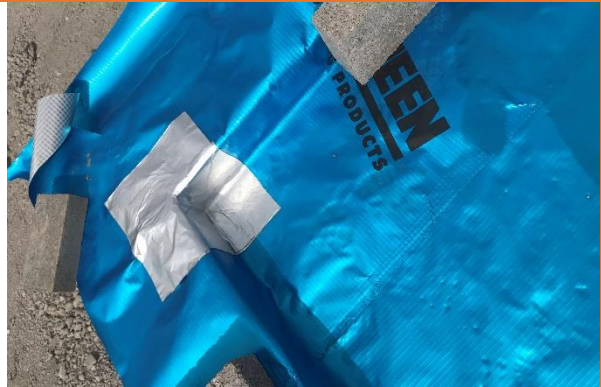
**Verification of Joints and Seals-Good Condition**

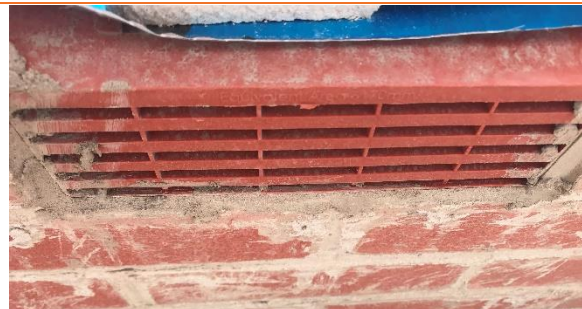
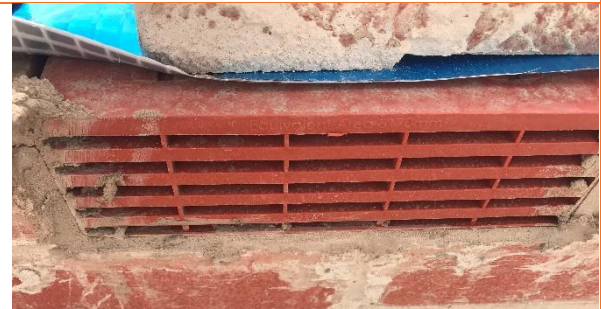
**Verification of Service Penetrations-Good Condition**

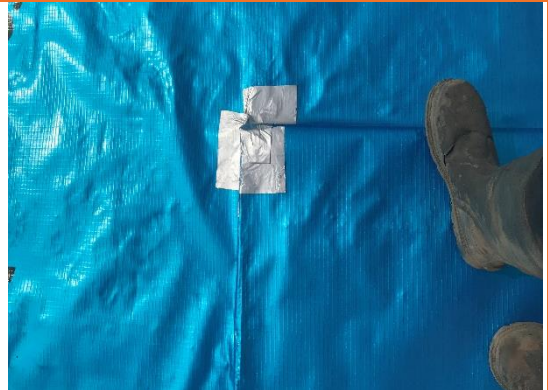
**Plot - 51**

**Verification of Joints and Seals-Good Condition**

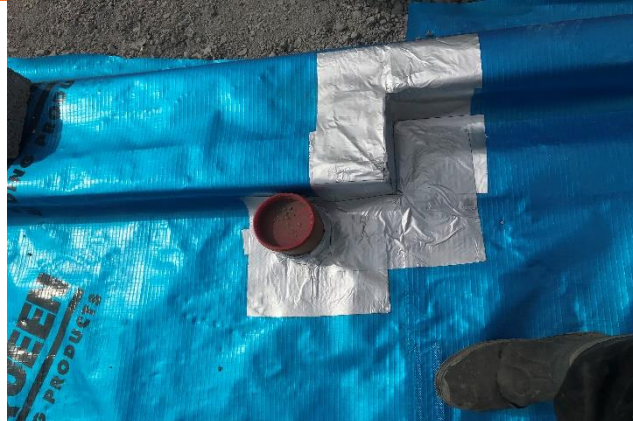
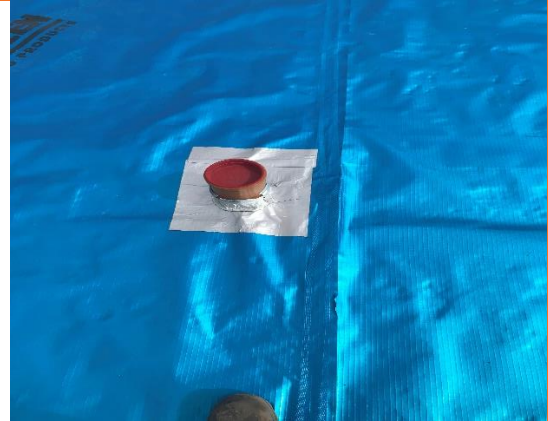
**Verification of Service Penetrations-Good Condition**

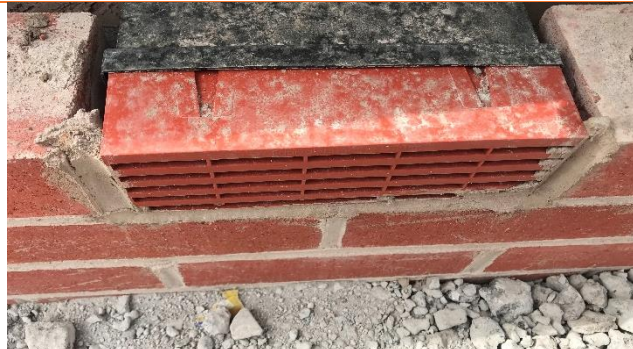
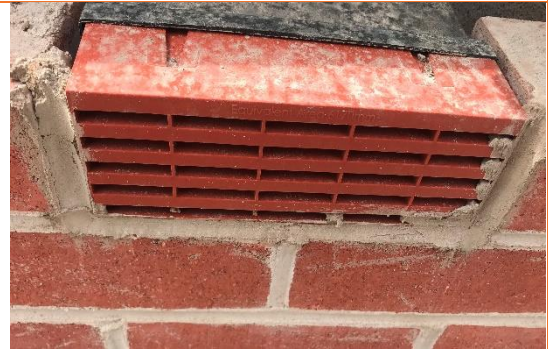
**Verification of Service Penetrations-Good Condition**

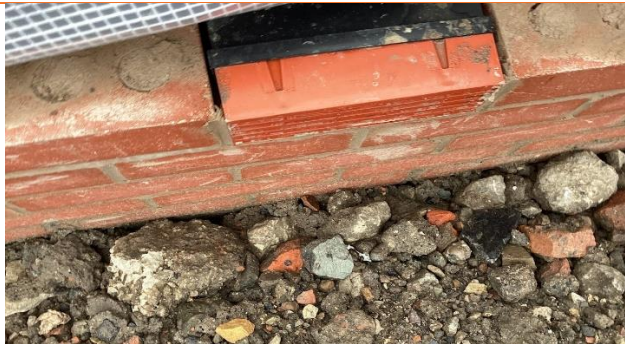
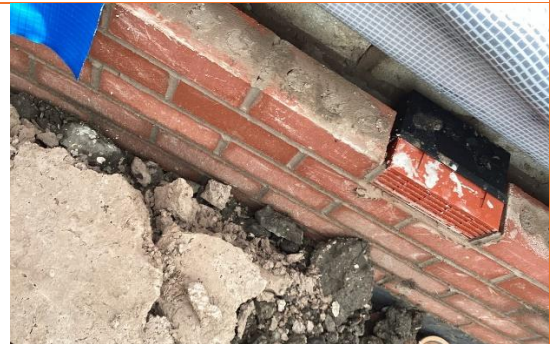
**Verification of Service Penetrations-Good Condition**

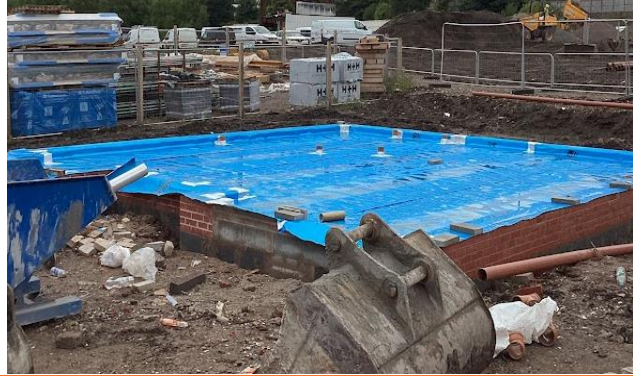
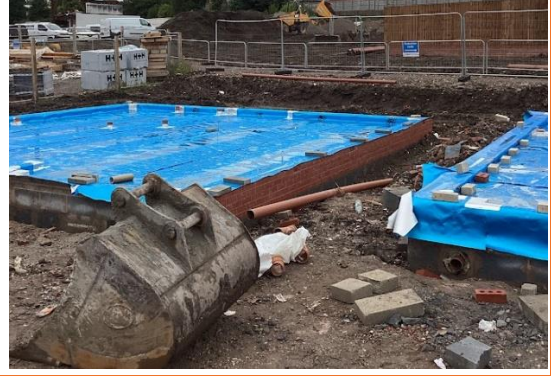
**Plot - 15**

**General Condition of Membrane-Good Condition**

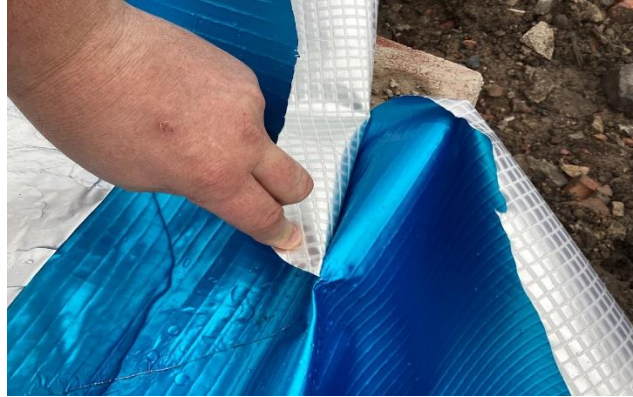
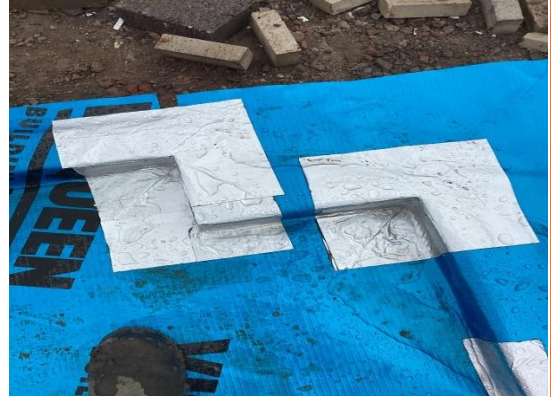
**Verification of Joints and Seals-Good Condition**

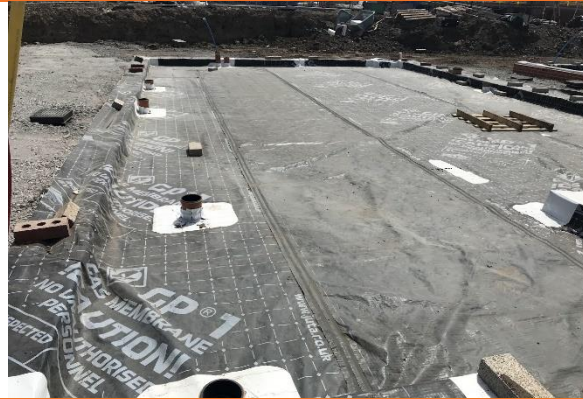
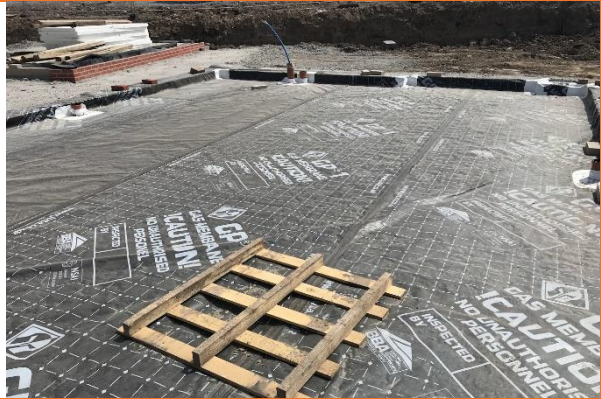
Plot – 39

General Condition of Membrane-Good Condition

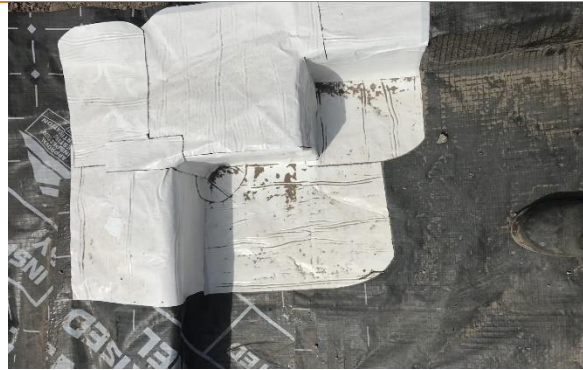
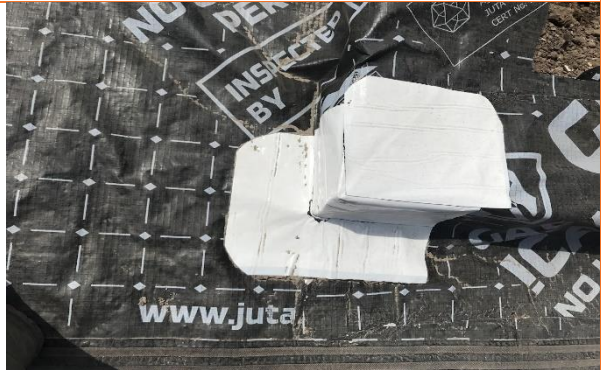
Verification of Joints and Seals-Good Condition

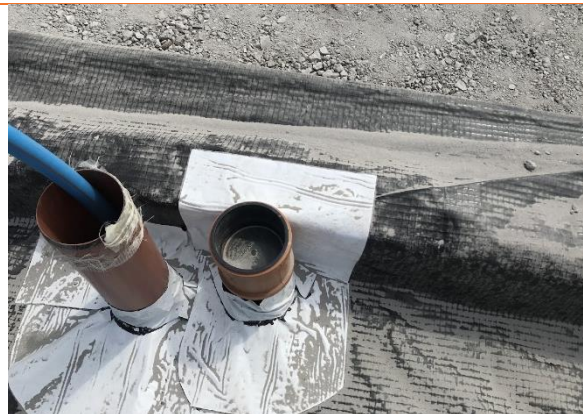
Verification of Service Penetrations-Good Condition

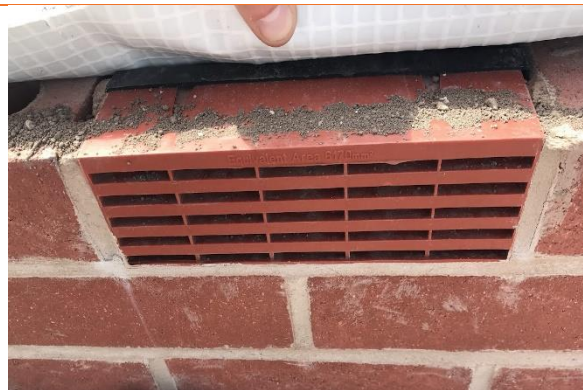
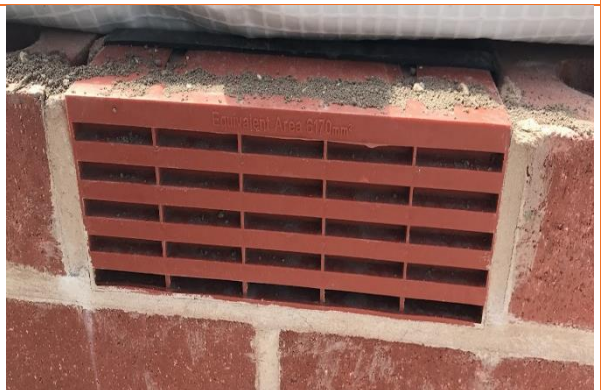
Verification of Service Penetrations-Good Condition

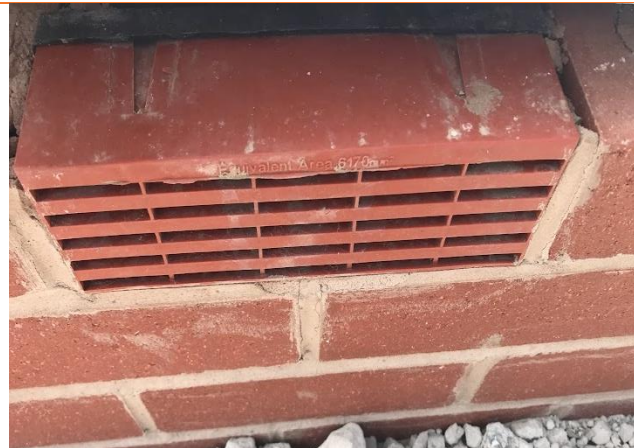
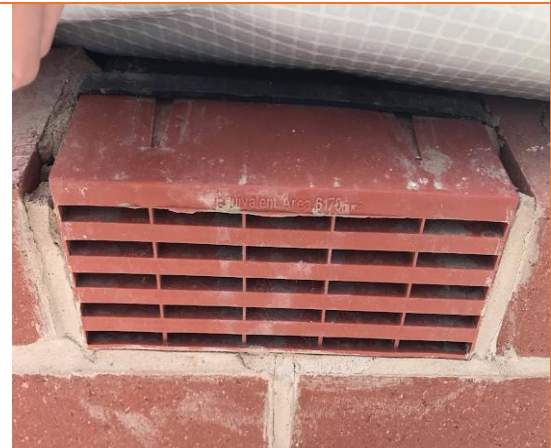
Verification of Service Penetrations-Good Condition

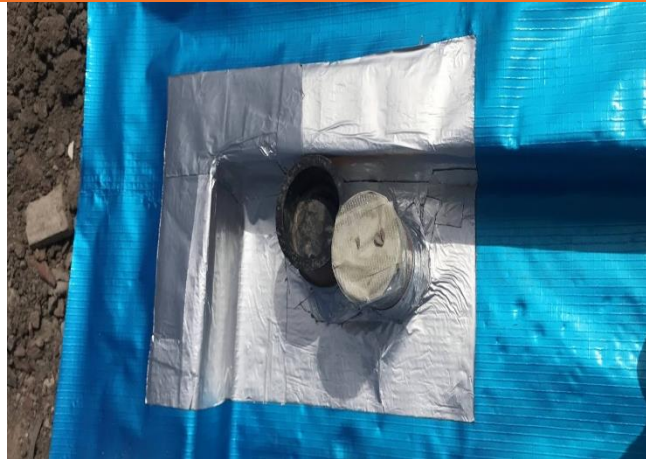
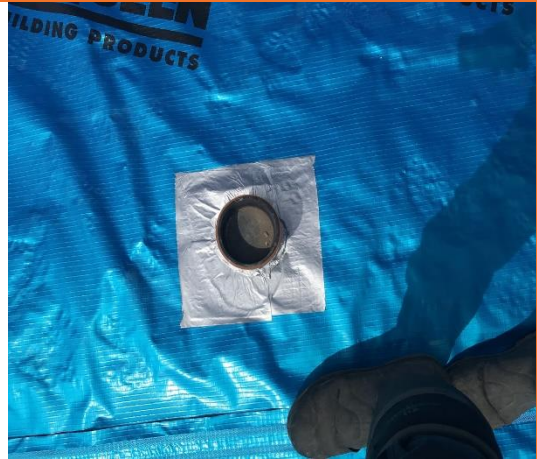
Verification of Service Penetrations-Good Condition
