# Validation Completion Report

Site: Sonnet Gate, Prescott

Reference:15-292-R1

Date: July 2025

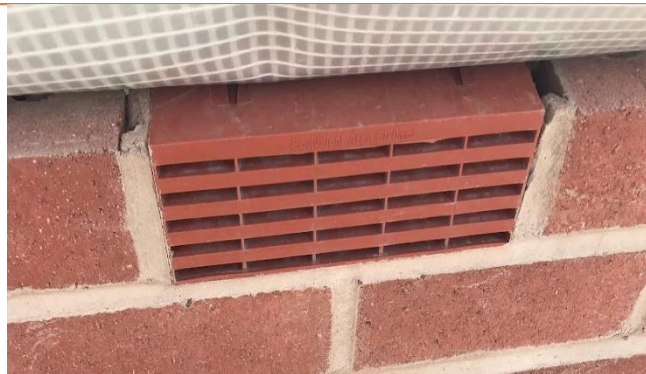
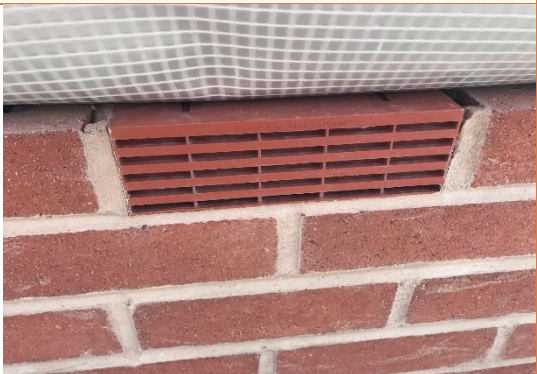
Verification of Service Penetrations-Good Condition

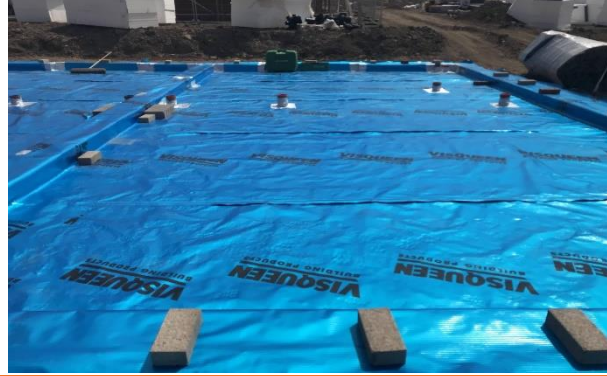
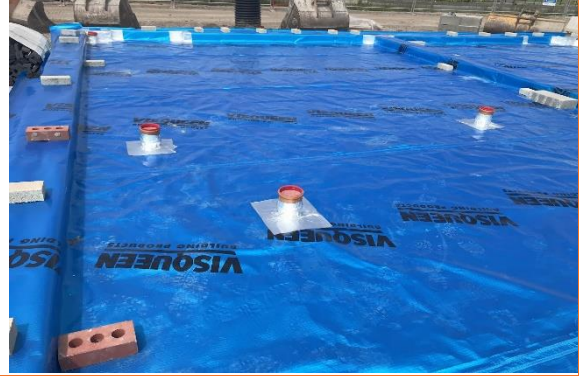
**Plot - 43**

**General Condition of Membrane-Good Condition**

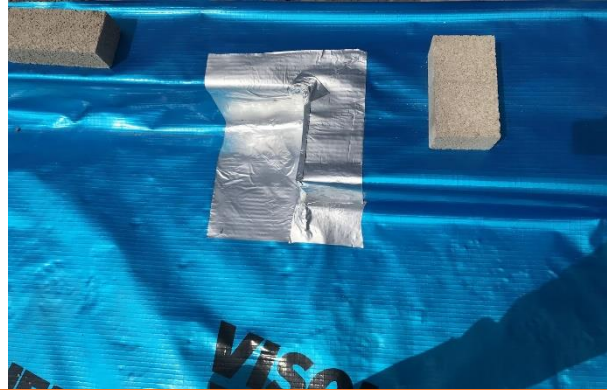
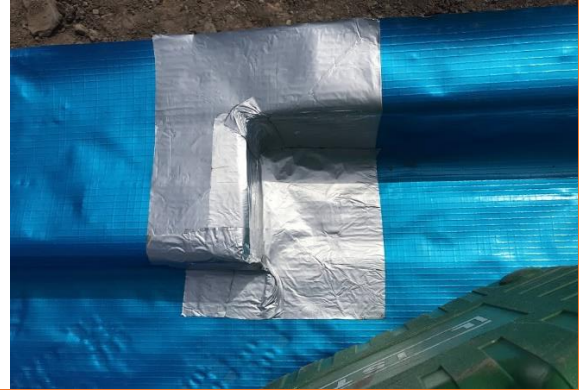
**Verification of Joints and Seals-Good Condition**

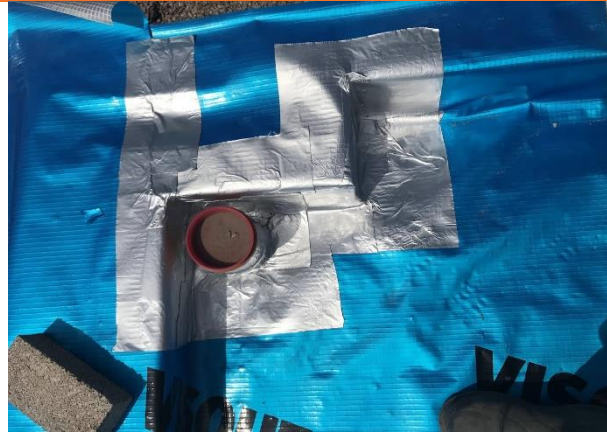
**Verification of Service Penetrations-Good Condition**

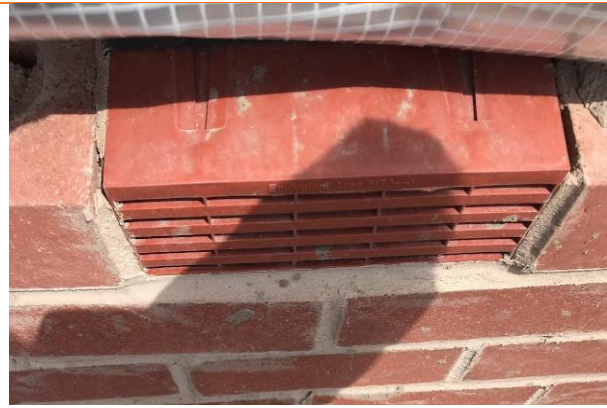
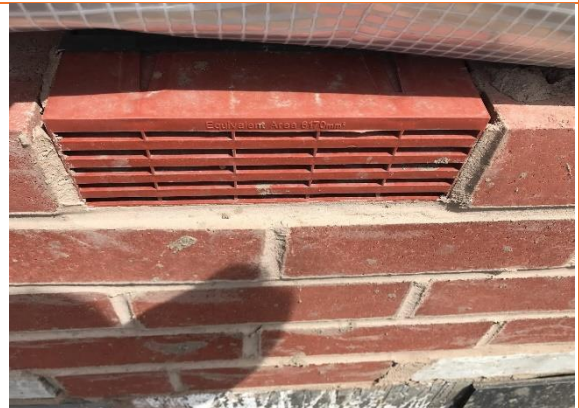
**Verification of Service Penetrations-Good Condition**
