## STRUCTURAL ENGINEERS REPORT

C15403

Huyton Cricket Club Pavillion  
Huyton Lane, Knowsley  
Liverpool L36 7XD

13 June 2025

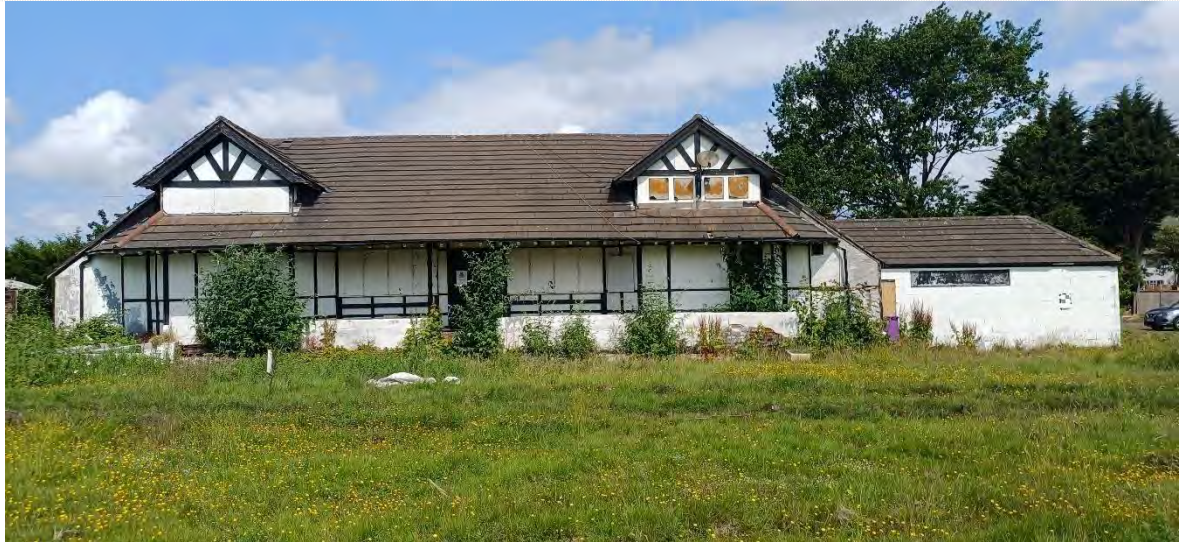
*Figure 1 – Front elevation*

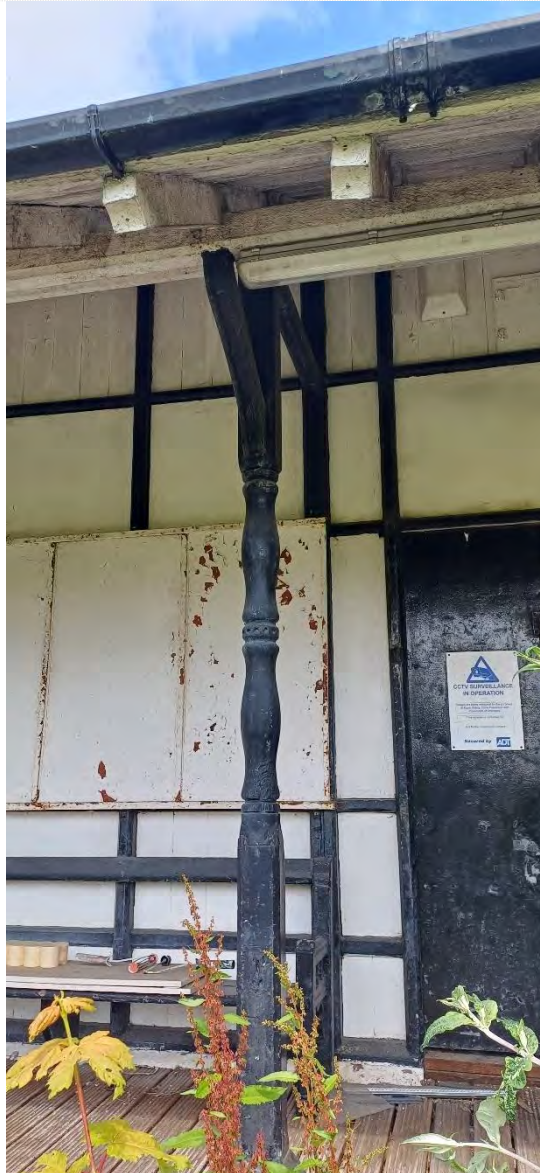
*Figure 2 – Timber post to roof*

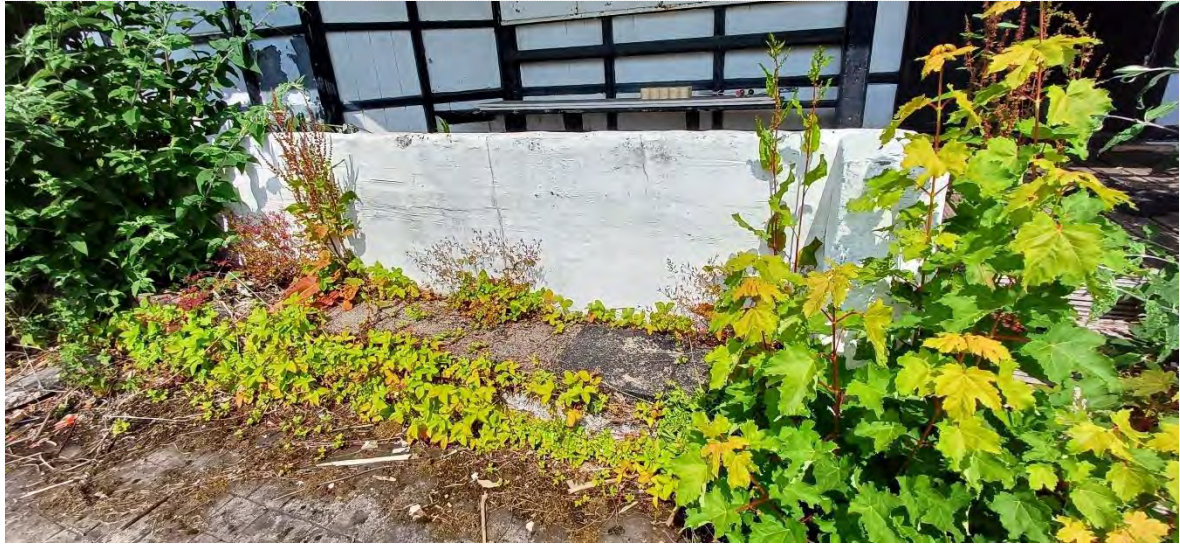
*Figure 5 – Retaining wall to veranda*

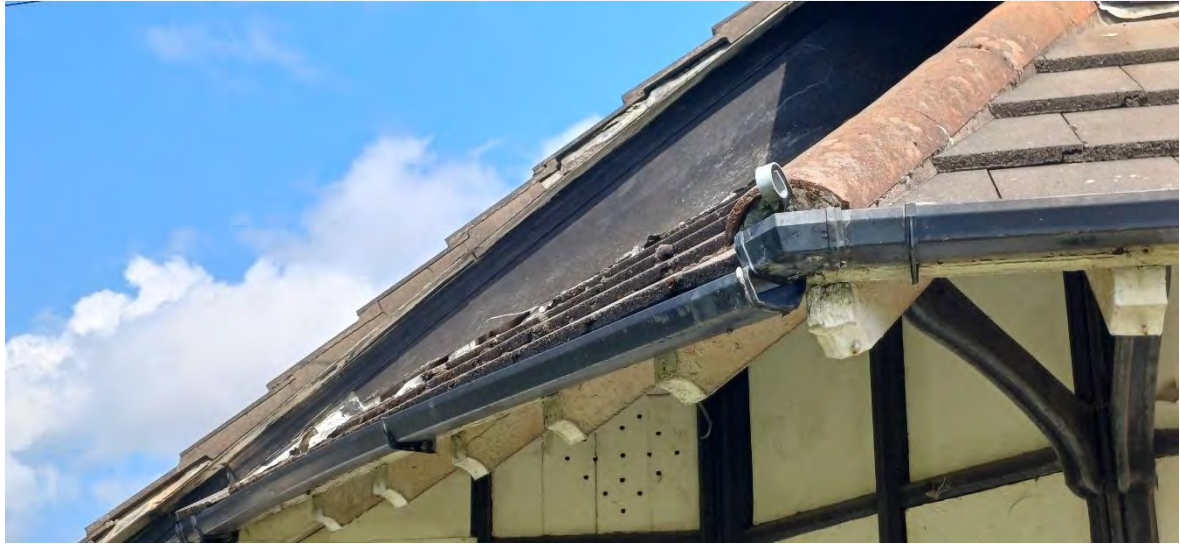
*Figure 9 – Gap to render/tiling, misaligned guttering*

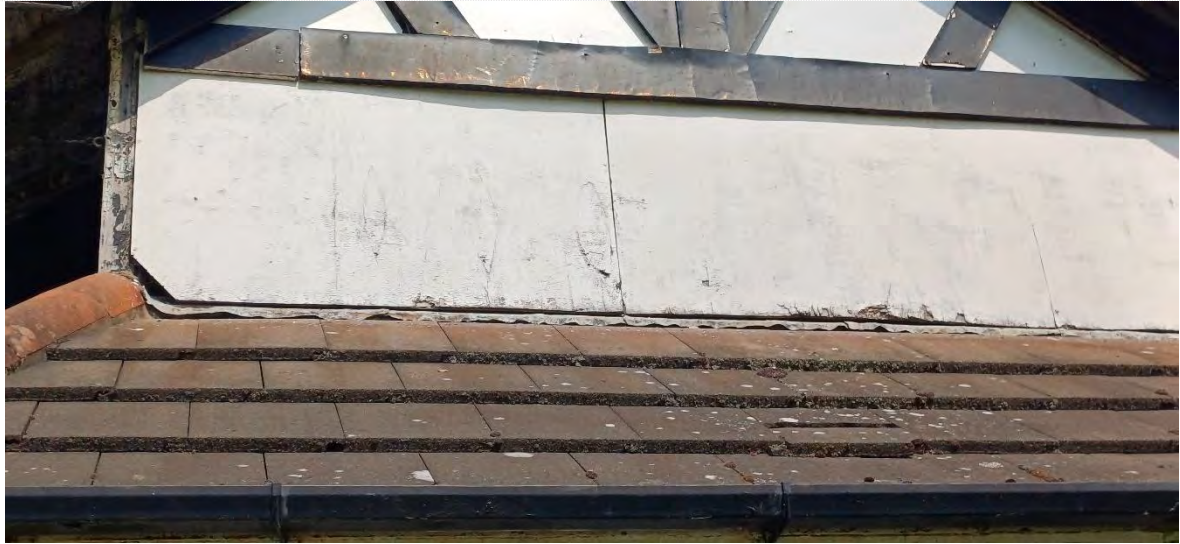
*Figure 11 – Flashing detail, left dormer*

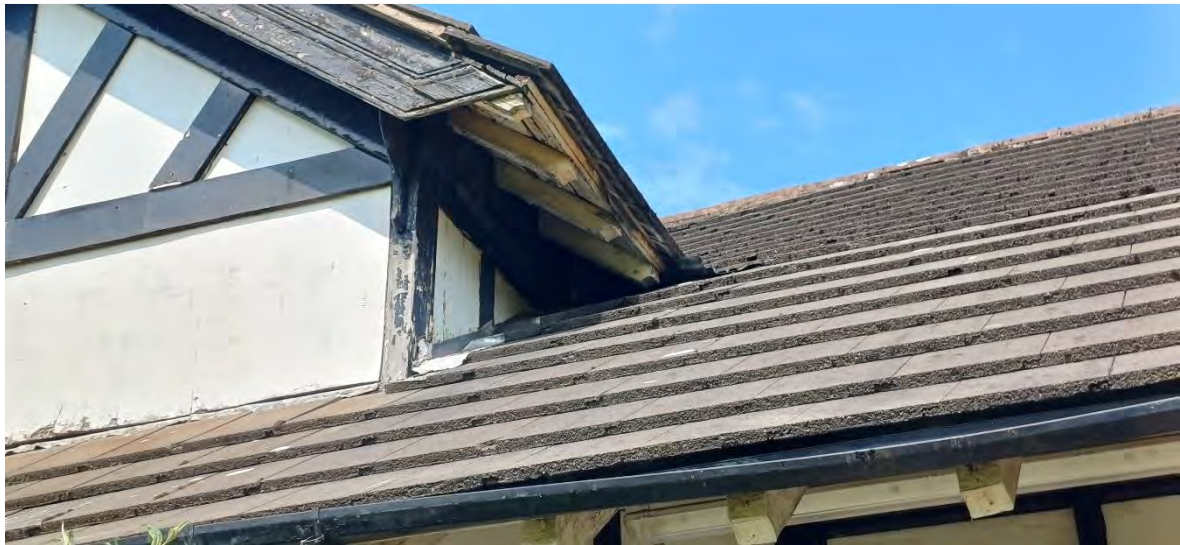
*Figure 12 – Flash banding, right side of left dormer*

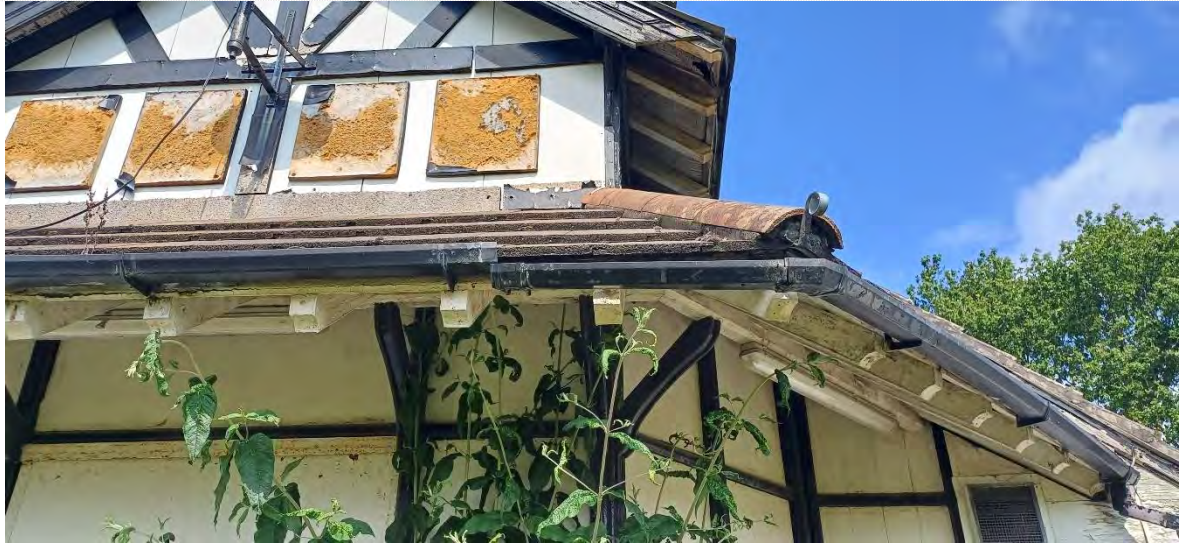
*Figure 15 – Misaligned guttering, right side*

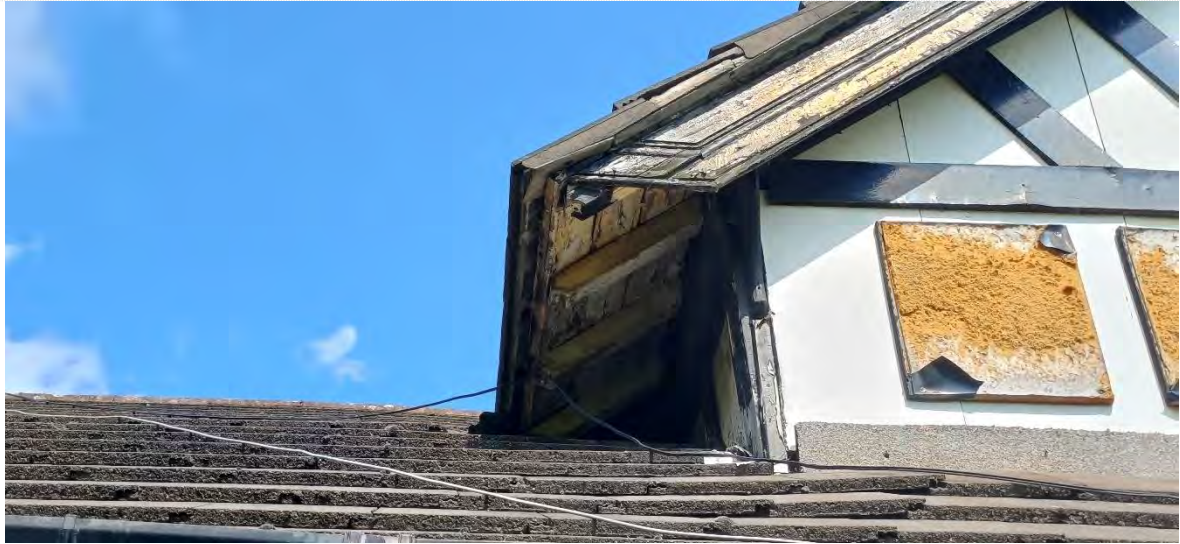
*Figure 17 – Boarding to roof, left side of right dormer*

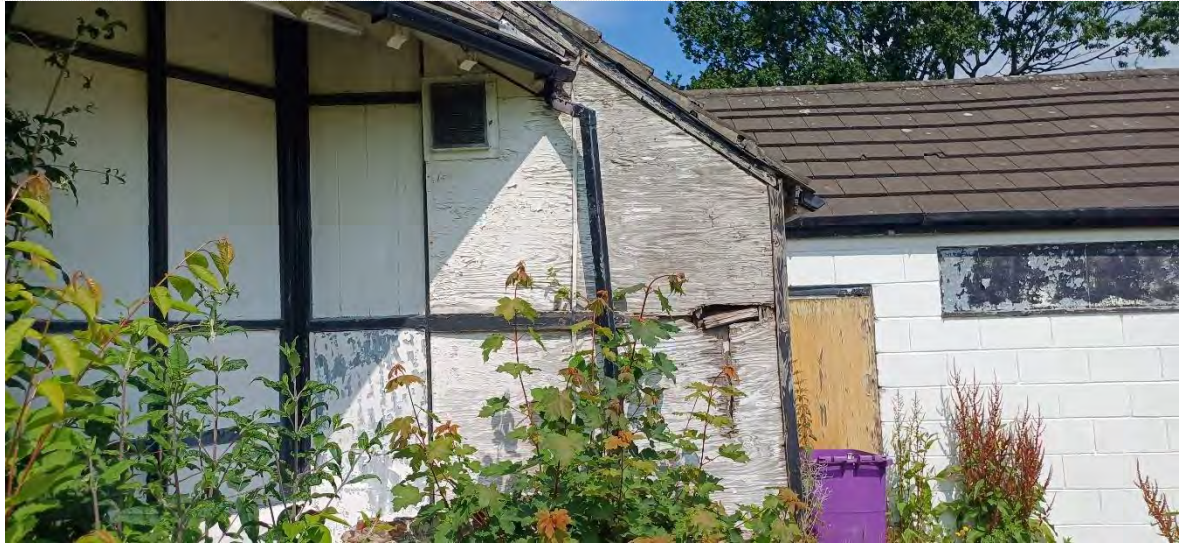
*Figure 19 – Timber cladding, right side*

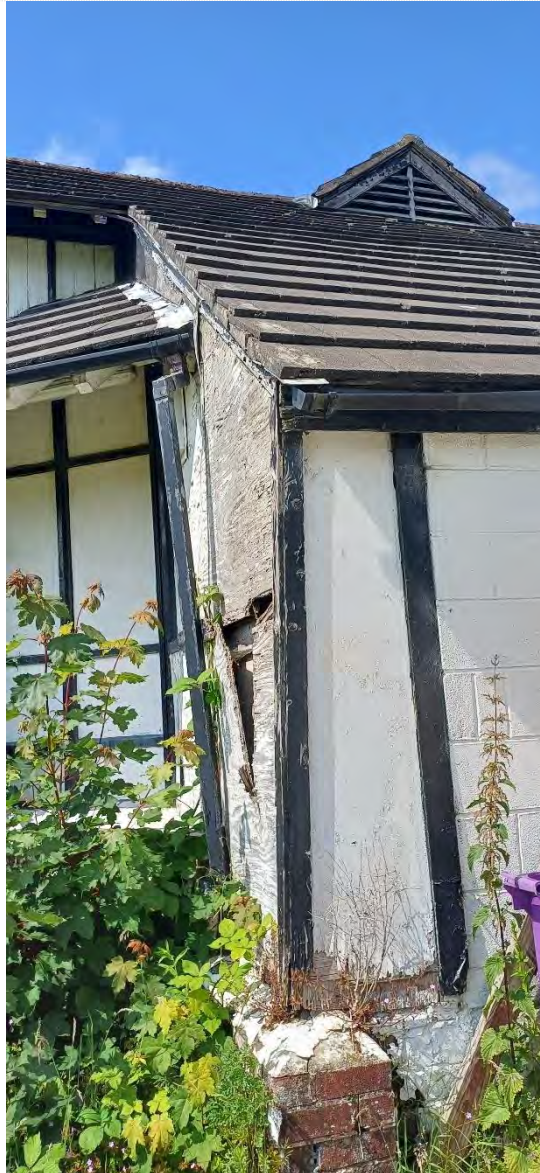
*Figure 20 – Cladding & corner non-vertical*

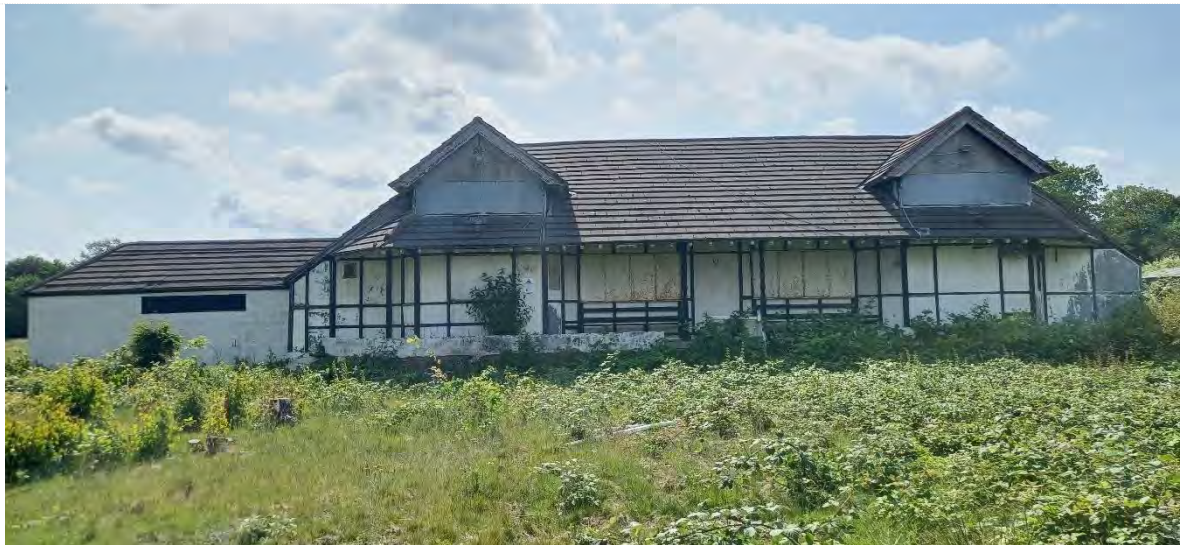
*Figure 22 – Rear elevation*

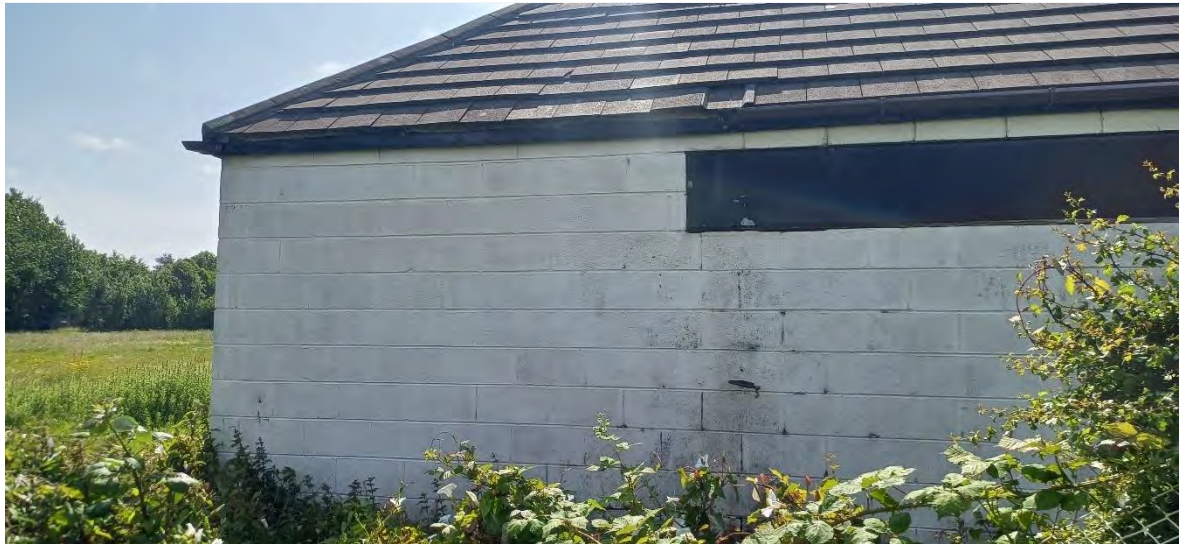
*Figure 23 – Missing guttering, right side, rear*

1. Rainwater goods – these are missing or incomplete around the building
2. Flashing details – some repairs have been made but generally new flashing is required to the gables, dormers and possibly the valleys
3. The roof tiles are dislodged or missing, with felt in some areas and not in others – hopefully this could be addressed by re-roofing with appropriate materials
4. We noted that stained glass windows are damaged where boarded over
5. Connect drainage to a formal system

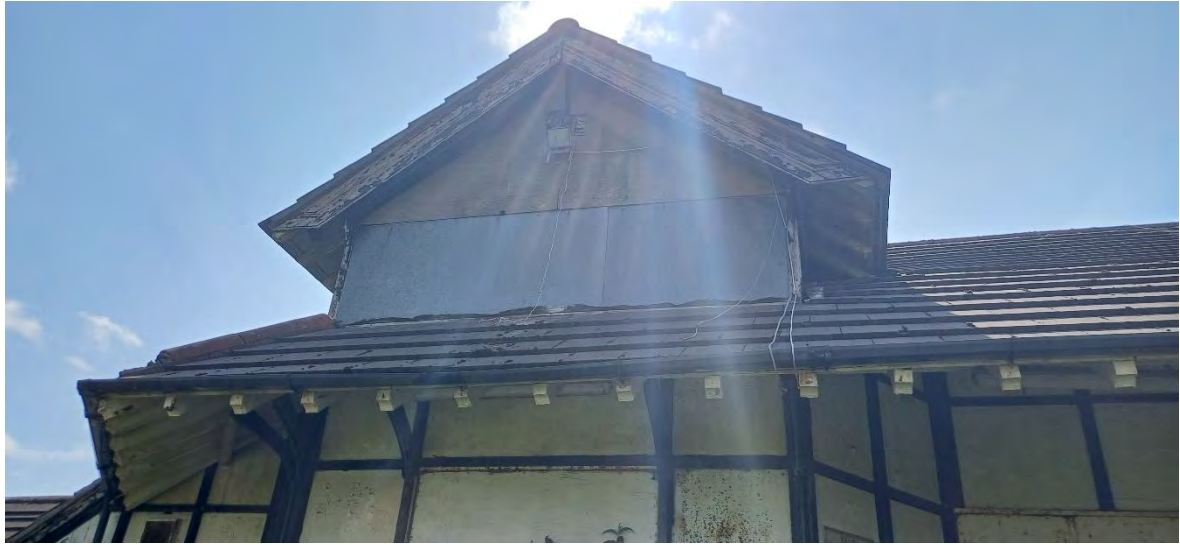
*Figure 30 – Right dormer to rear*

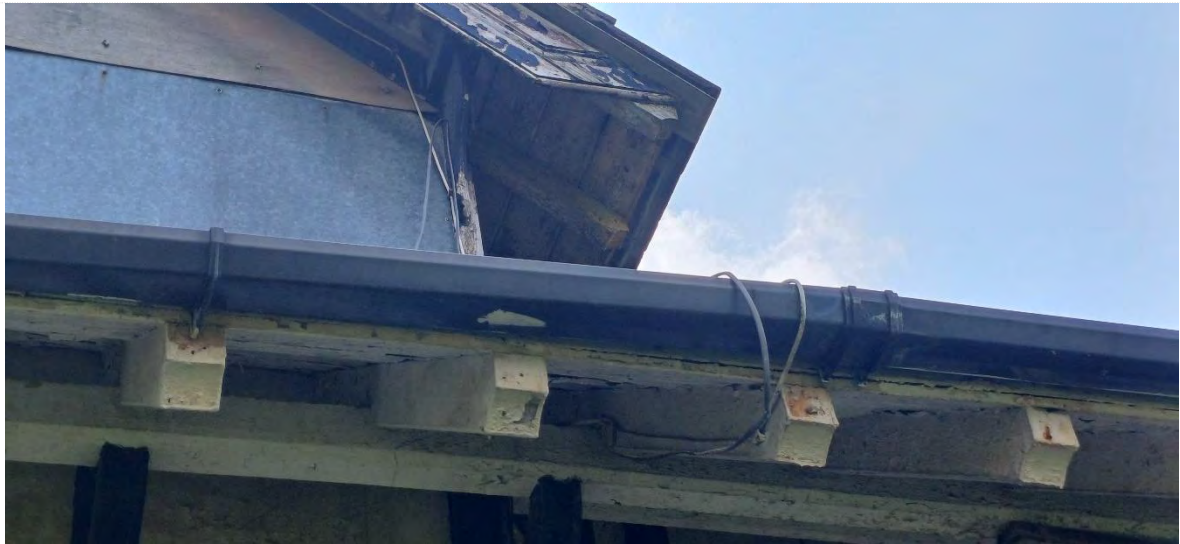
*Figure 32 – Boarding to roof, left side of rear right dormer*

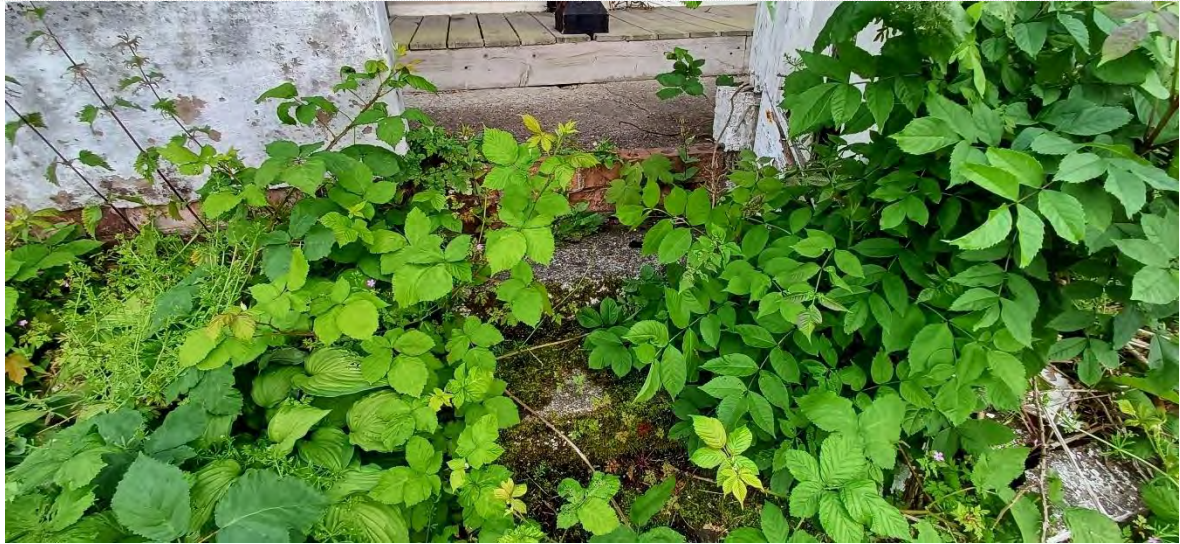
*Figure 34 – Steps up to veranda*

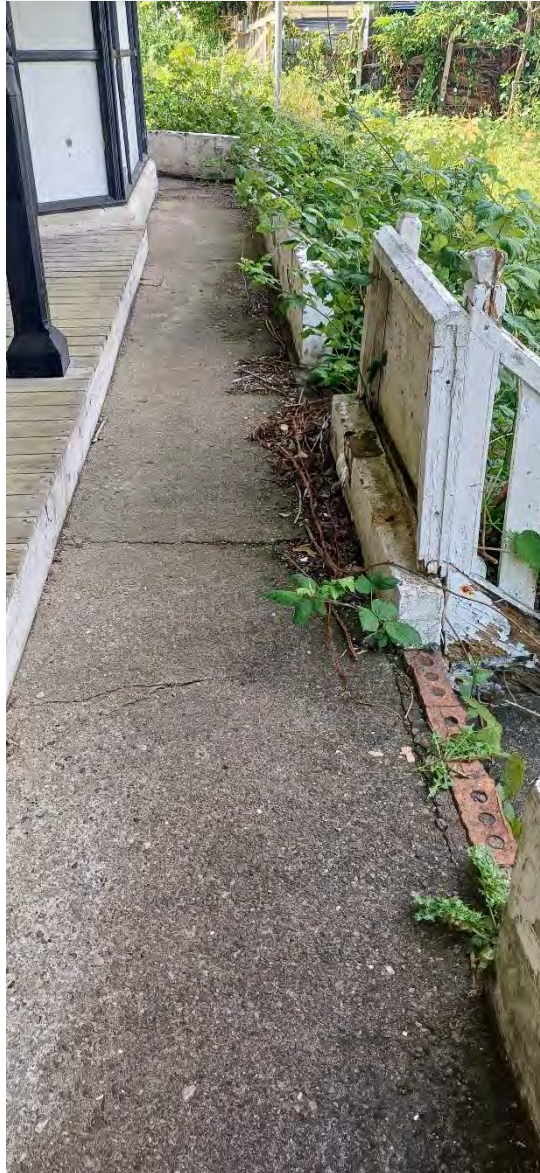
*Figure 35 – Path to rear of decking*

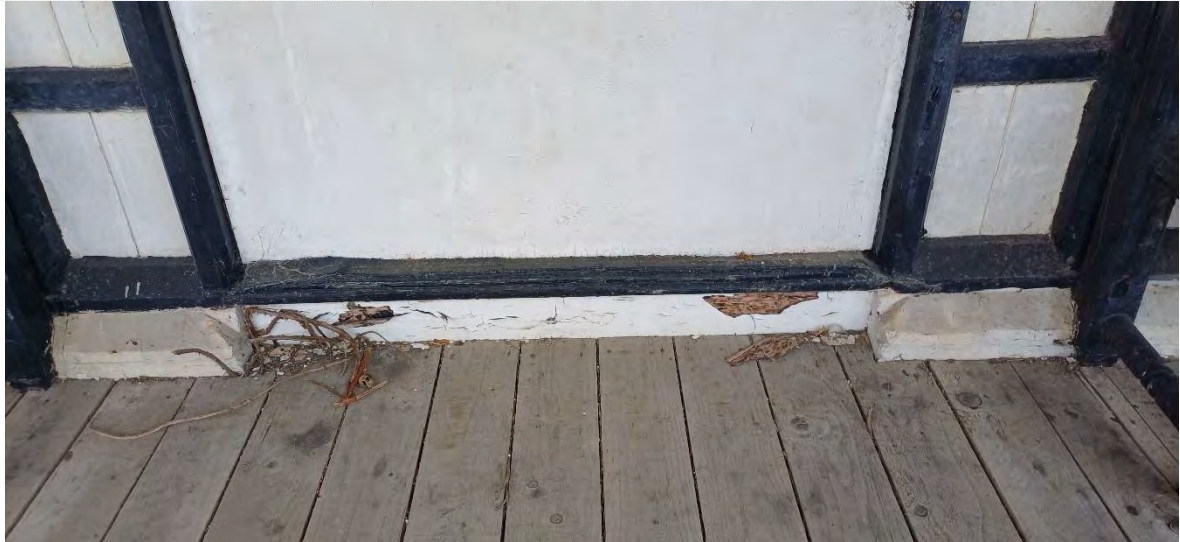
*Figure 36 – Rotting timber to centre*

1. Carry out a dimensional survey of the structural members – this is likely to need a contractor to open-up and make areas safe
2. Replace all damaged and rotting panels to the elevations with new T&G to match existing
3. Replace affected vertical and horizontal timbers to the front, rear and sides
4. Rebuild the front retaining wall
5. Replace the suspended ground floor structure
6. Provide suitable beams over the kitchen opening

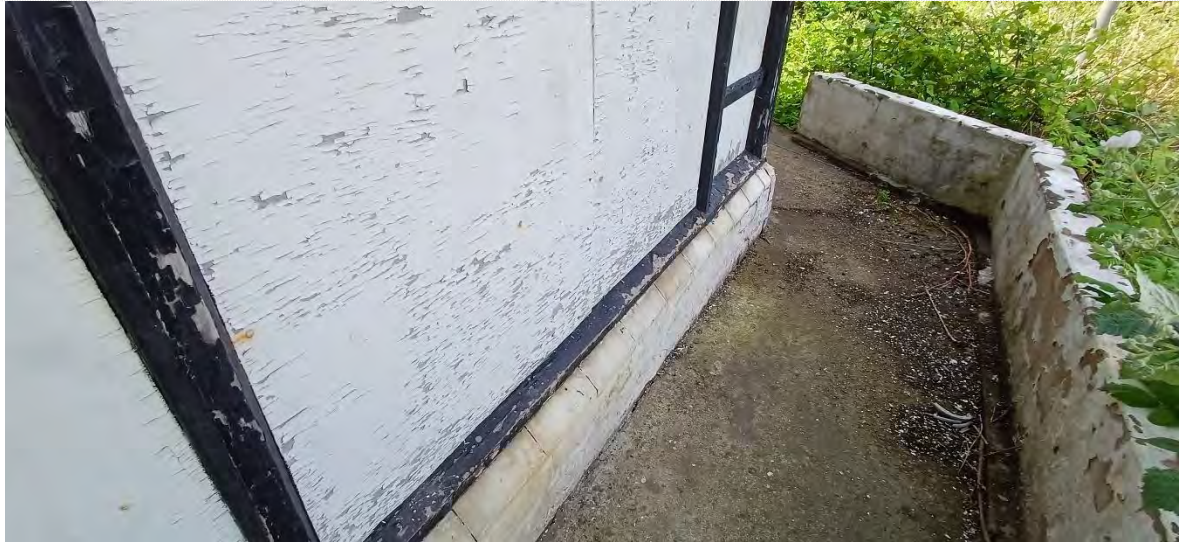
*Figure 38 – Ply panelling adjacent to lathe panel*

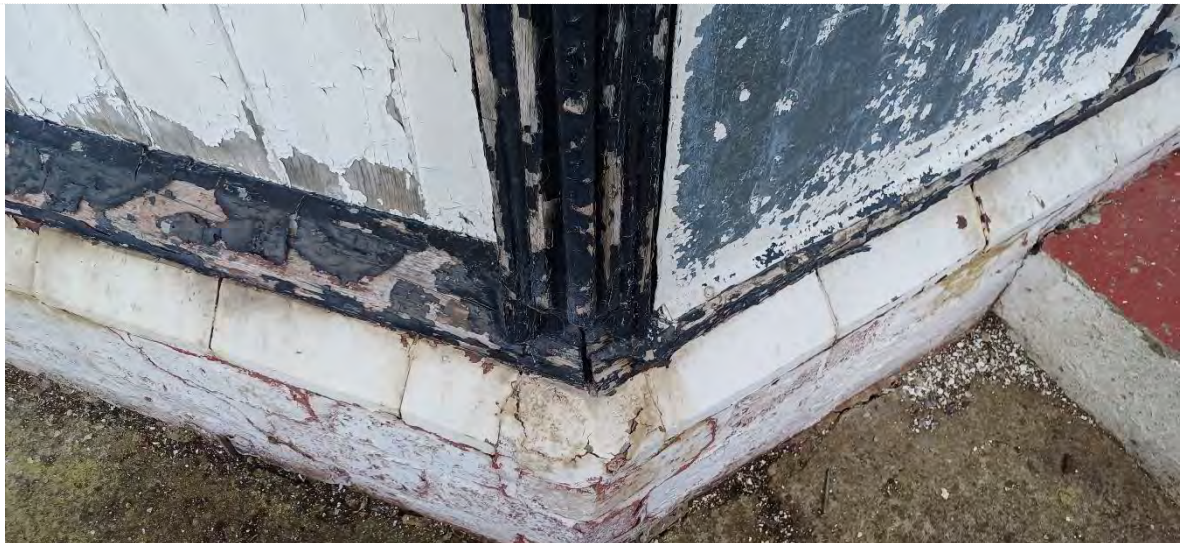
*Figure 39 – Left corner*

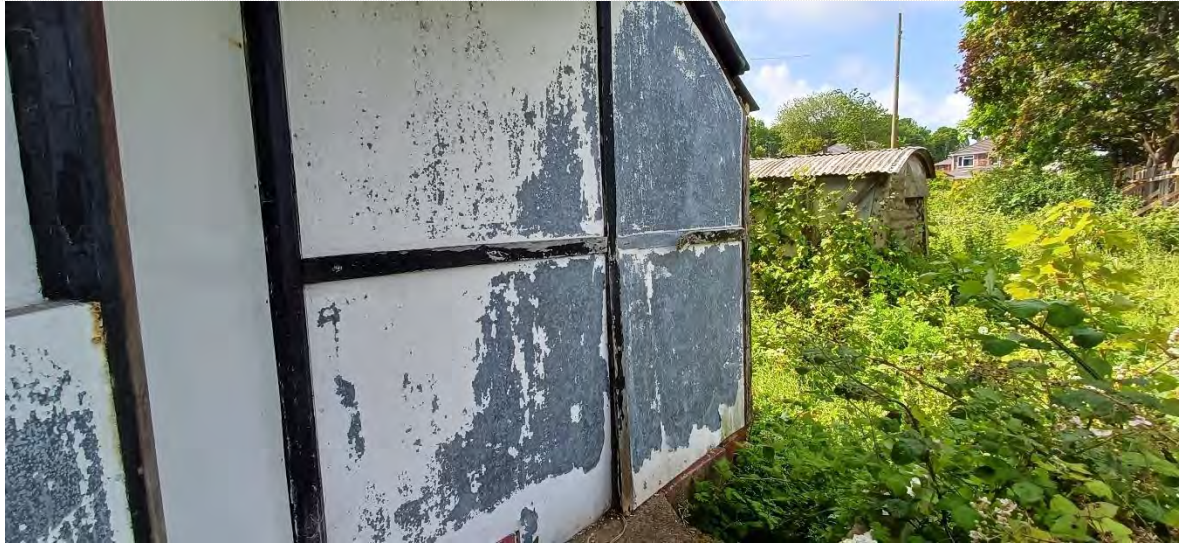
*Figure 40 – Left end of rear elevation*

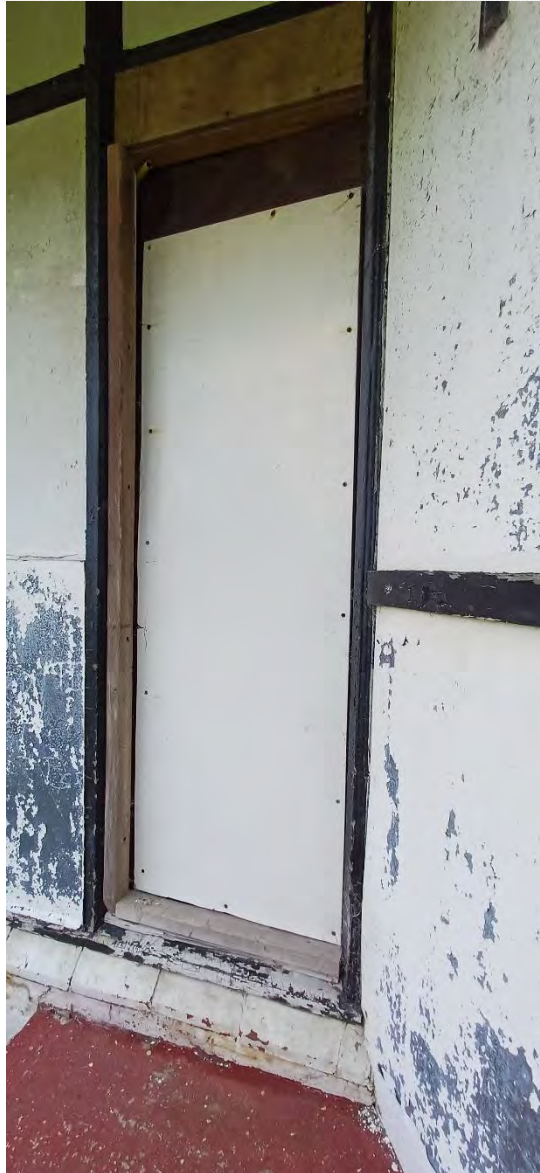
*Figure 42 – Back door*

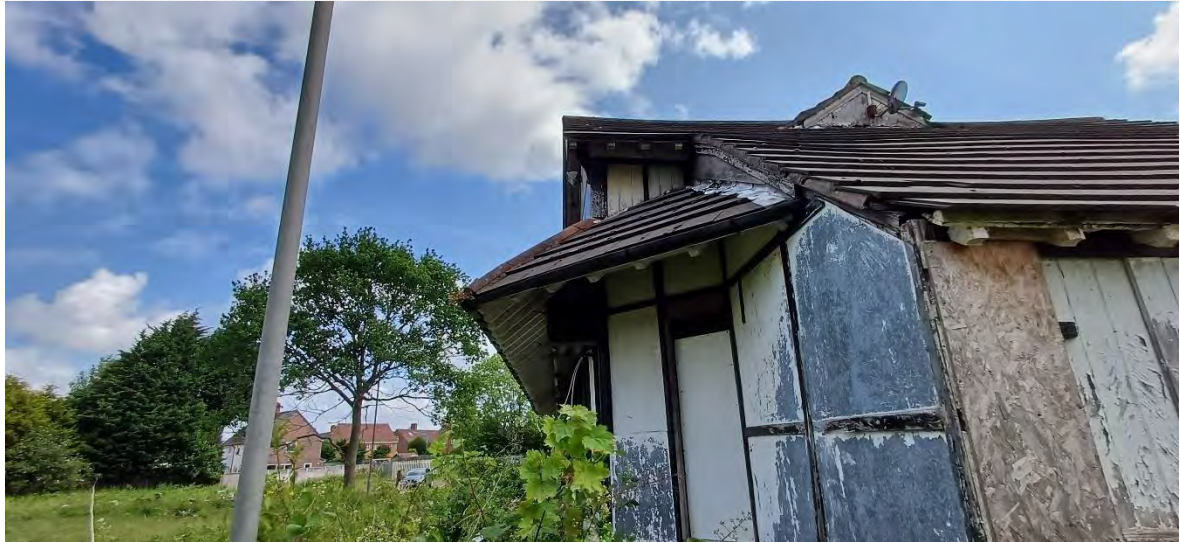
*Figure 43 – Missing guttering, rear left corner*

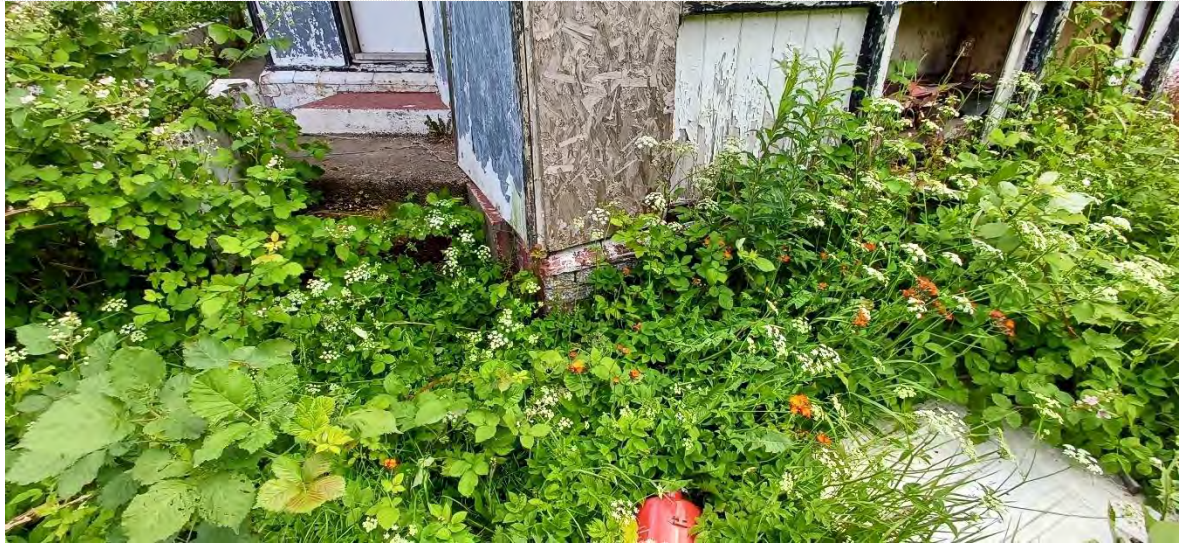
*Figure 45 – Brickwork to base of wall*

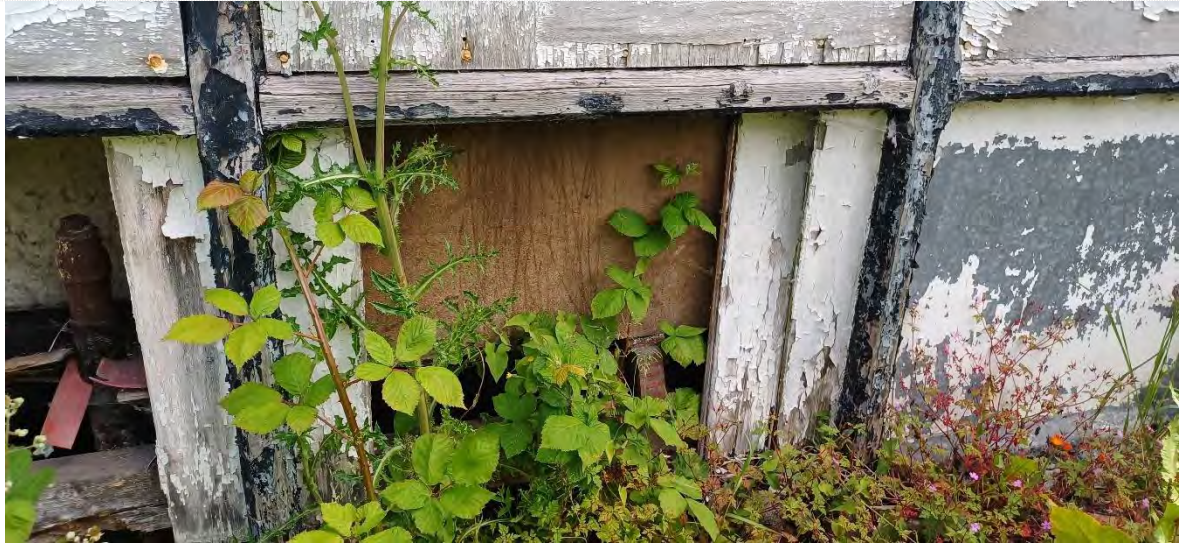
*Figure 47 – Opening, left elevation*

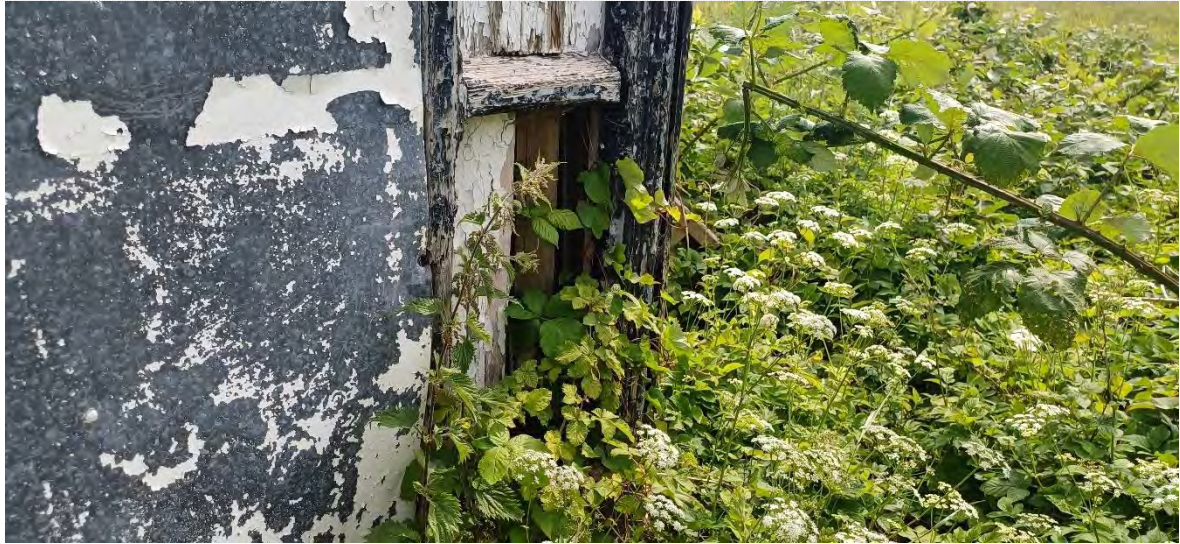
*Figure 49 – Front left corner*

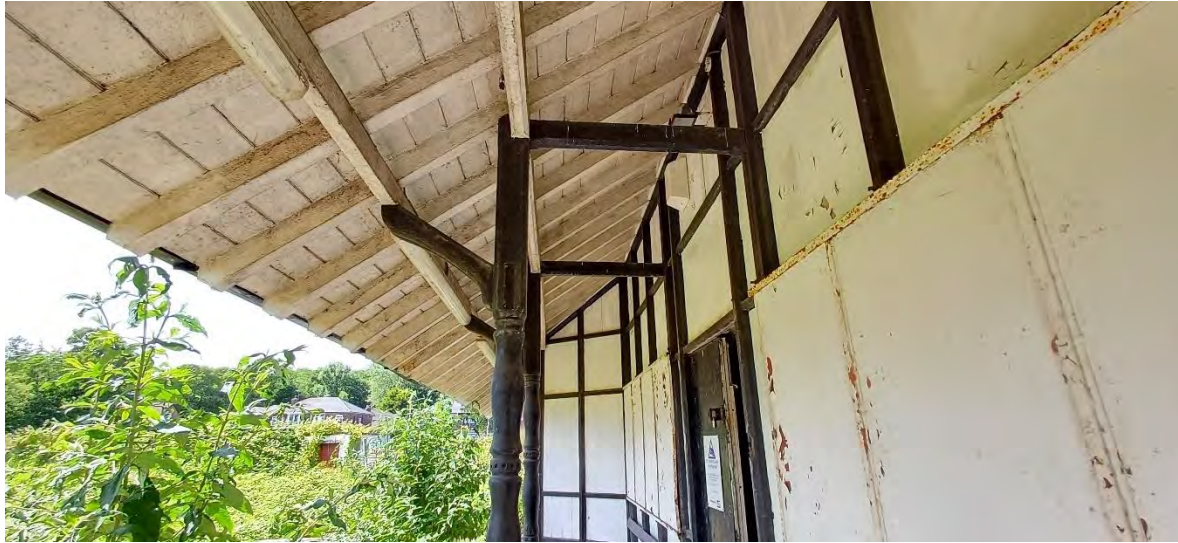
*Figure 54 – Purlins to roof over veranda*

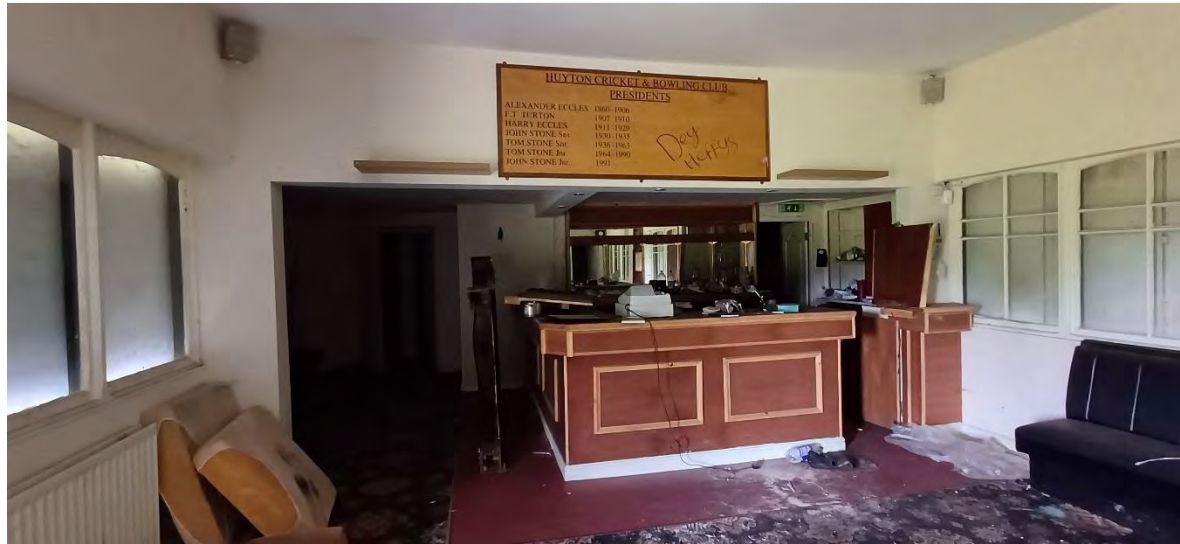
*Figure 56 – Main, central room looking left*

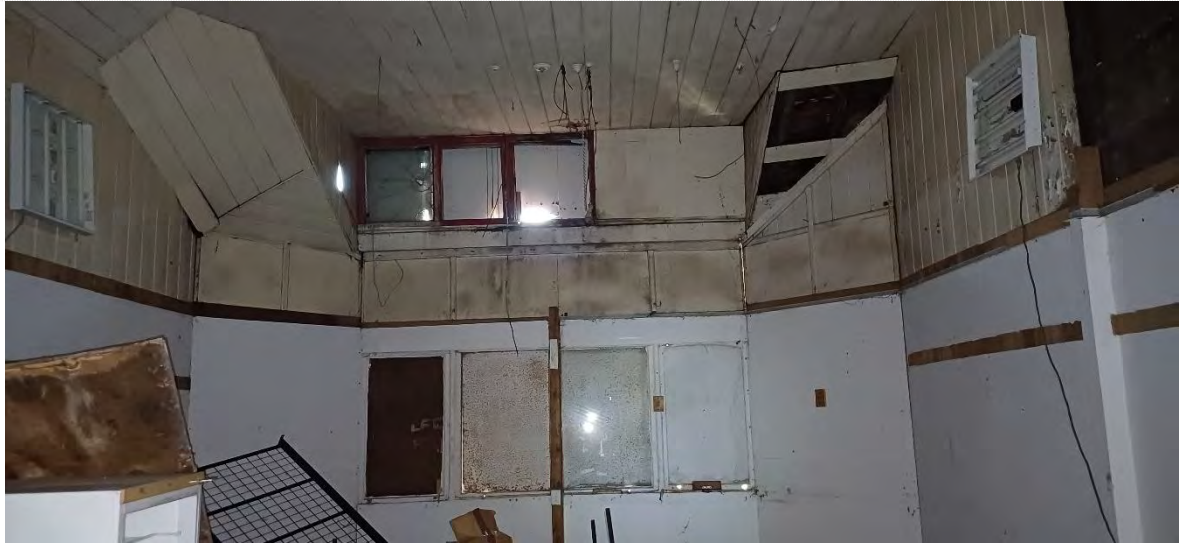
*Figure 58 – Right hand room, main building*

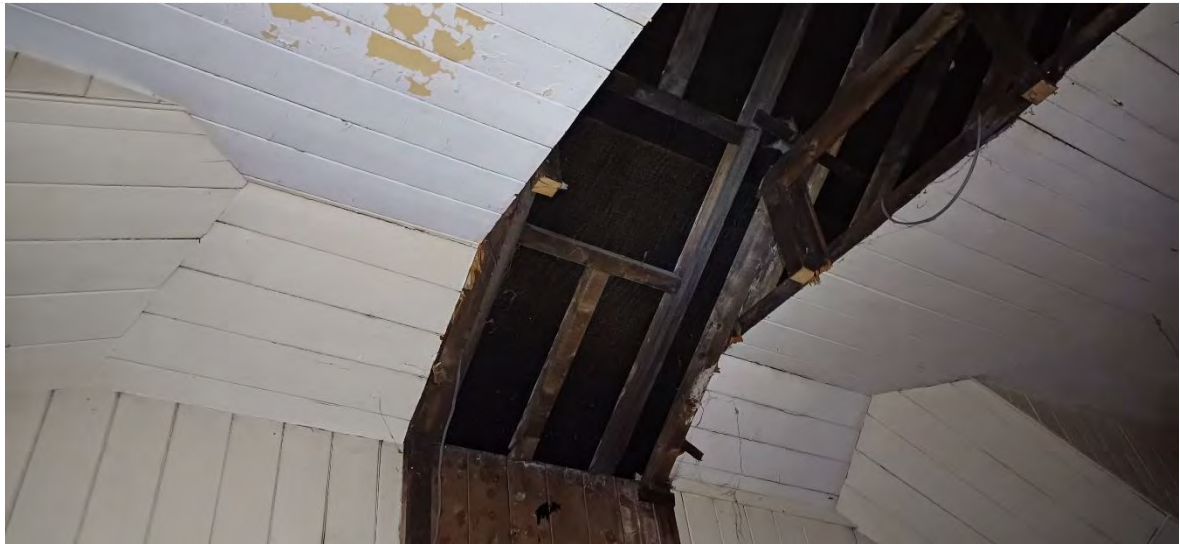
*Figure 60 – Roofing felt over right side of right hand room*

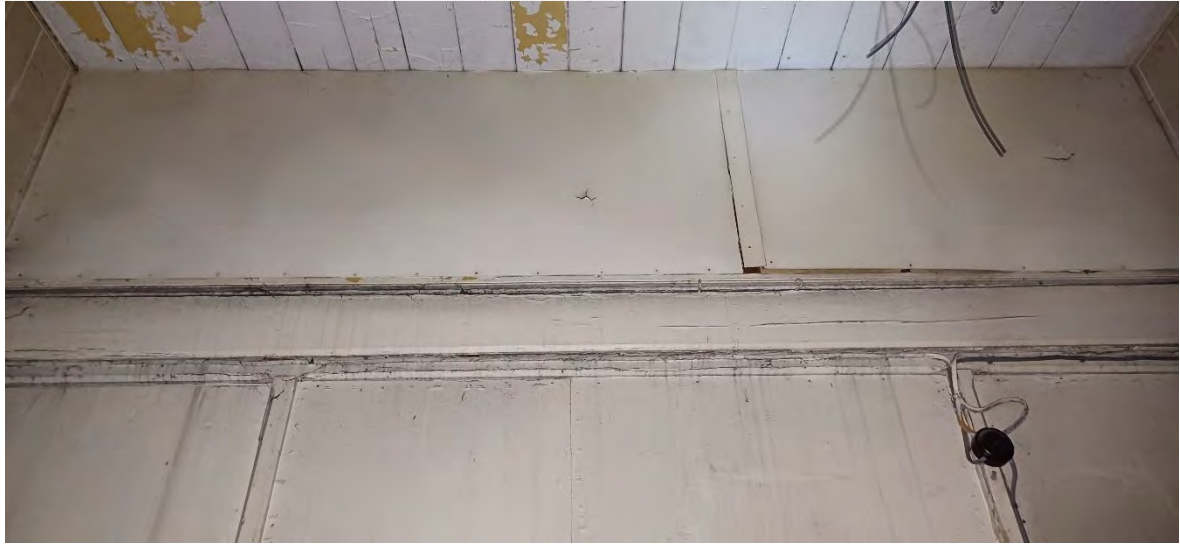
*Figure 62 – Top of rear wall, right hand room*

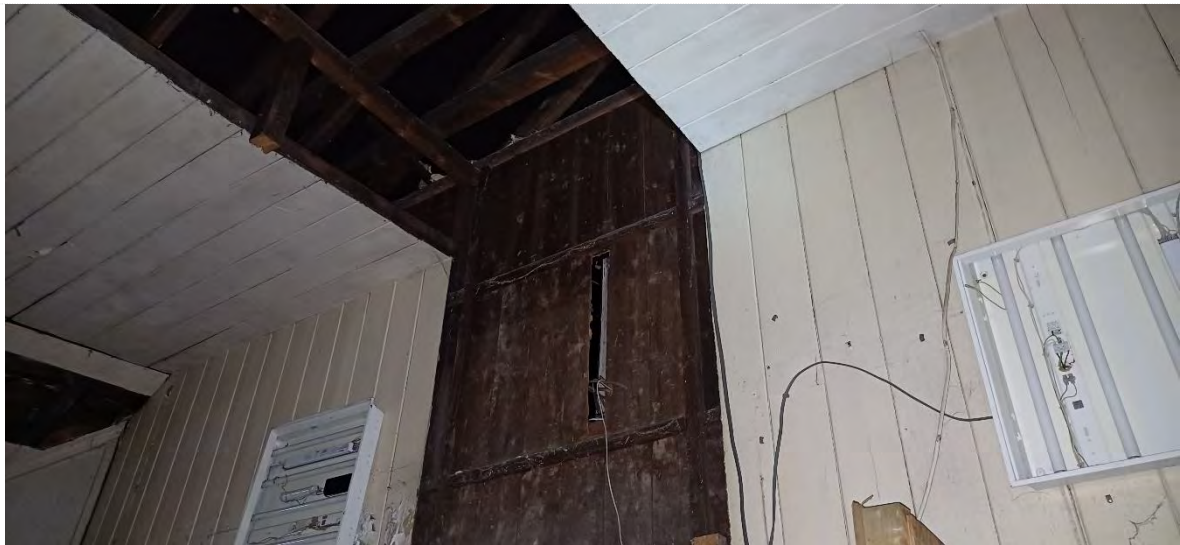
*Figure 63 – Centre of left wall, right hand room*

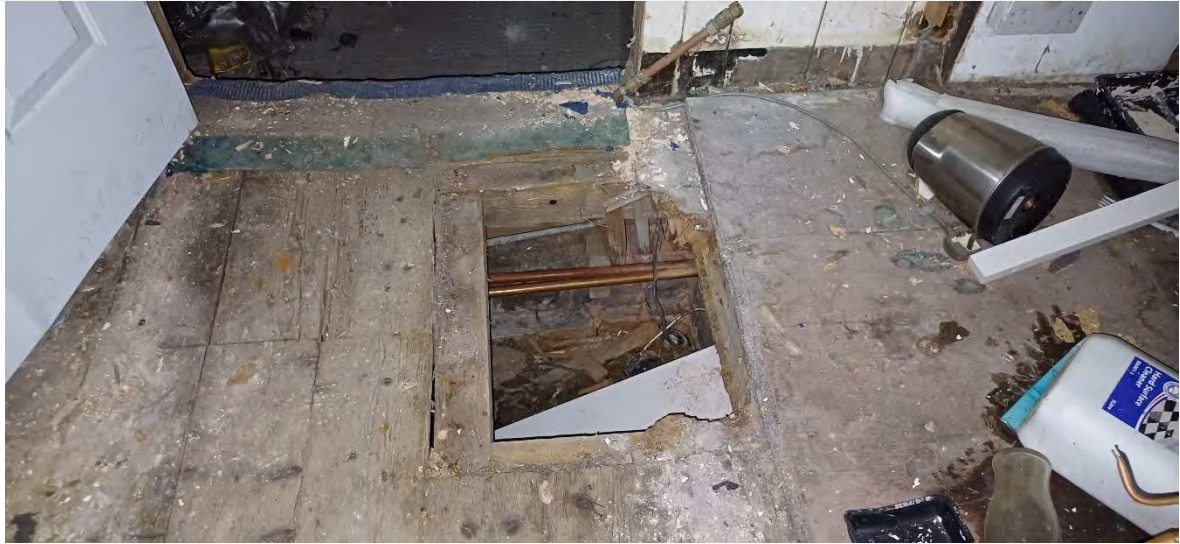
The floor appears to be compromised and requires replacing. There are no undue signs of foundation movement to the building, and it is to be hoped that the brickwork below floor level is in an acceptable condition.

*Figure 66 – Hole in floor, right hand room*

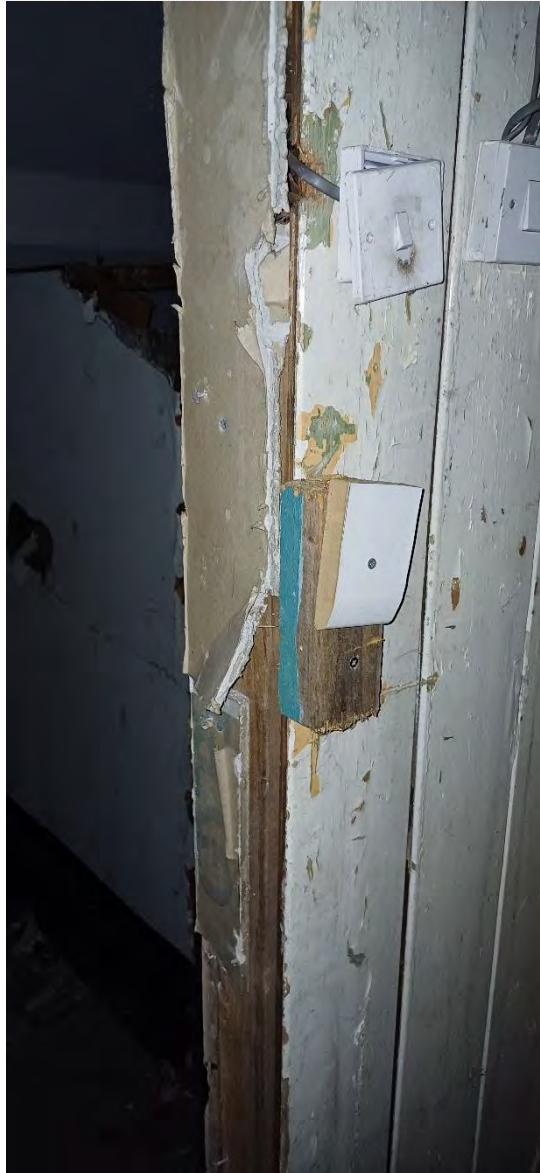
*Figure 67 – Right wall to right hand room*

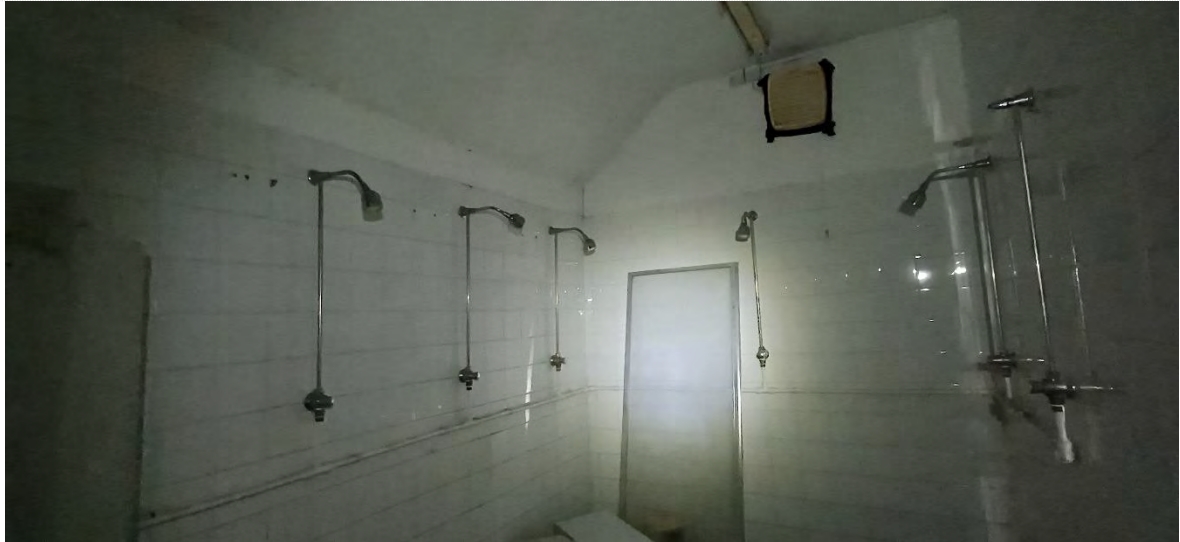
*Figure 69 – Shower room*

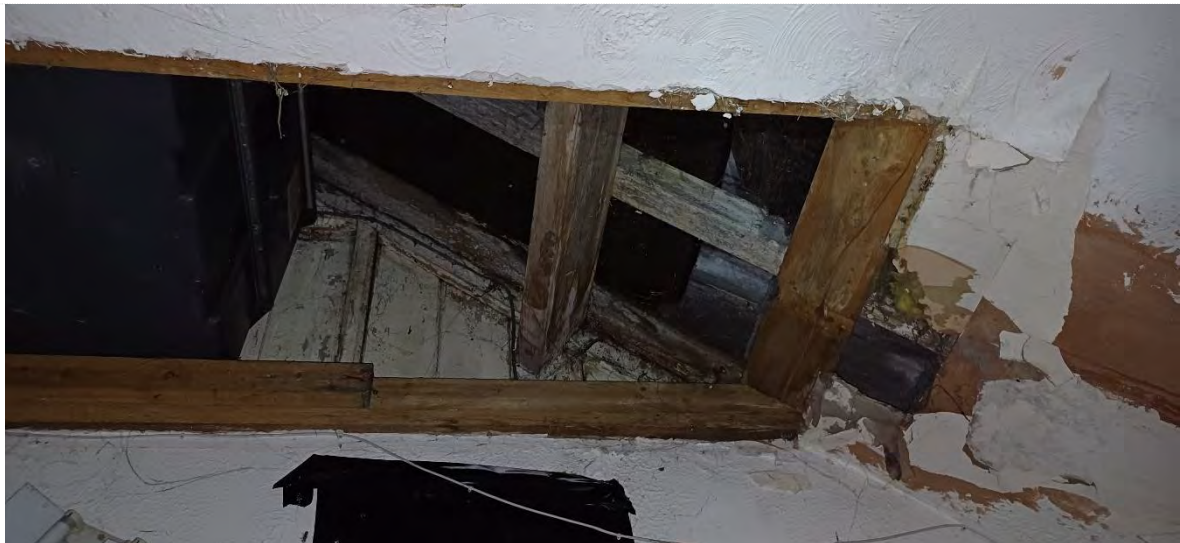
*Figure 70 – Roof to shower/toilets*
