## STRUCTURAL ENGINEERS REPORT

C15403

Huyton Cricket Club Pavillion  
Huyton Lane, Knowsley  
Liverpool L36 7XD

13 June 2025

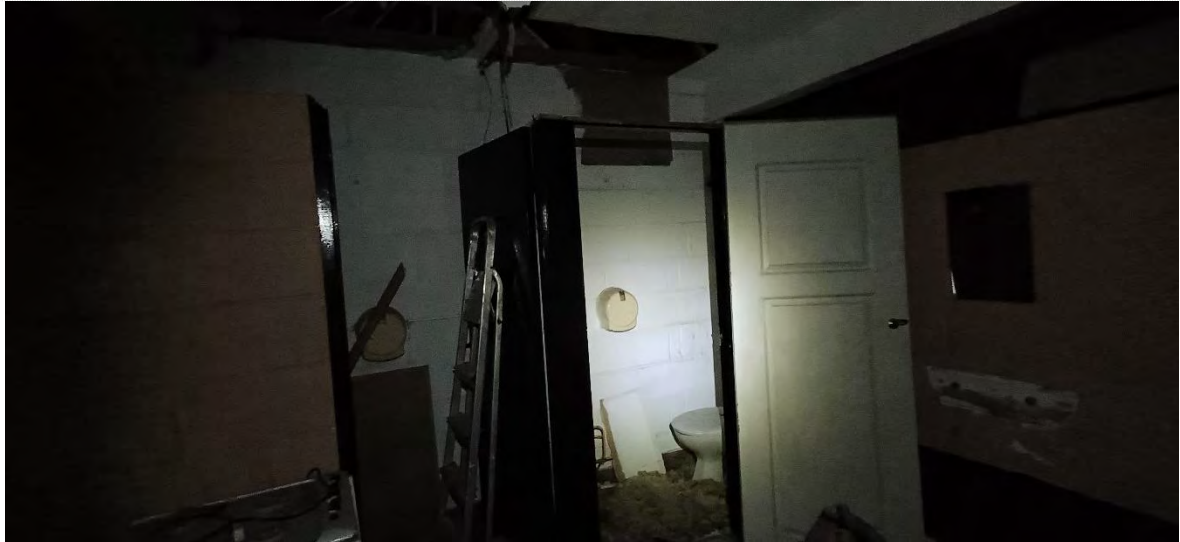
*Figure 76 – Right toilet room*

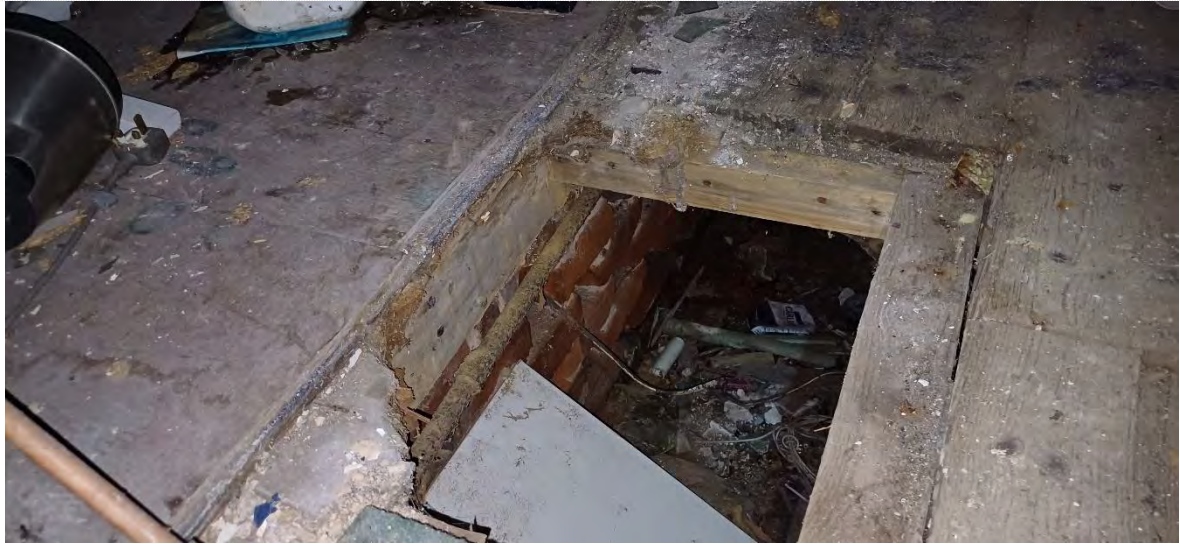
*Figure 78 – Sleeper wall, right room*

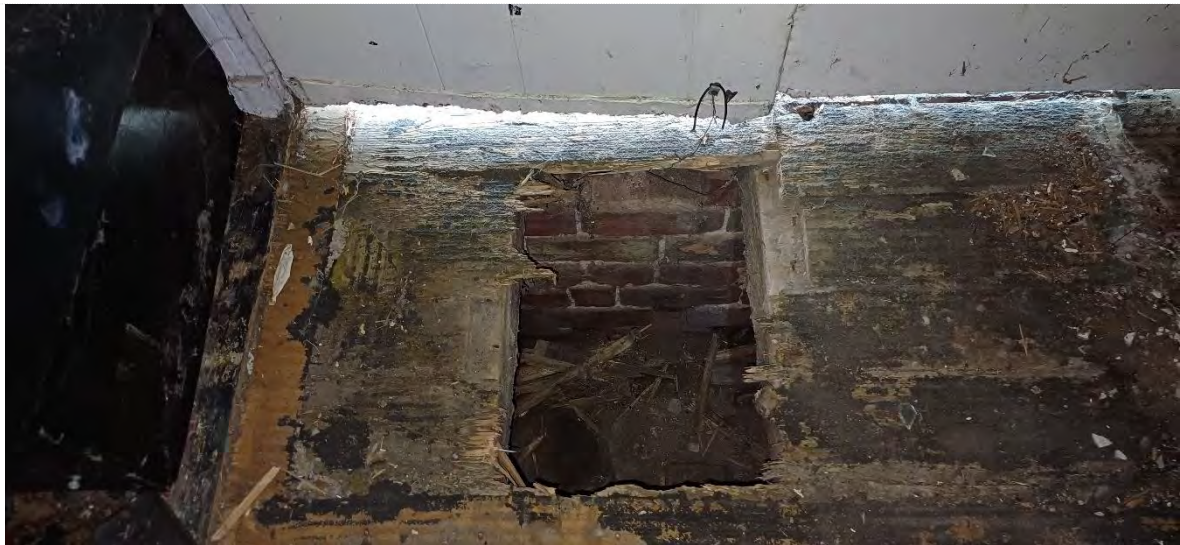
*Figure 79 – Wall & hole in main room*

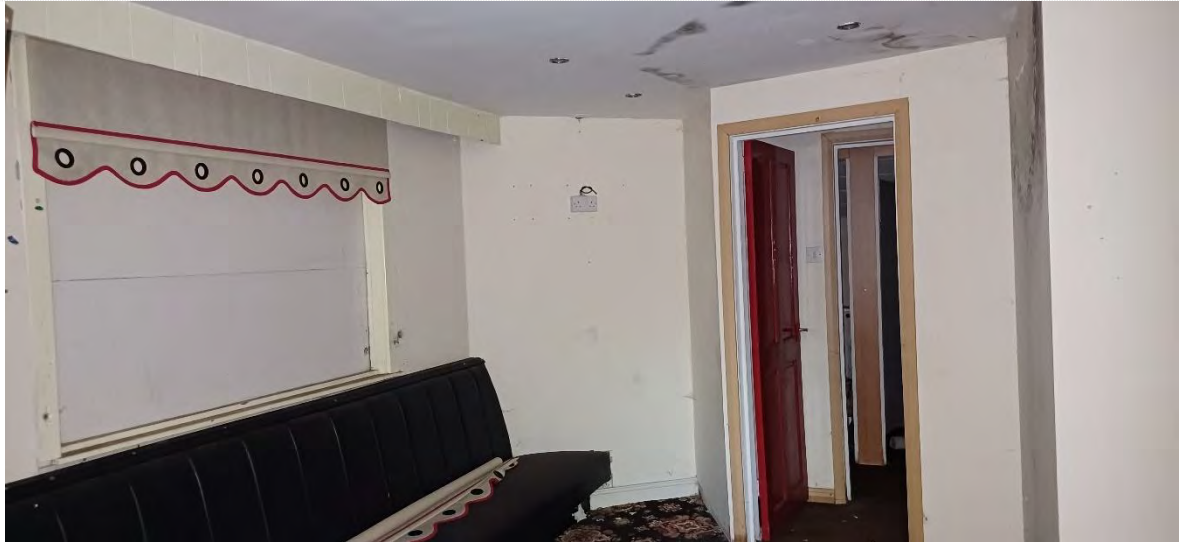
*Figure 80 – Left front of main room*

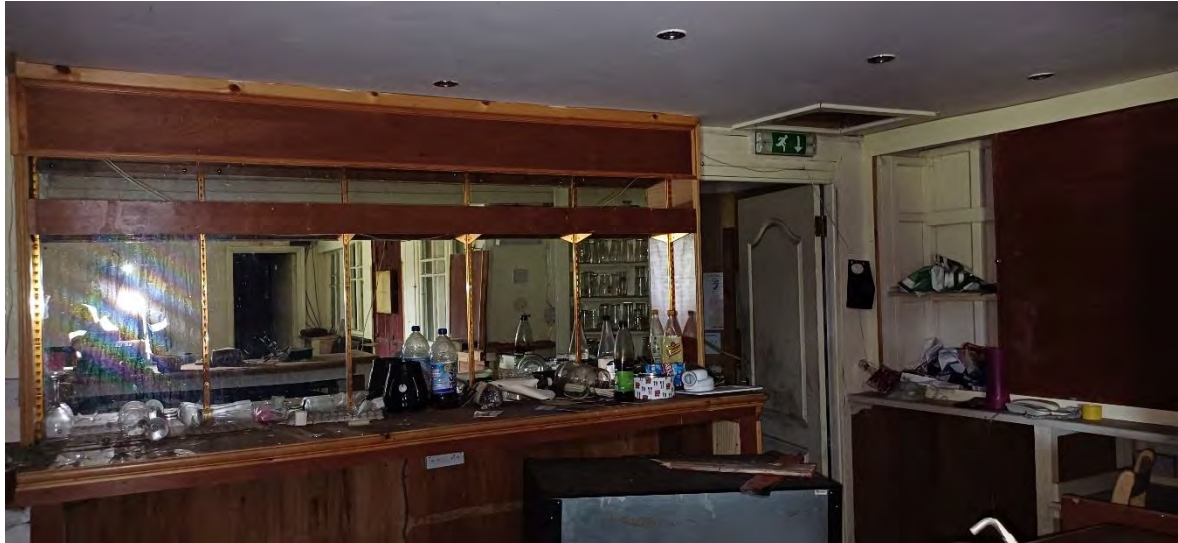
*Figure 84 – Bar*

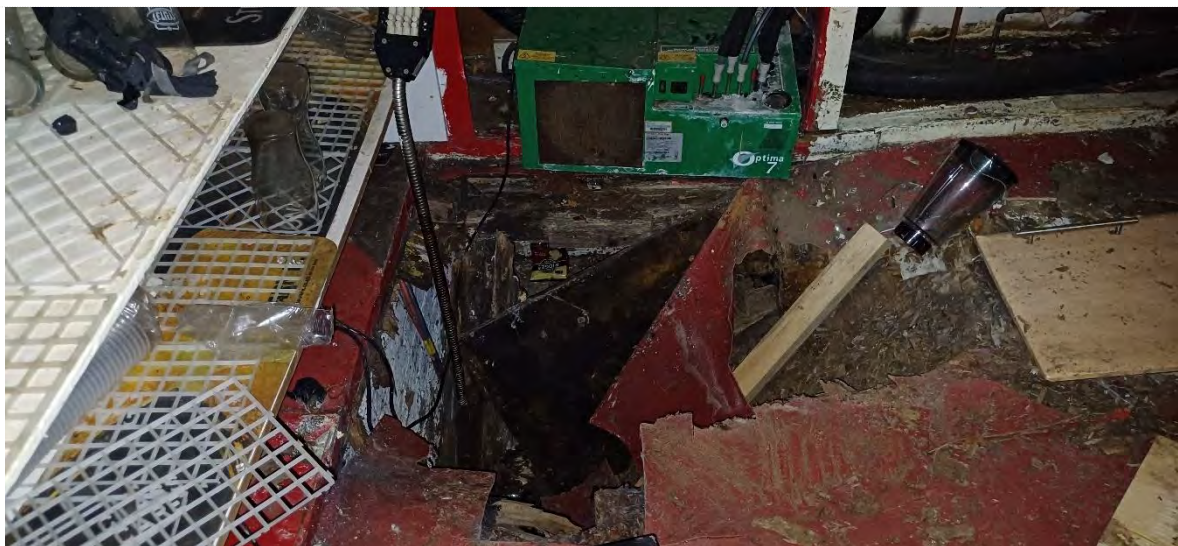
*Figure 85 – Floor behind bar*

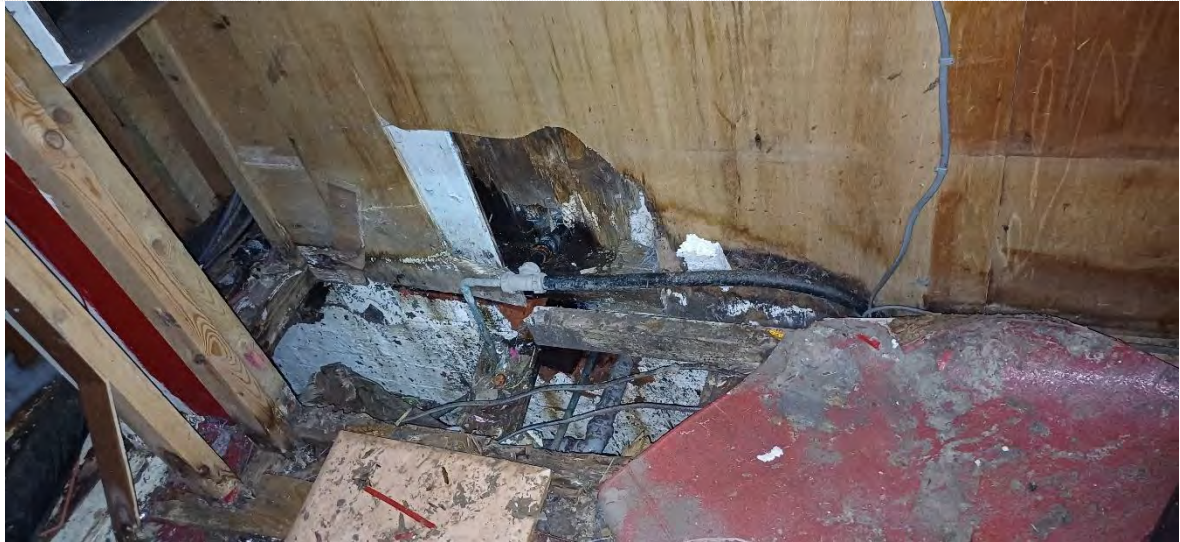
*Figure 86 – Floor behind bar*

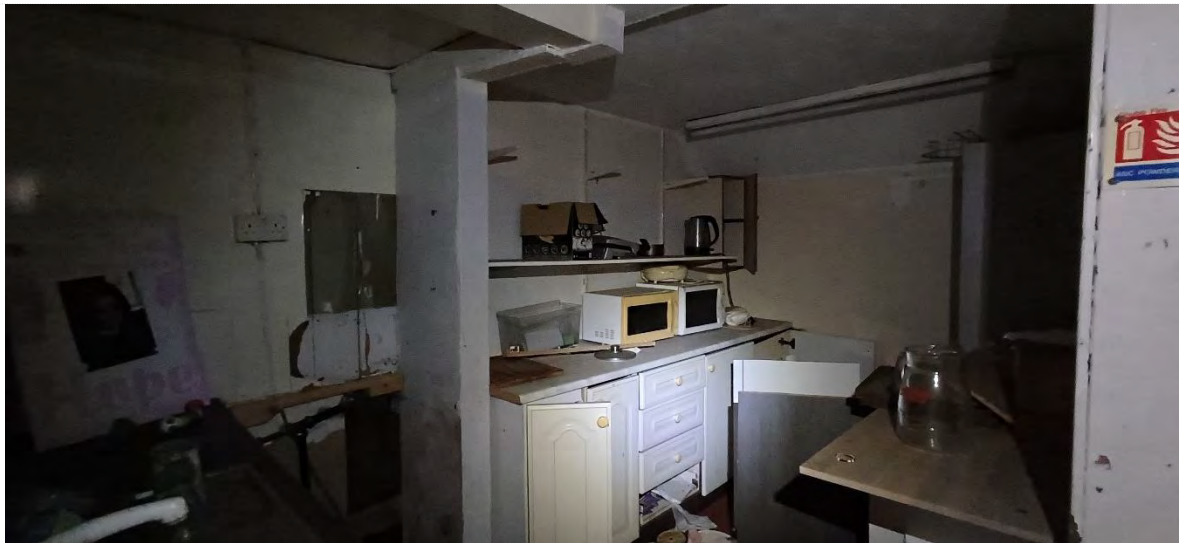
*Figure 87 – Kitchen – rear left*

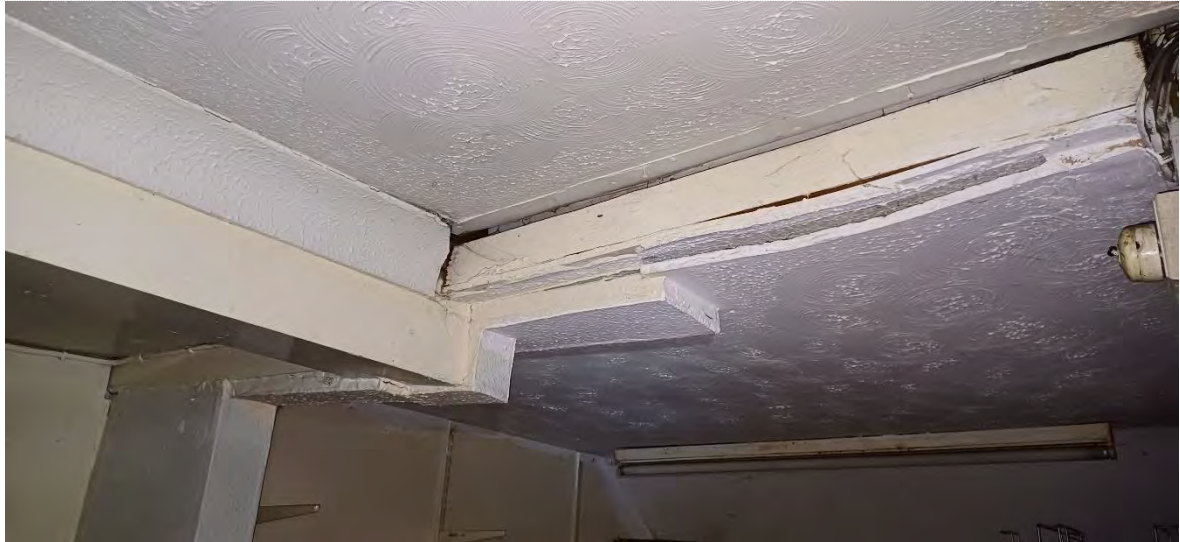
*Figure 88 – Opening to left of kitchen*

1. Carry out a dimensional survey of the structural members – this is likely to need a contractor to open-up and make areas safe
2. Replace all damaged and rotting panels to the elevations with new T&G to match existing
3. Replace affected vertical and horizontal timbers to the front, rear and sides
4. Rebuild the front retaining wall
5. Replace the suspended ground floor structure
6. Provide suitable beams over the kitchen opening

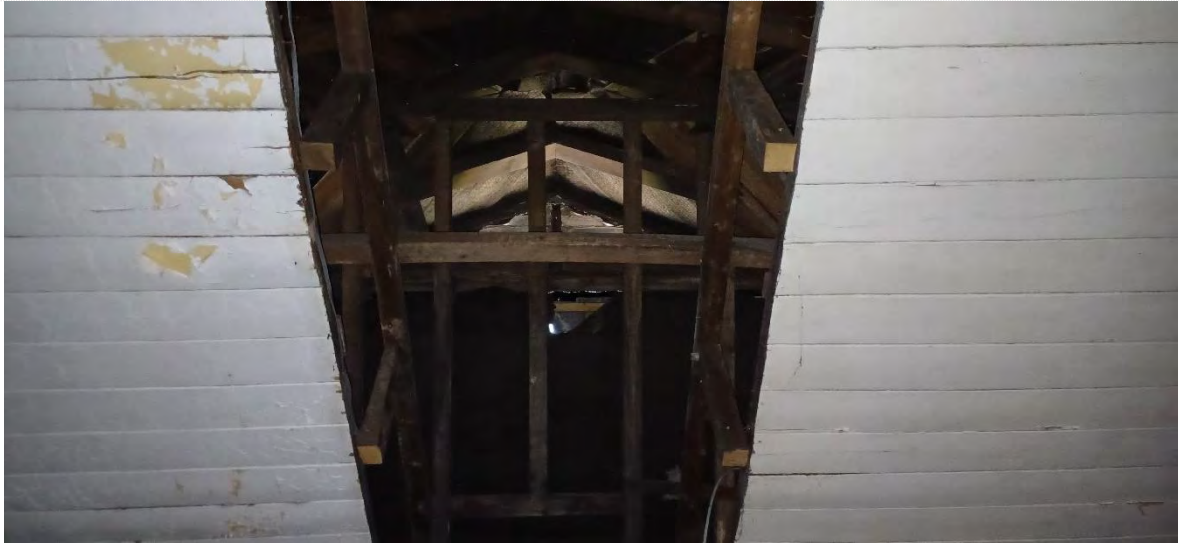
*Figure 90 – Roof – right side of right room*

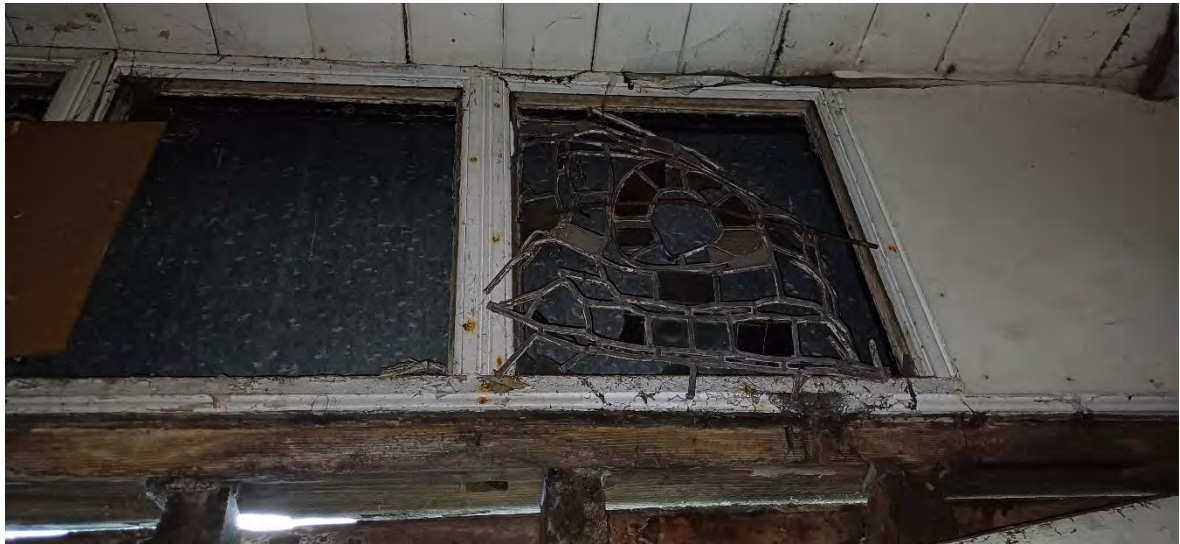
*Figure 92 – Former window, rear wall to bar*

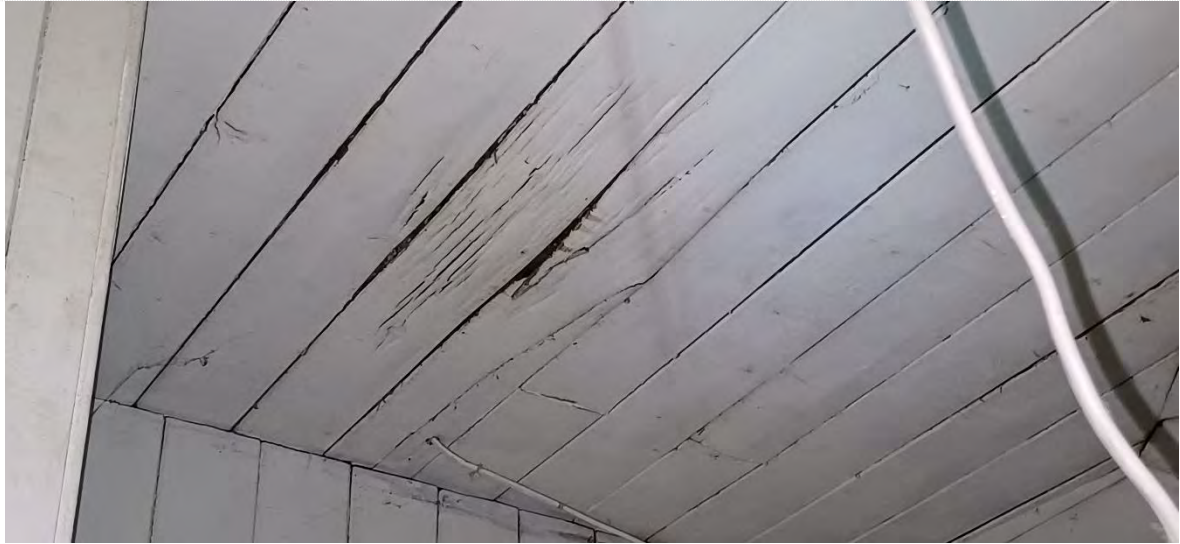
*Figure 94 – Damage to ceiling, rear of bar*

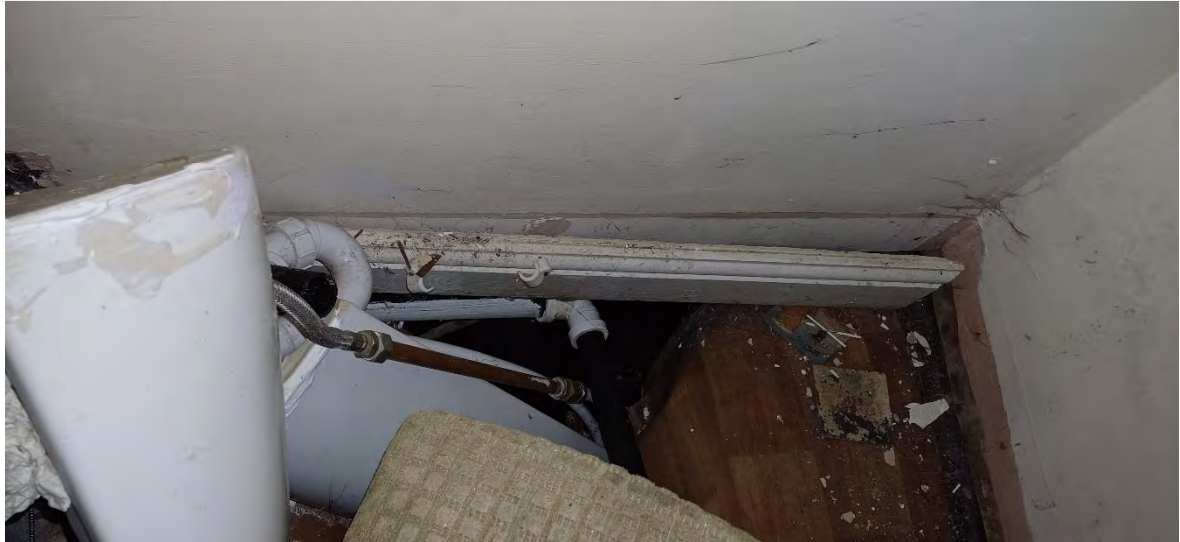
The floor appears to be compromised and requires replacing. There are no undue signs of foundation movement to the building, and it is to be hoped that the brickwork below floor level is in an acceptable condition.

*Figure 96 – Collapsed floor, left toilets*
