# Contaminated Land Phase One Desk Study for Proposed Residential Dwellings at, Foxhill Farm, Foxhill Lane, Halewood, L26 4XG.

Revised and Updated August 2022

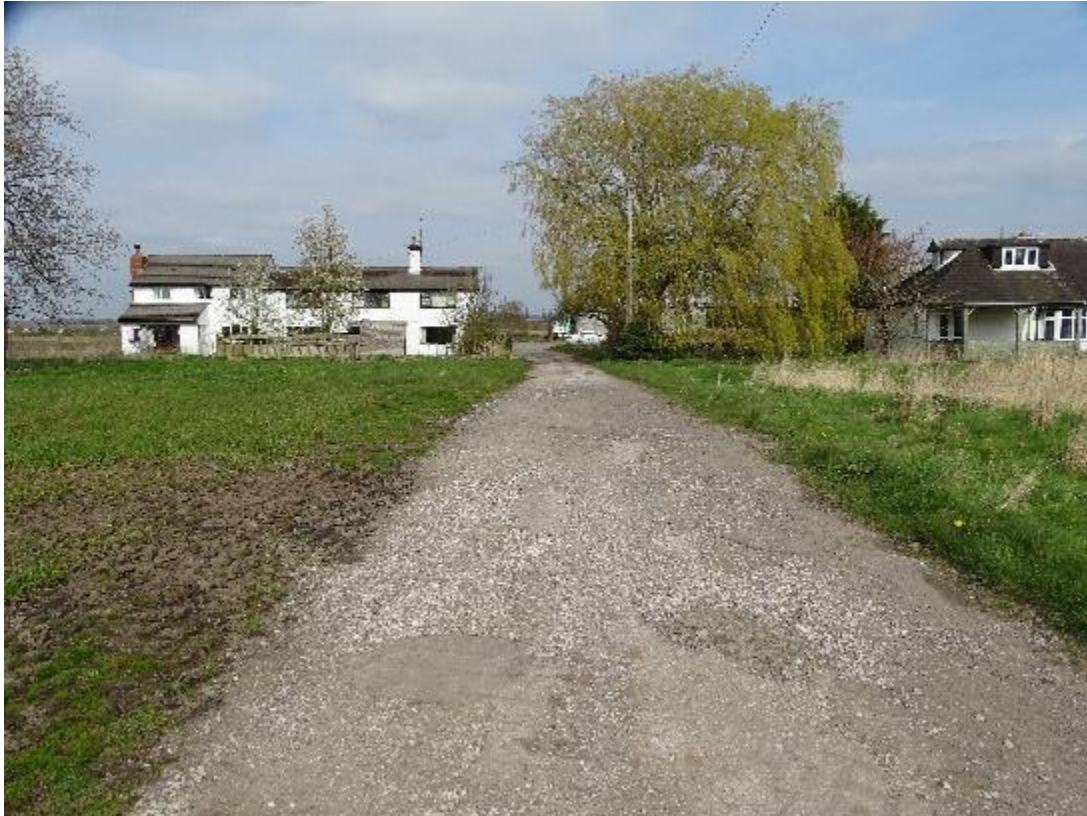
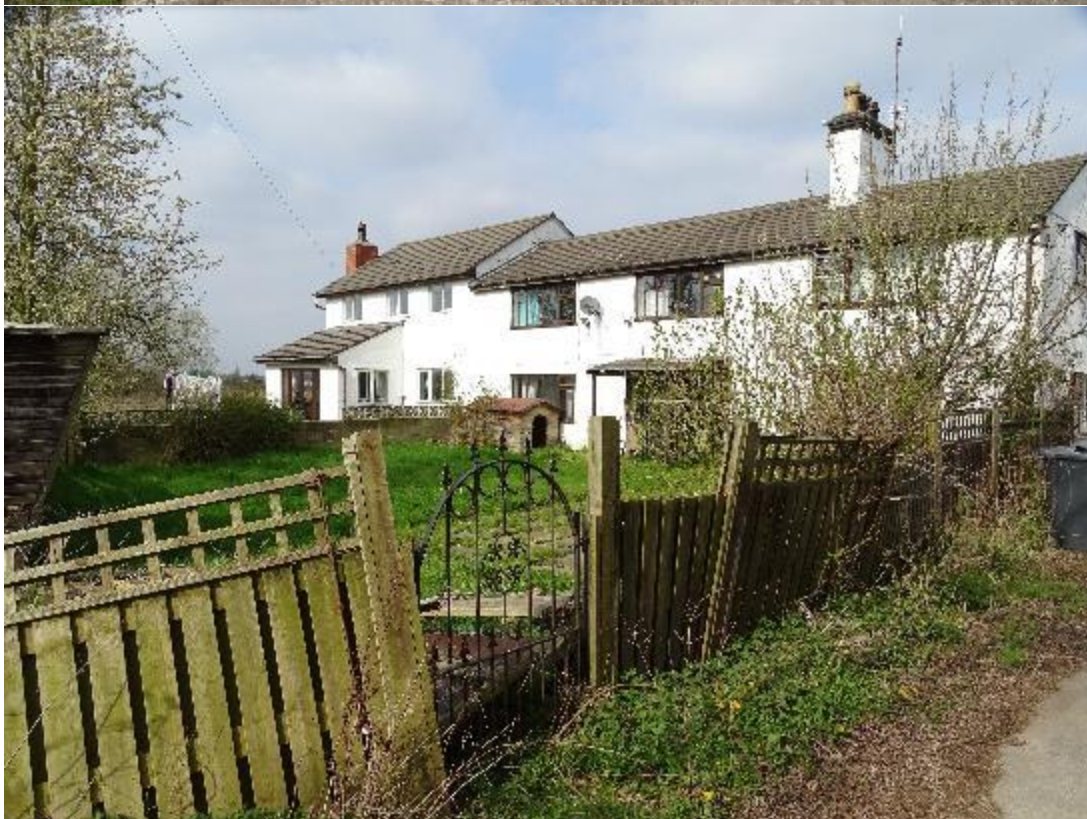
Site access drive and farm house

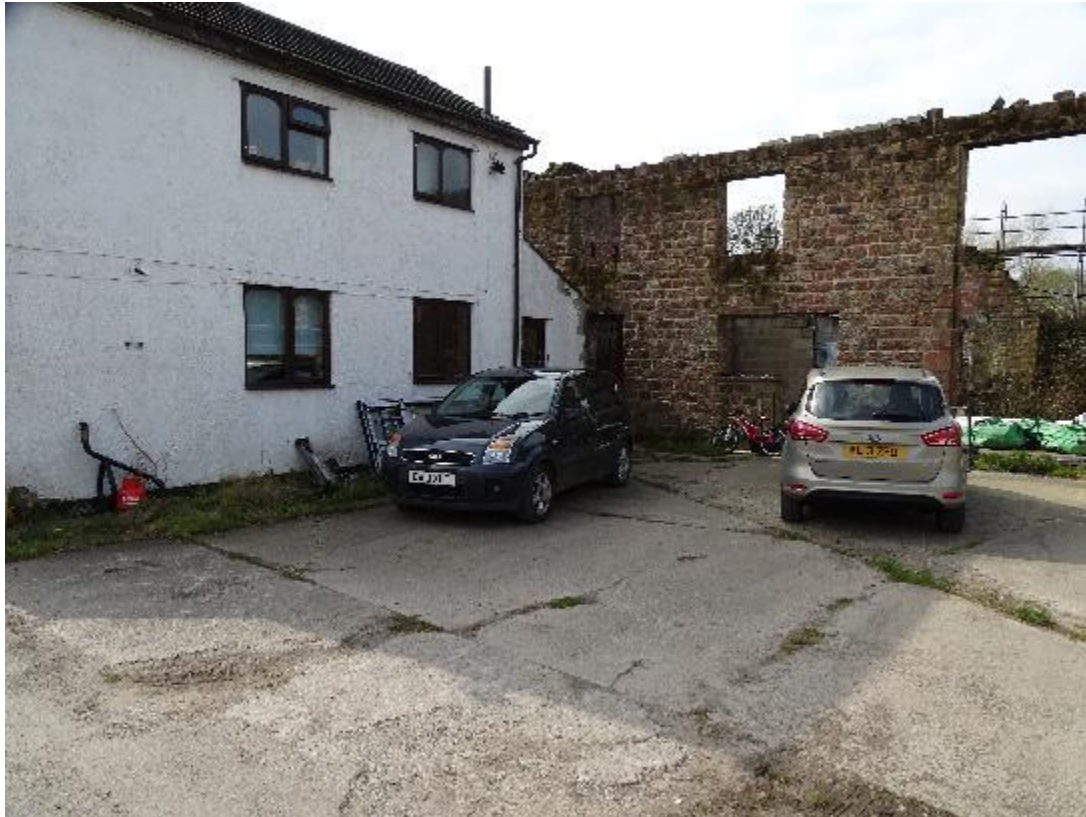
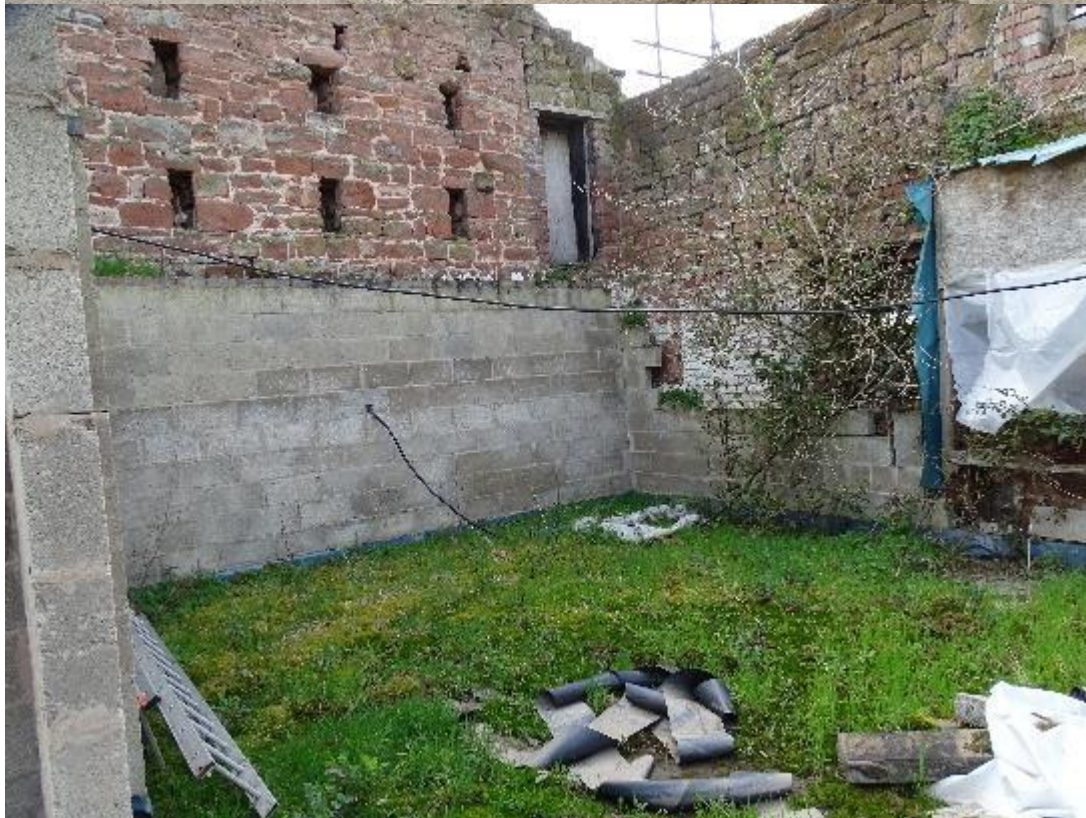
The remains of the barn

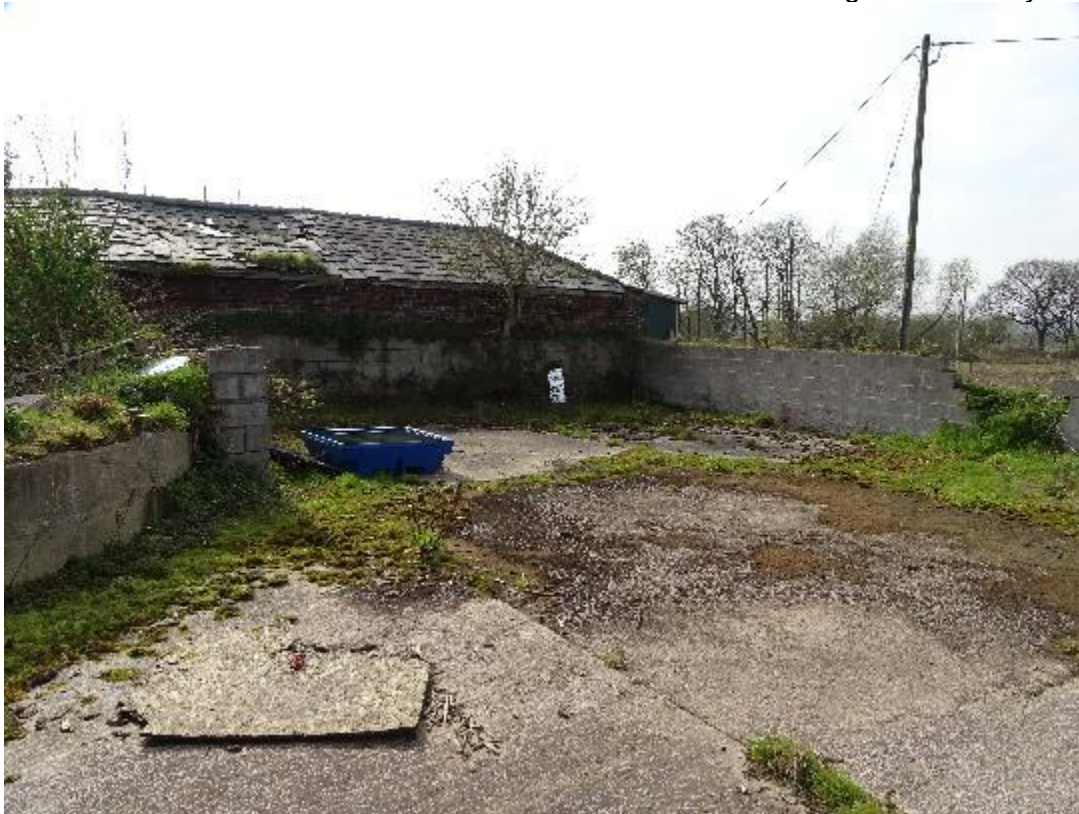
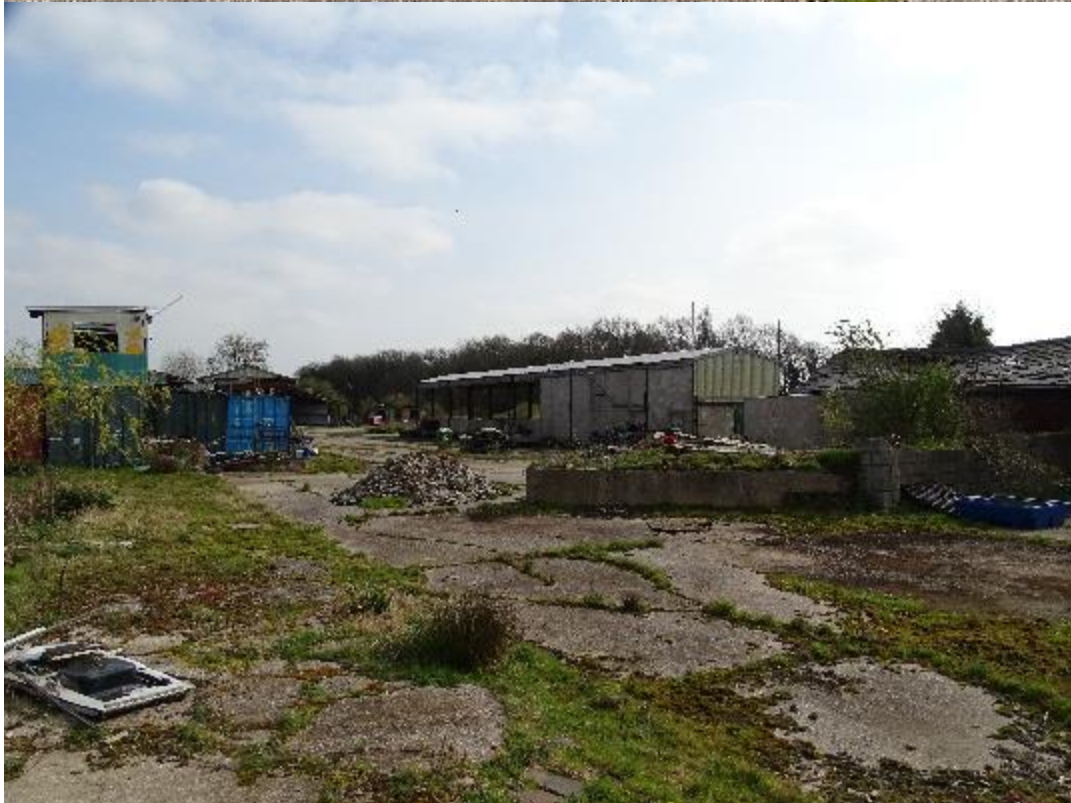
The old tank and view across the site from northwest corner along the boundary to the east

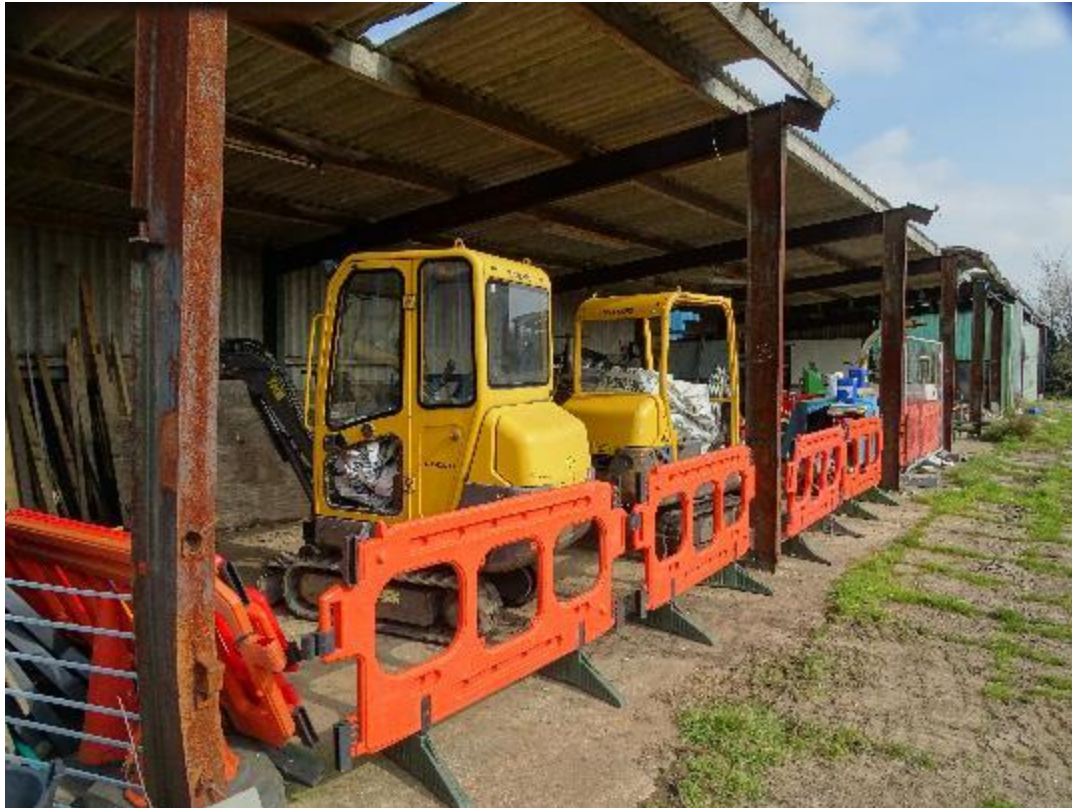
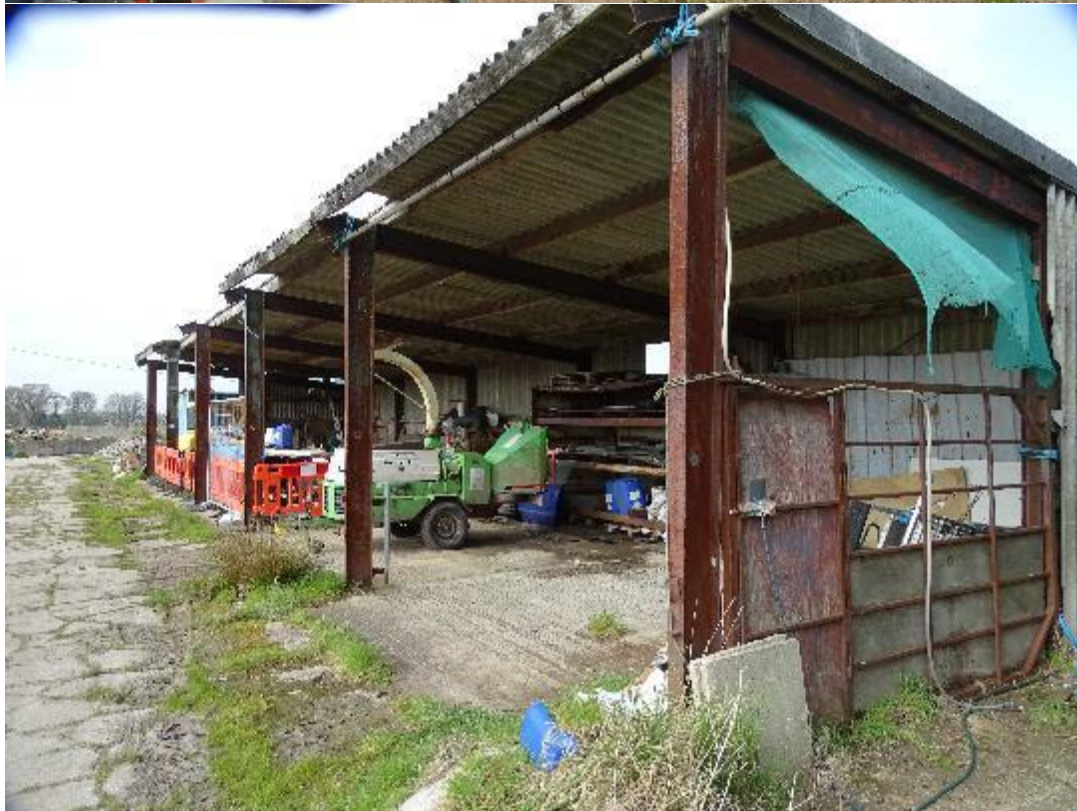
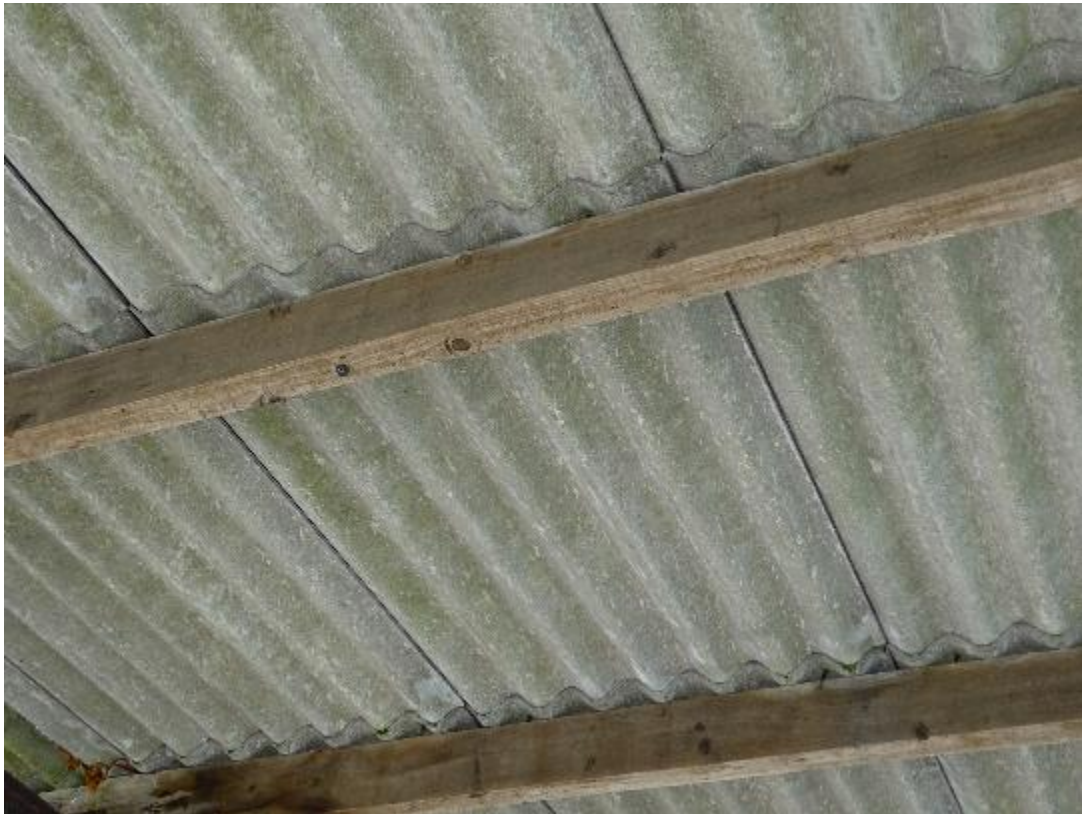
To the rear (north) of the site are located a number of metal storage containers and a row of two storey barns. The first from the west is open sided has a concrete base and breeze block lower walls with cement corrugated sheeting to the upper section and roof. The floor was in a good condition and there were no signs of any spillages.

The first of the northern barns

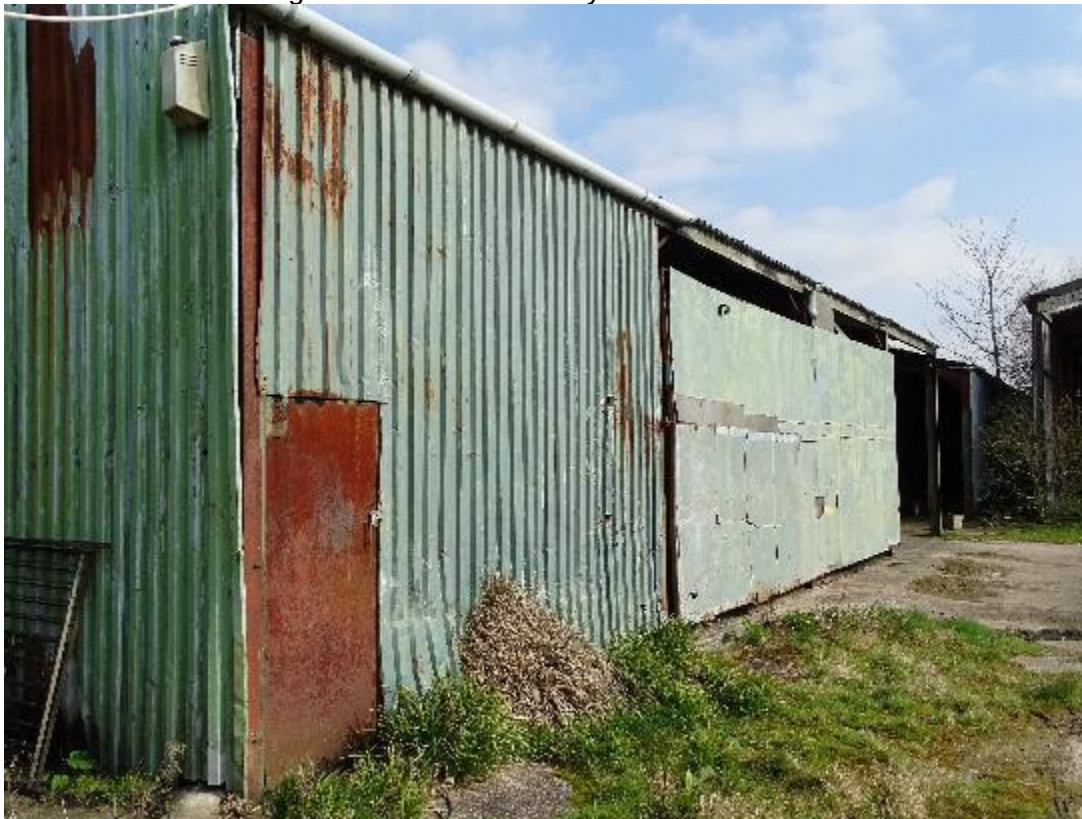
The second barn along the northern boundary

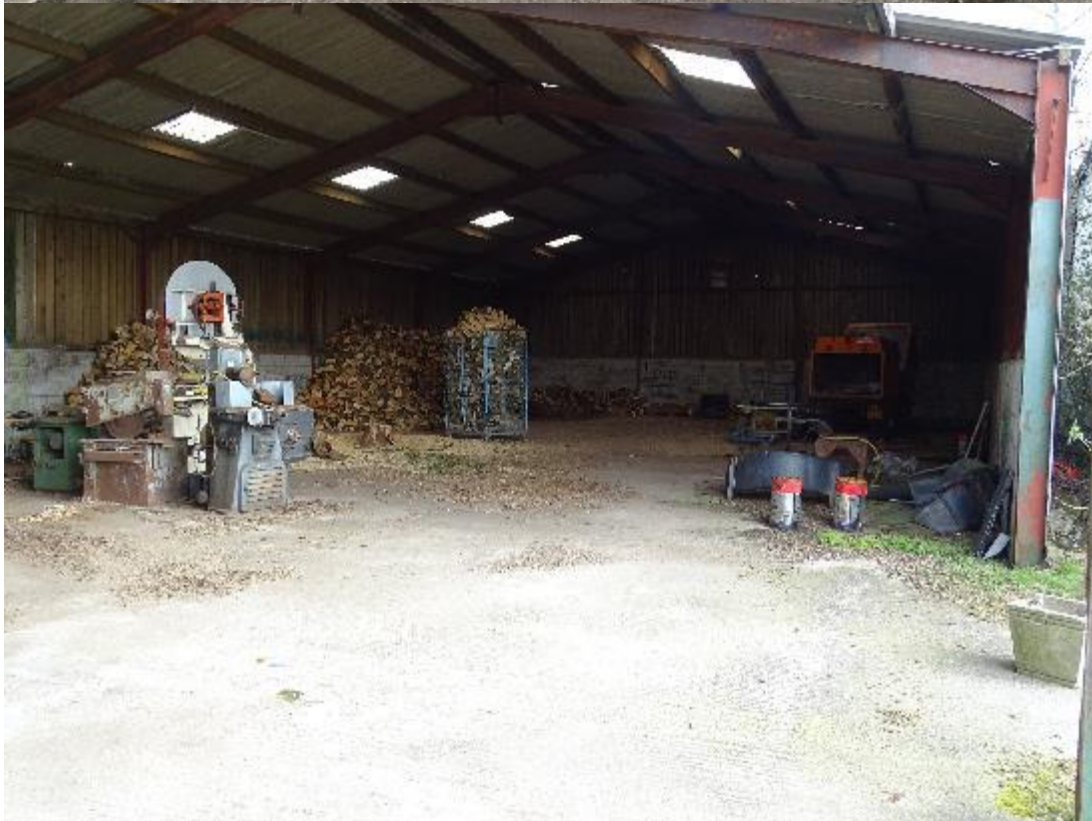
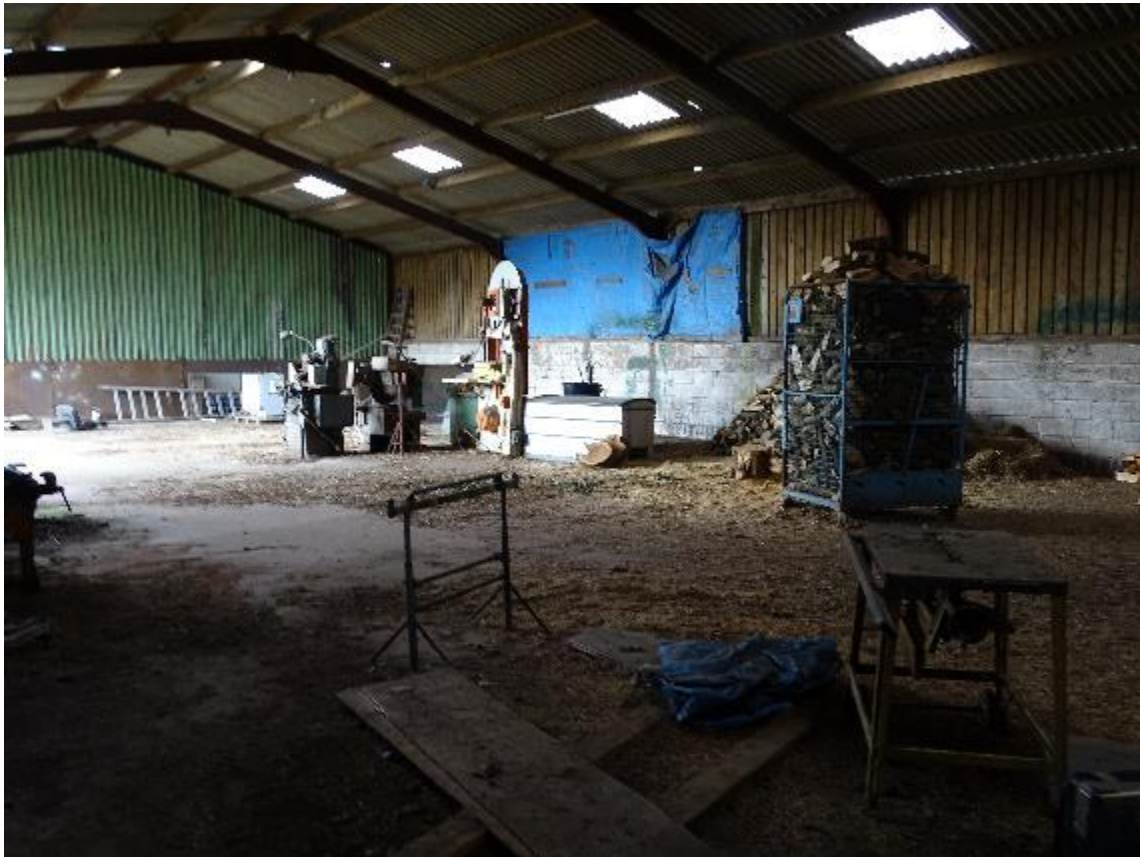
The second section of the barn

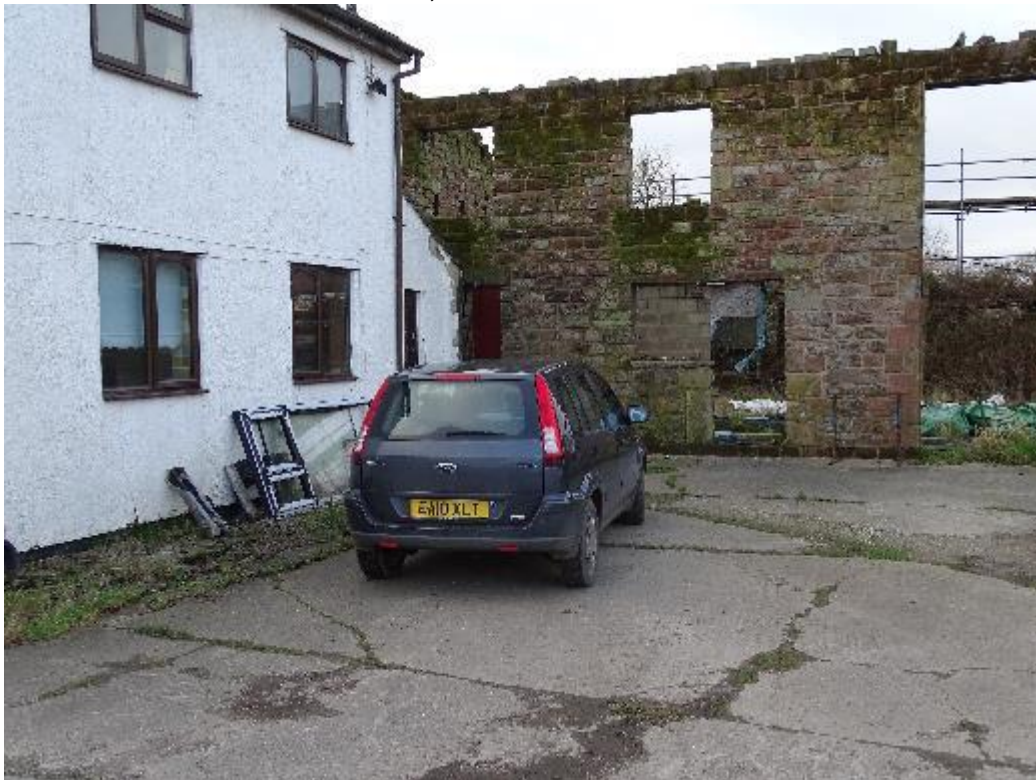
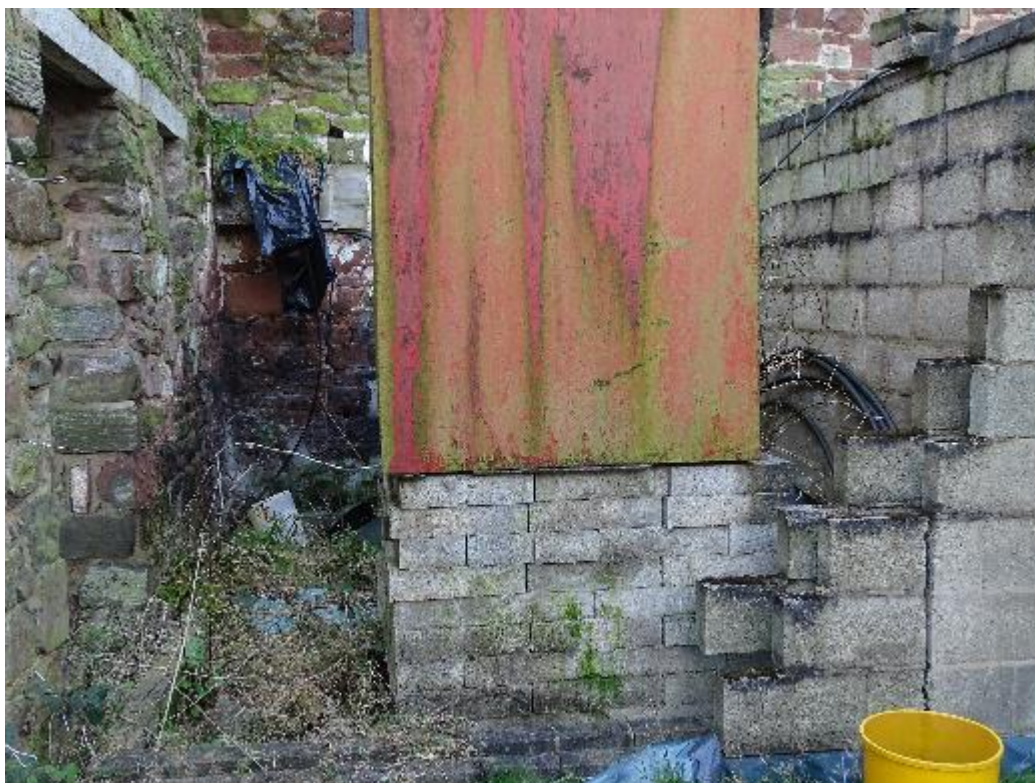
A double skinned elevated heating fuel tank is located within the two-storey barn, no signs of any leakage are present.

Remains of barn behind farm house, with double skinned fuel tank

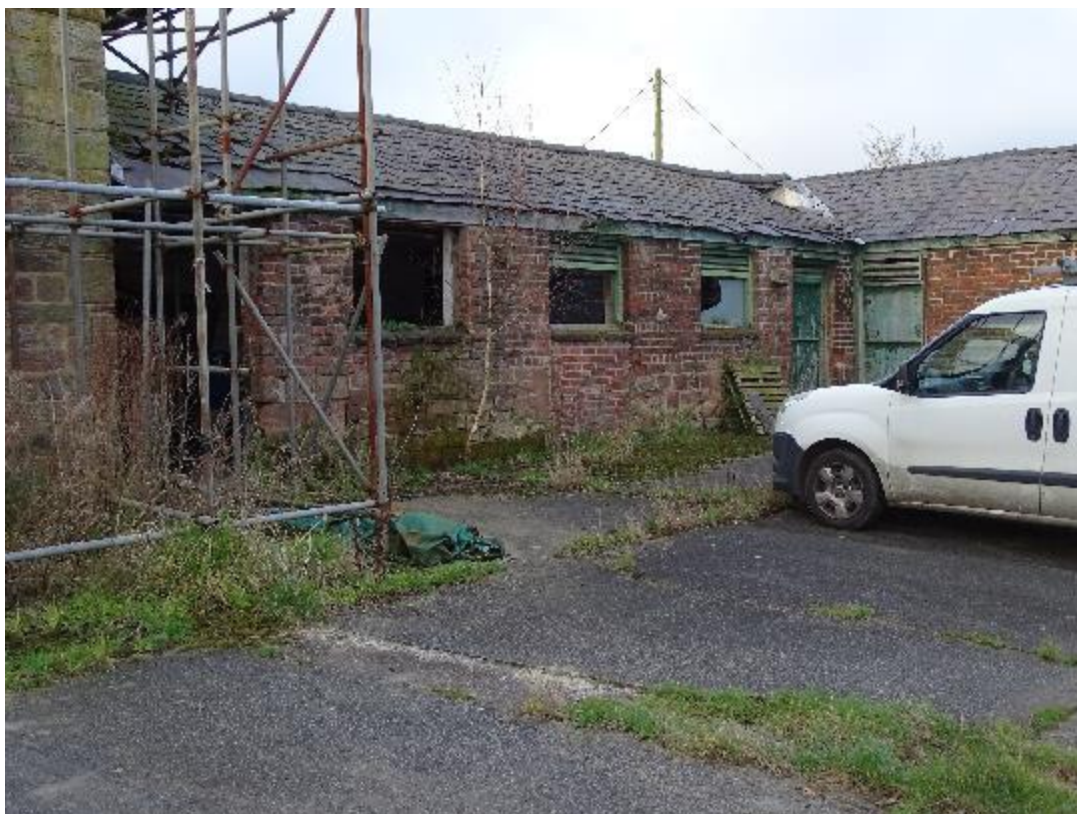
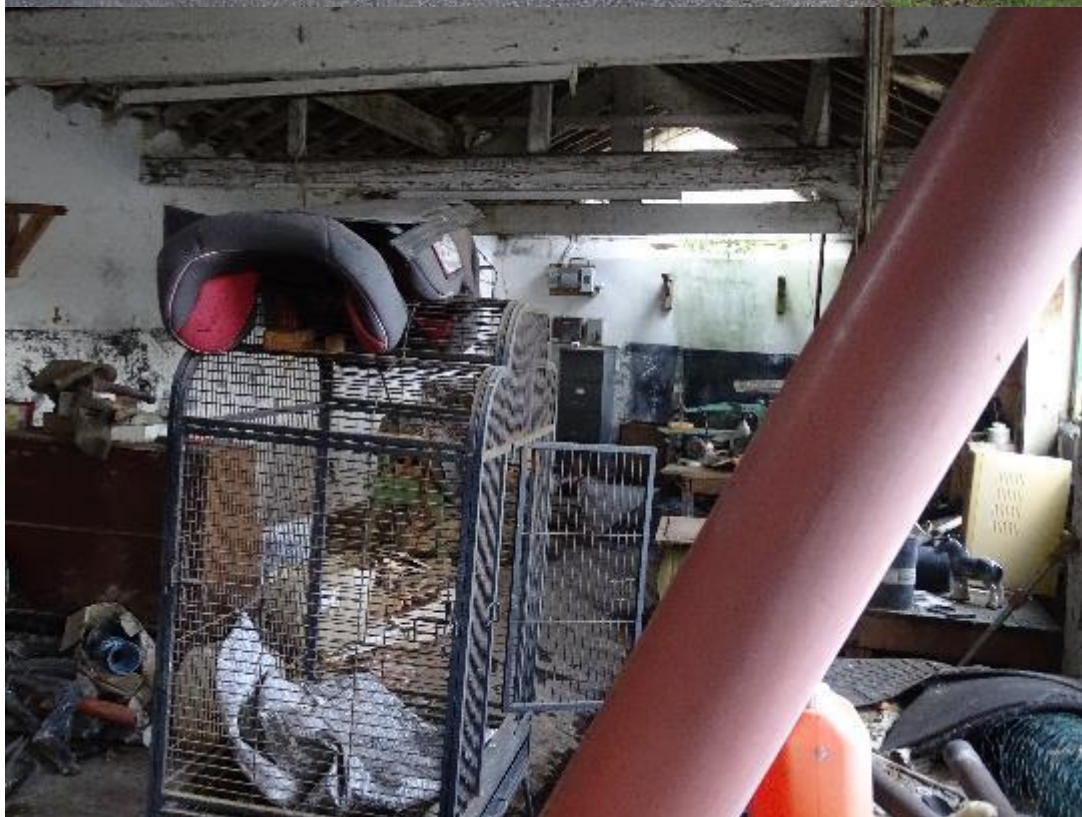
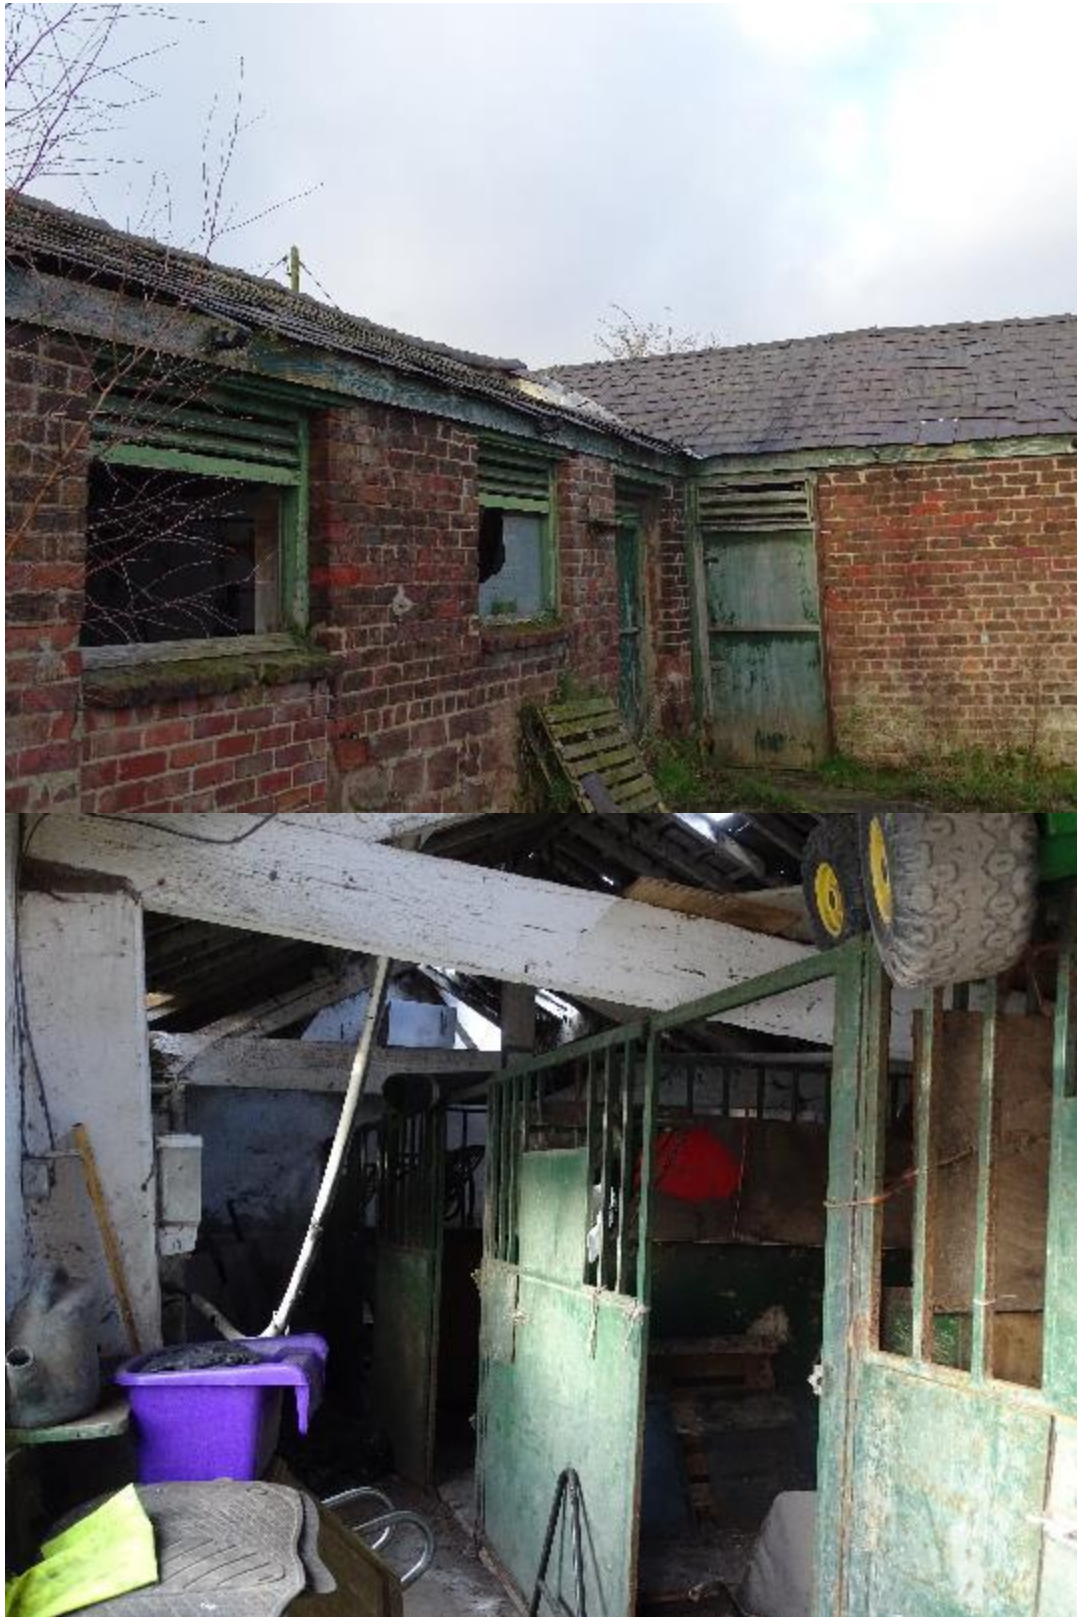
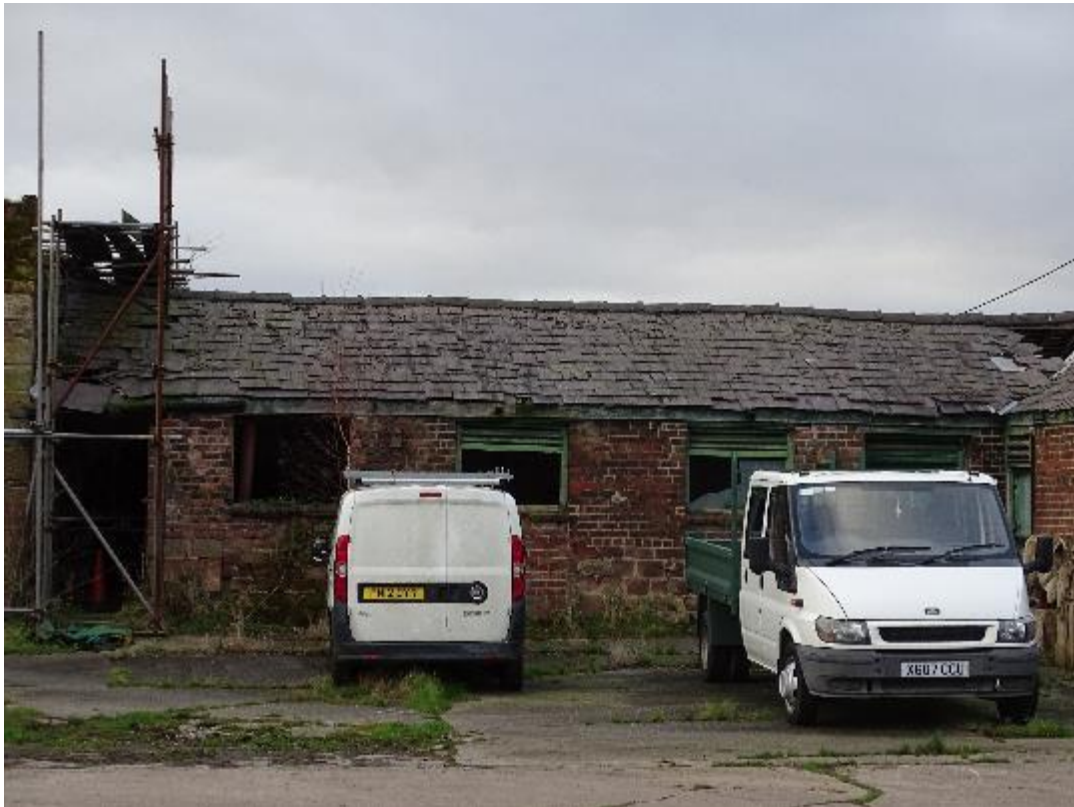
Single storey brick barn to rear of farmhouse

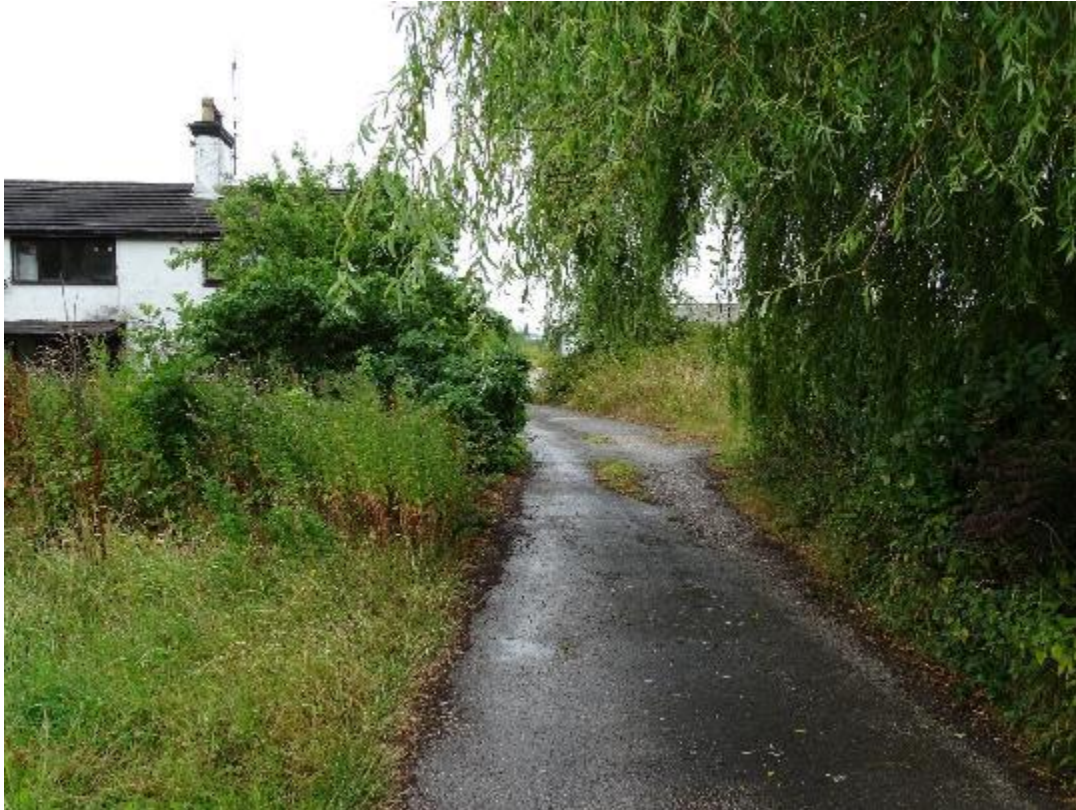
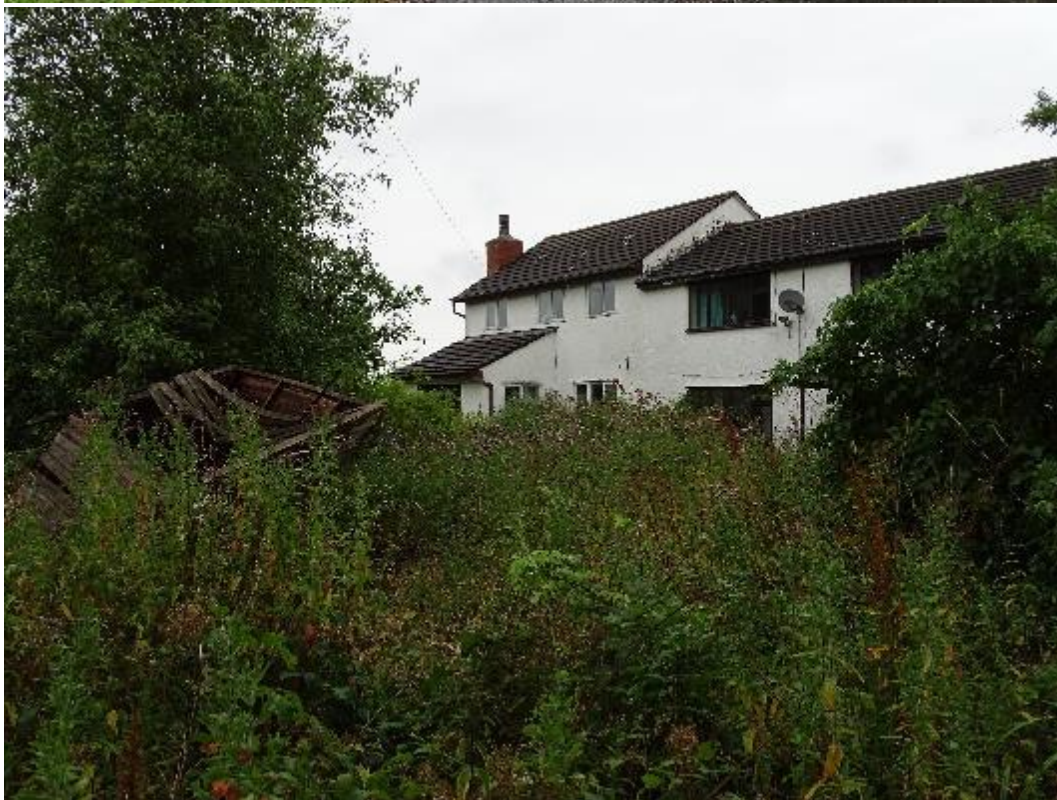
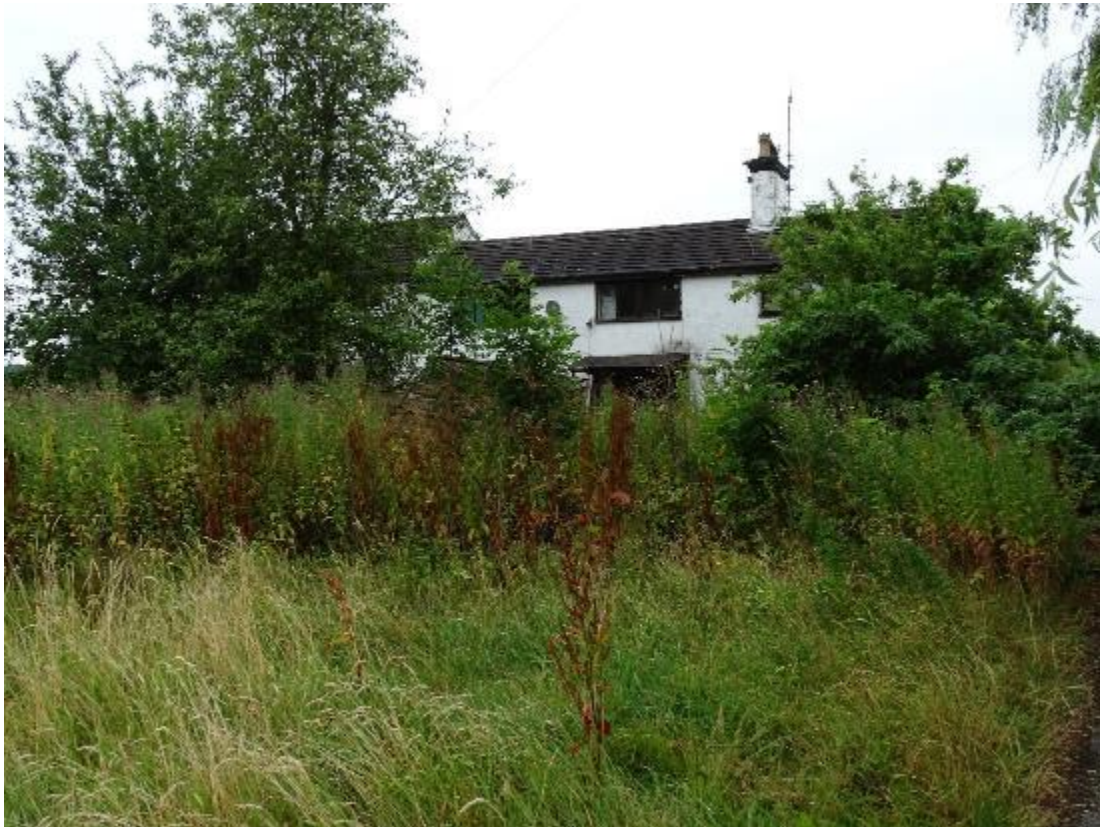
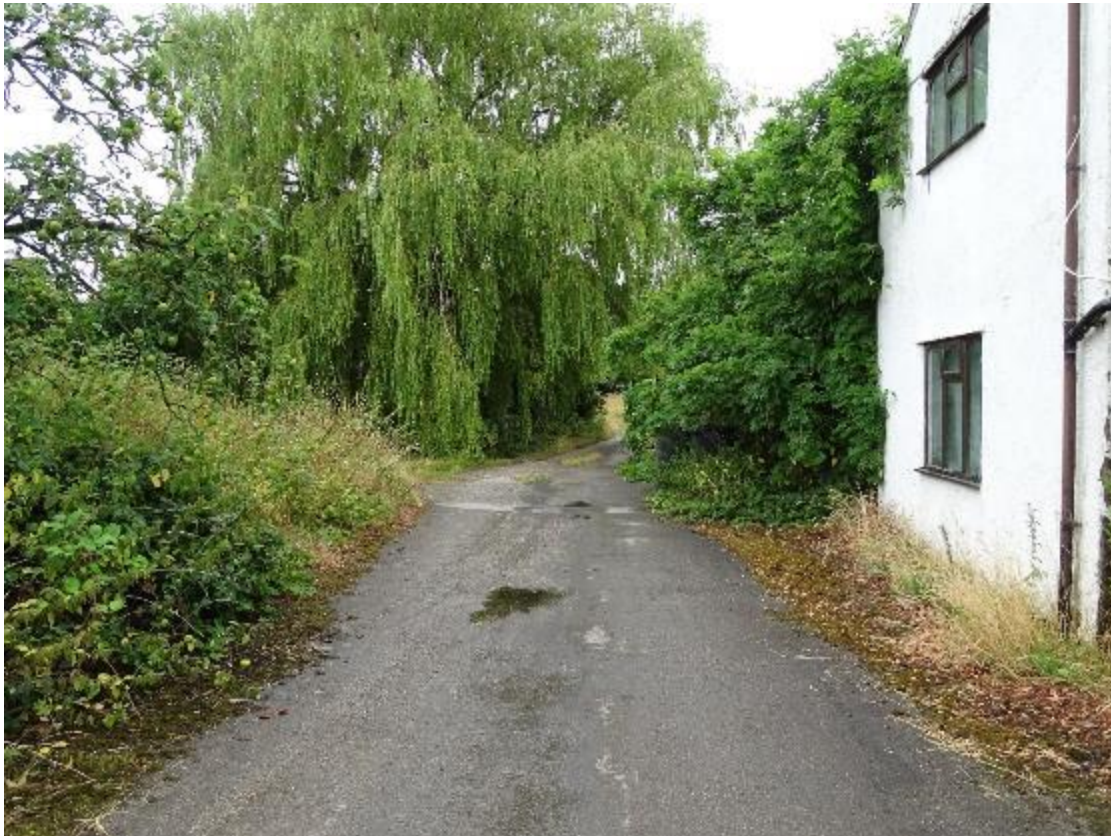
Entrance to the site and the Farm house

An addition site walkover has been conducted on the 22<sup>nd</sup> July 2022, photographs are included within Appendix 5, and provide a view of the current situation on site. There has been little change. Wood chip operations within the yard have now ceased and the buildings have deteriorated further.
