# Contaminated Land Phase One Desk Study for Proposed Residential Dwellings at, Foxhill Farm, Foxhill Lane, Halewood, L26 4XG.

Revised and Updated August 2022

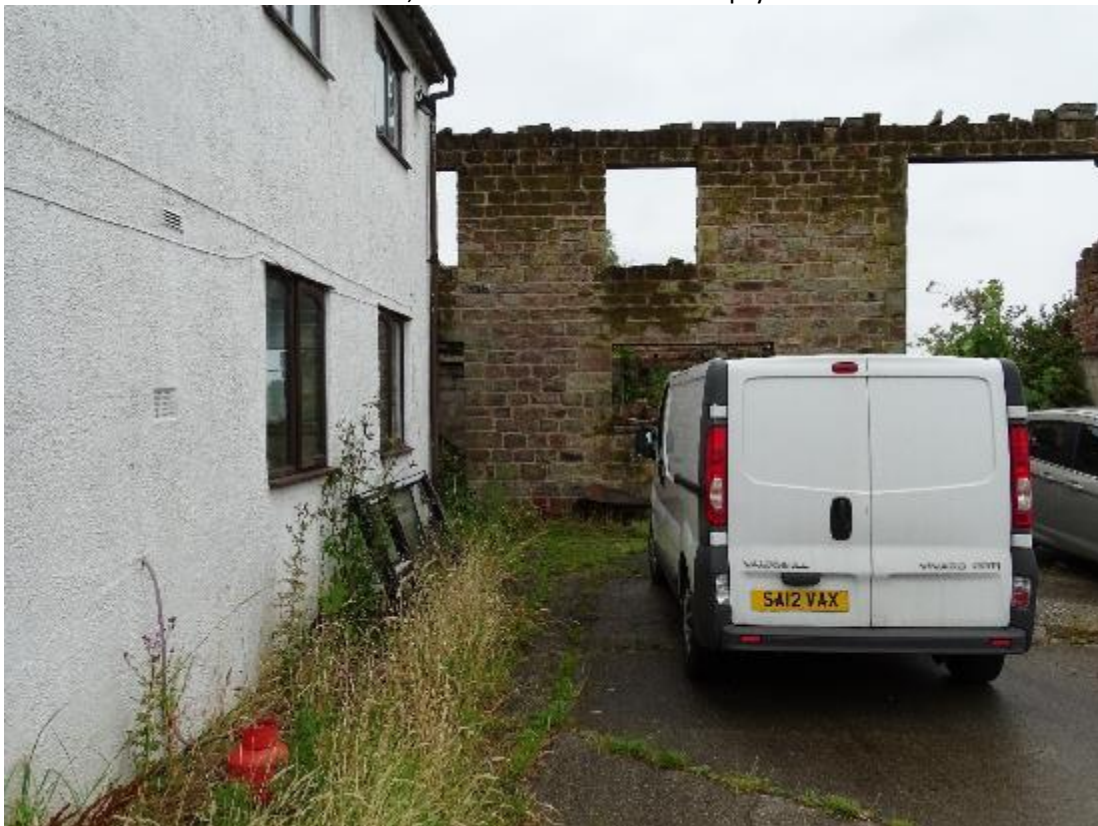
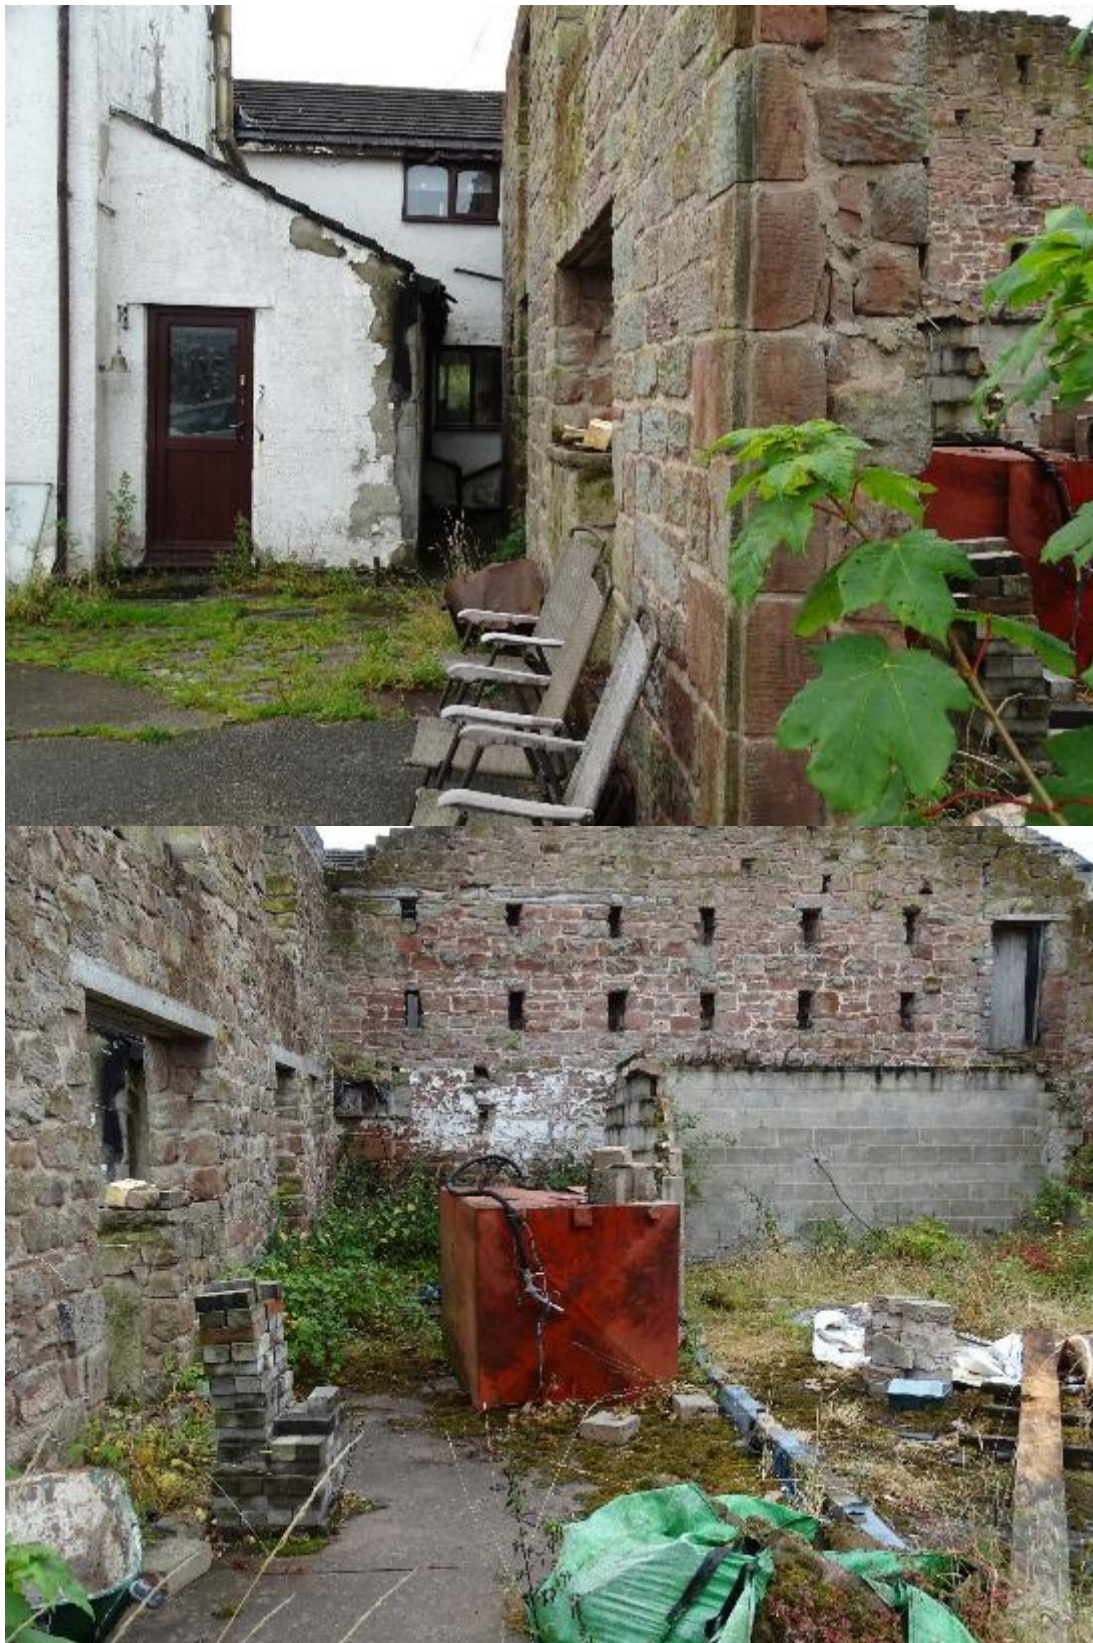
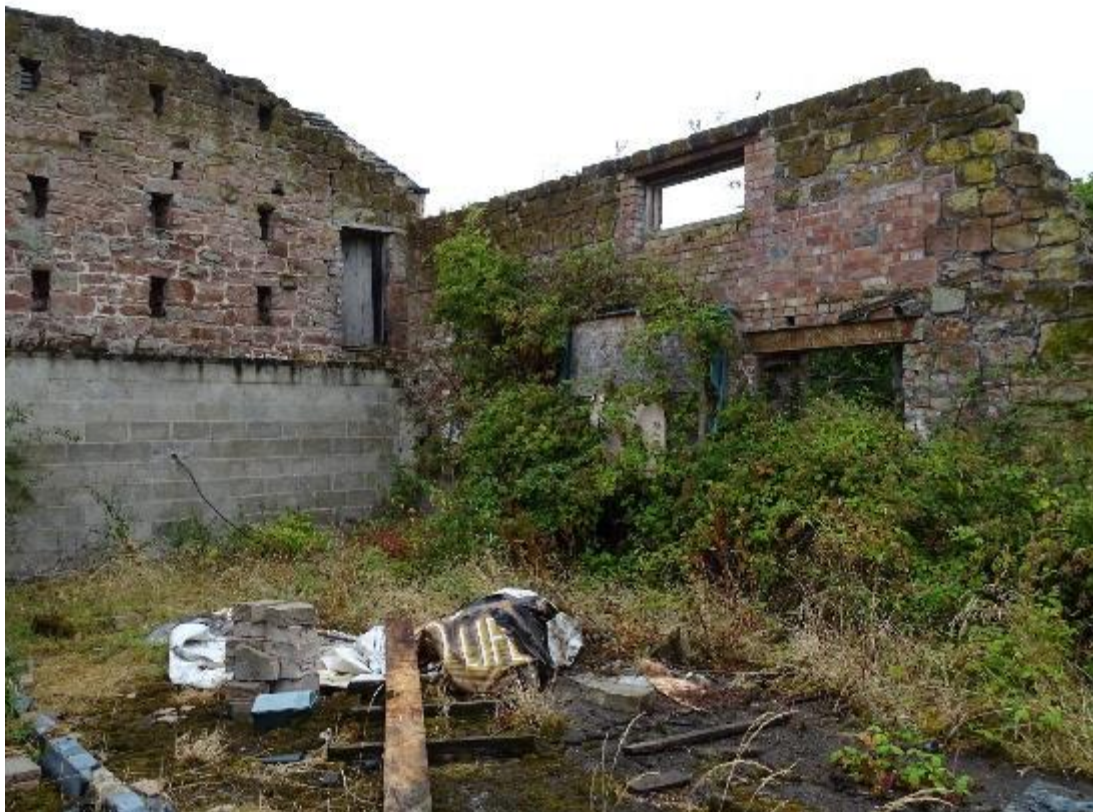
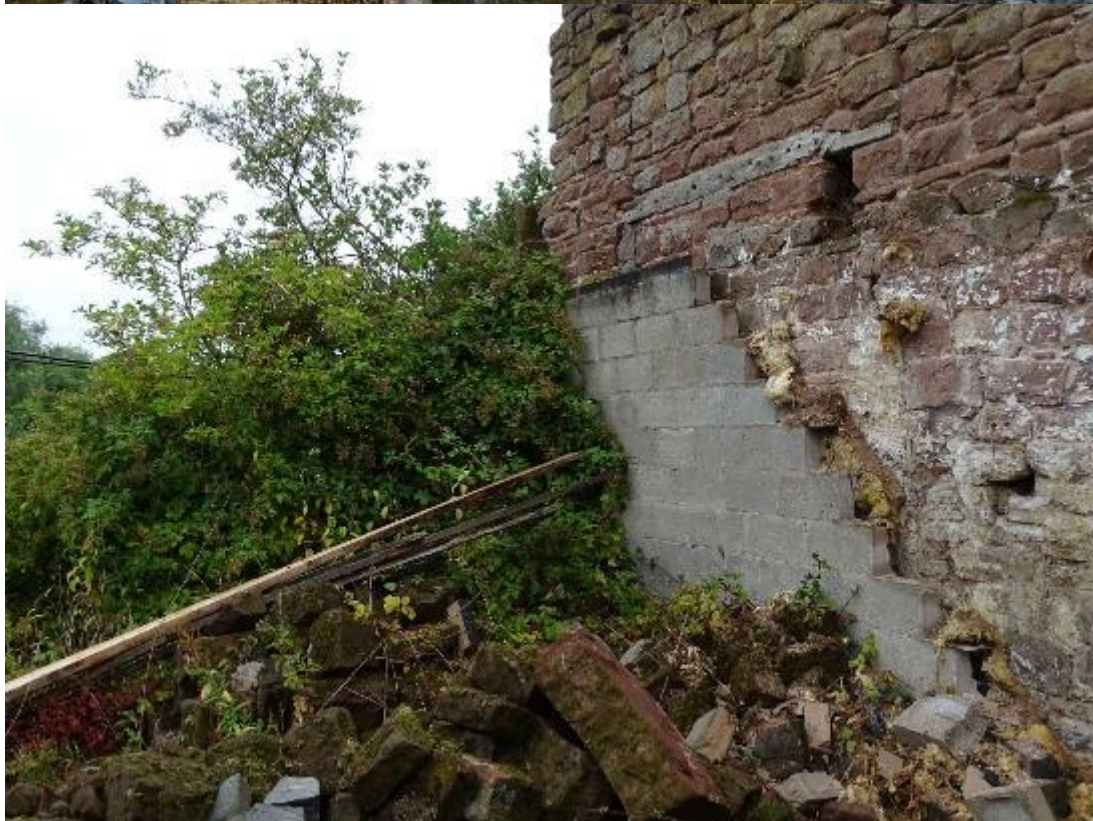
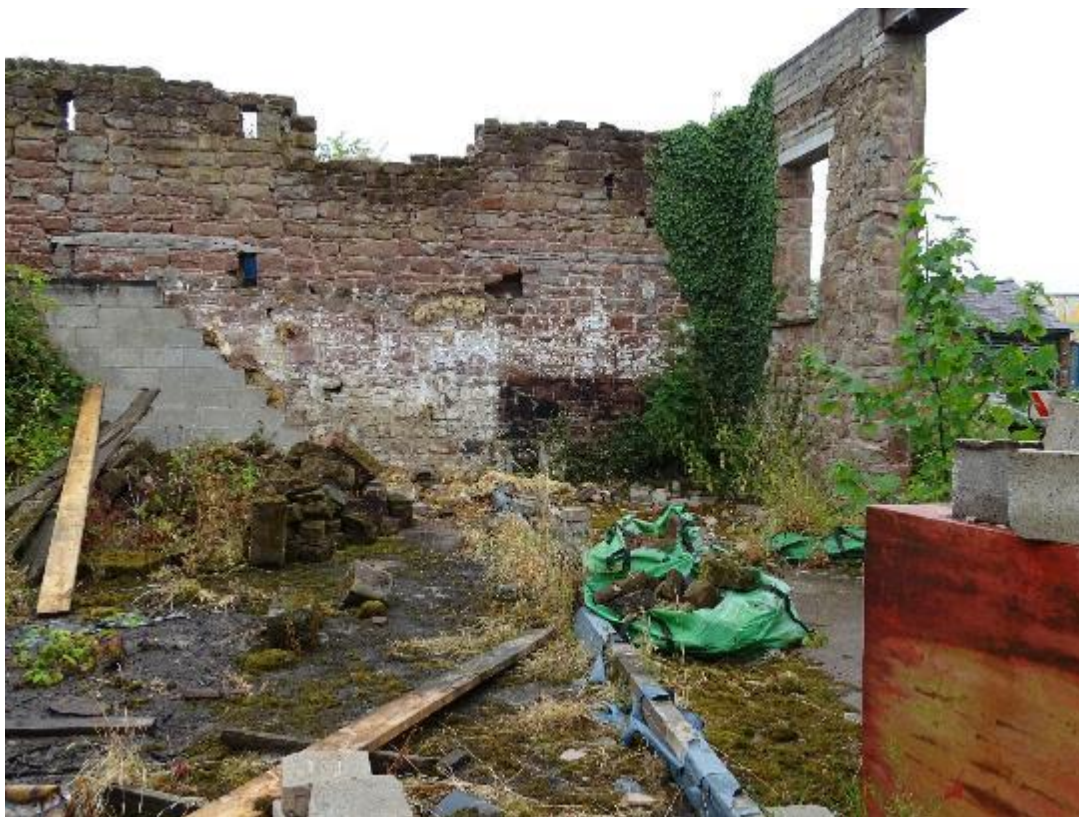
The former stone barn to the rear, with concrete base and empty unused fuel store

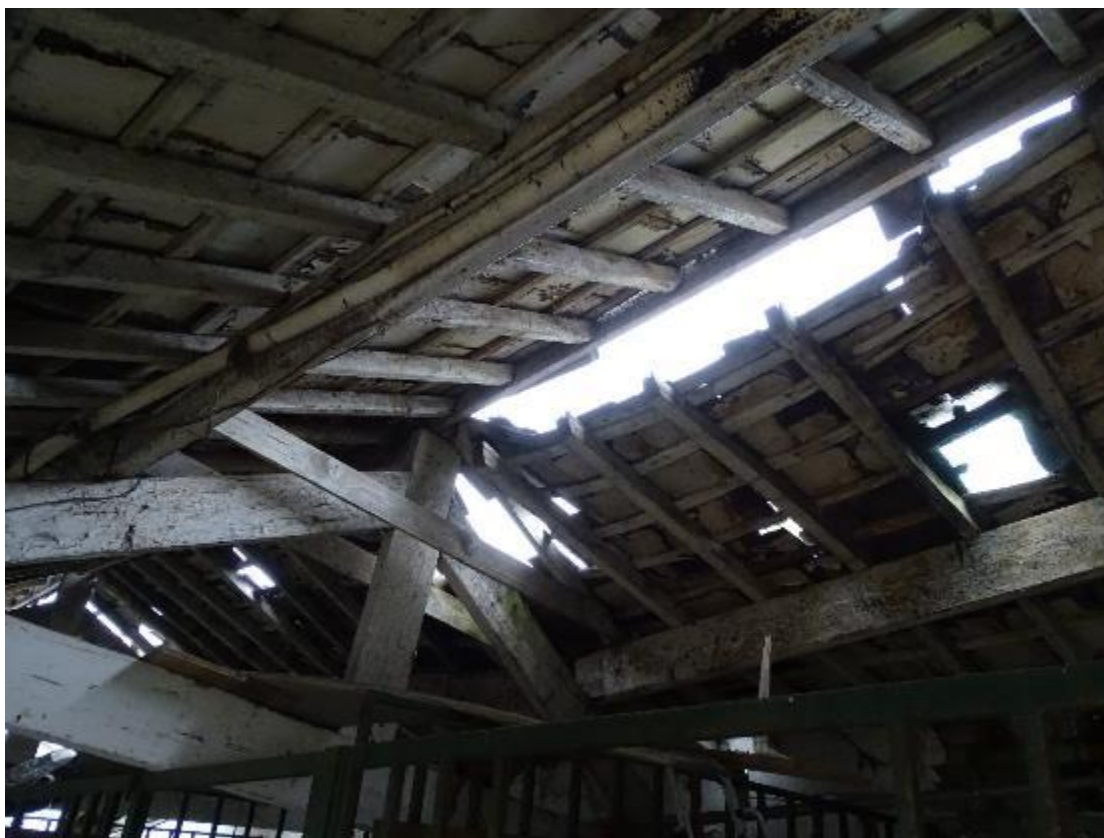
Behind the stone barn, north corner of the site.

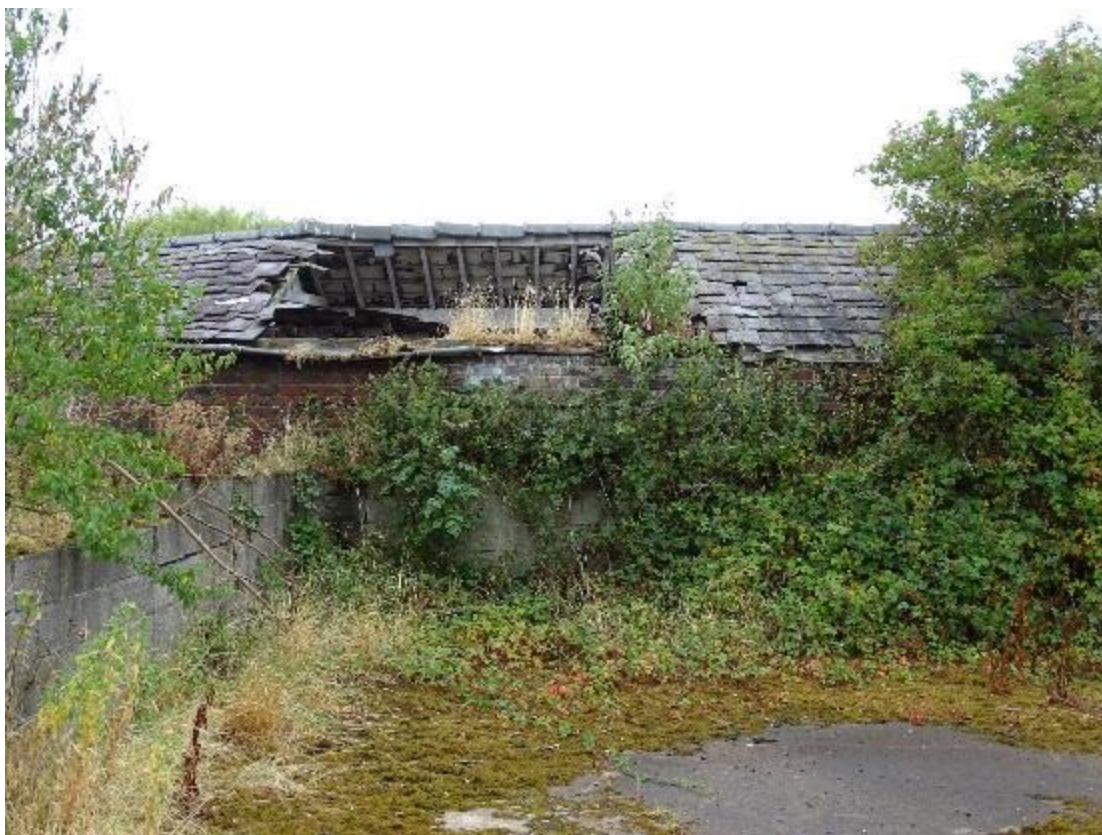
The north rear boundary of the site

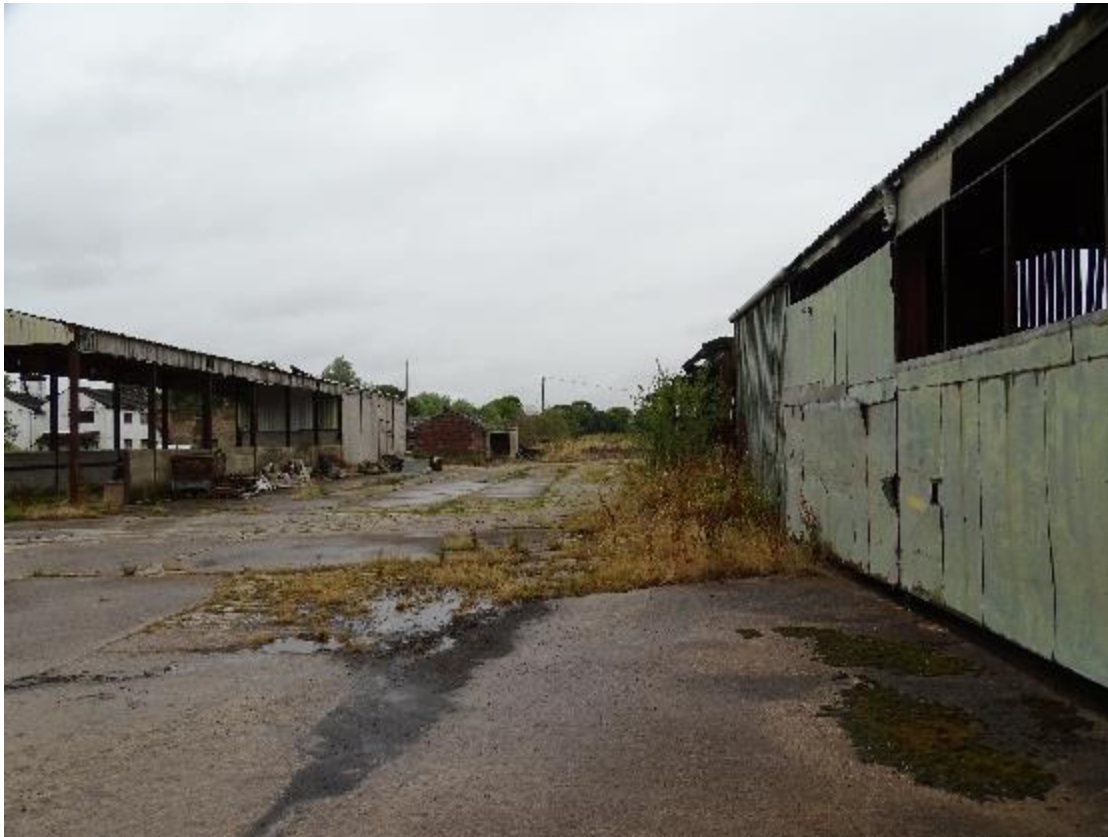
The building to the eastern boundary

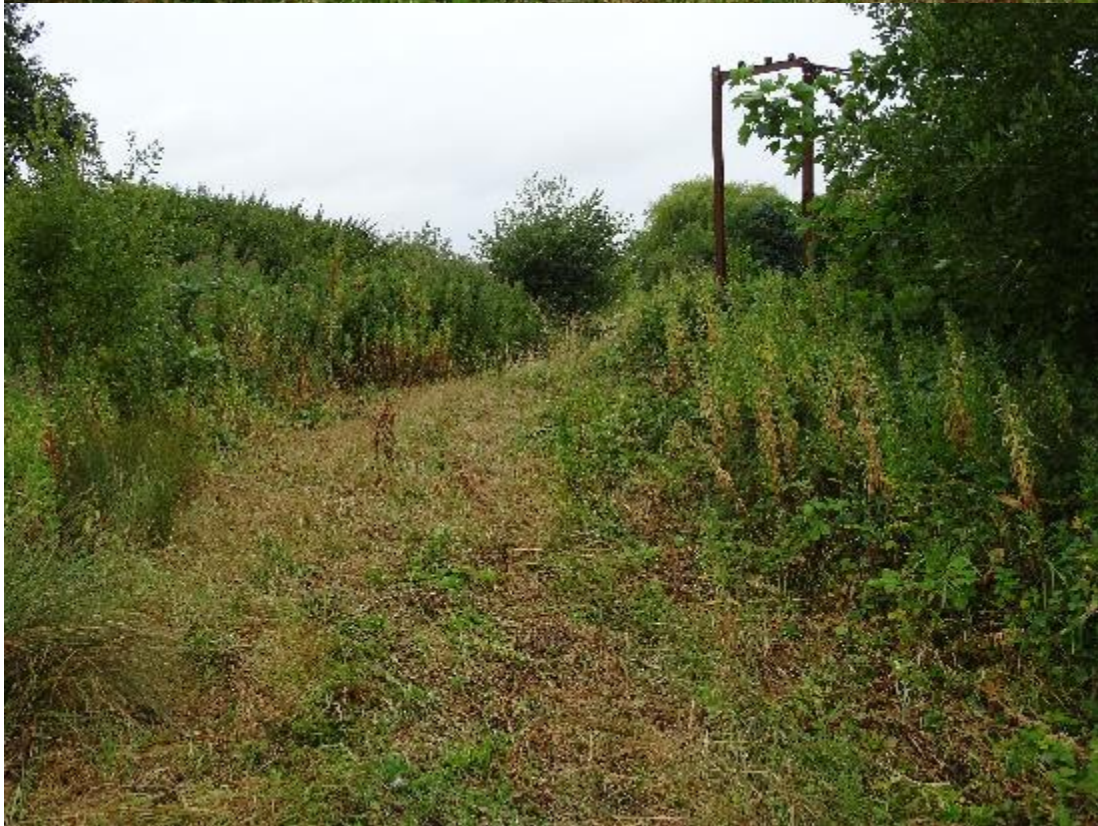
The area to the south of the site, now overgrown

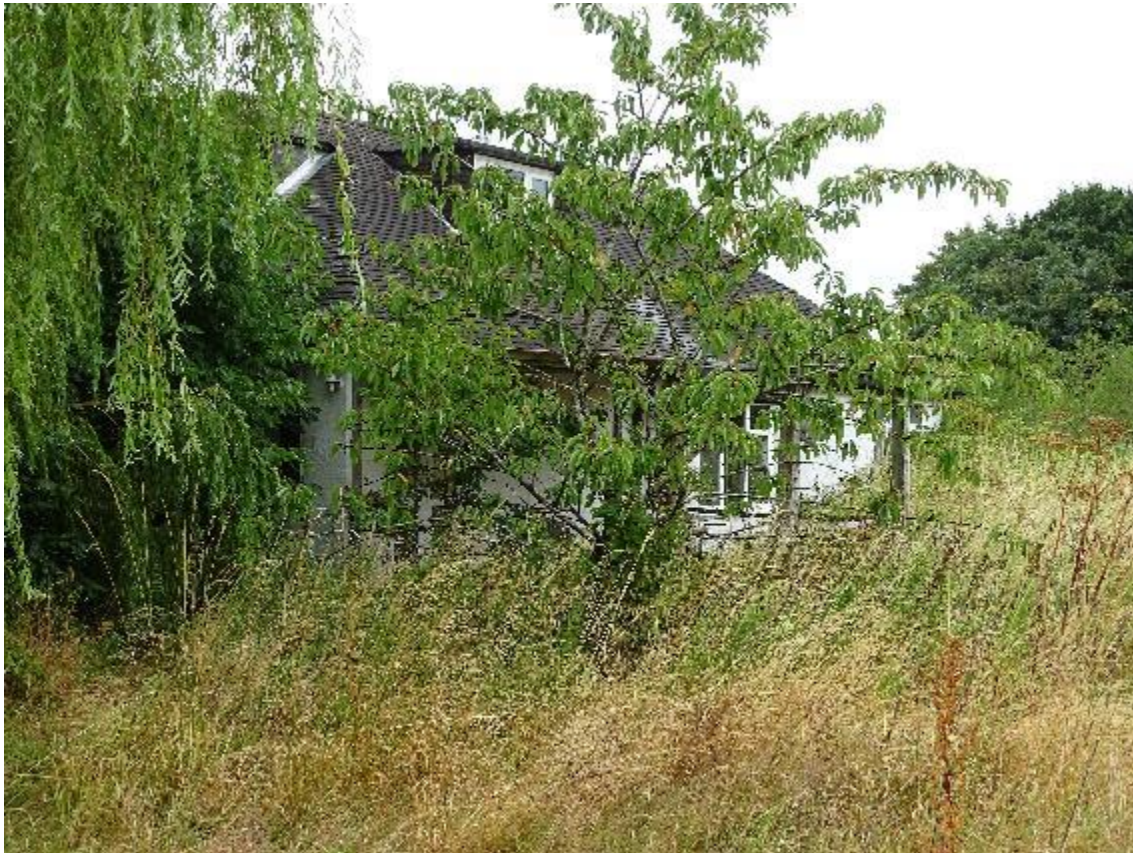
The building in the centre of the site
