# Validation Completion Report

Site: Sonnet Gate, Prescott

Reference:15-292-R1

Date: July 2025

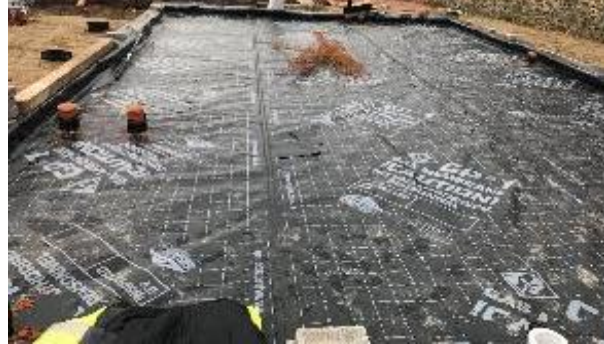
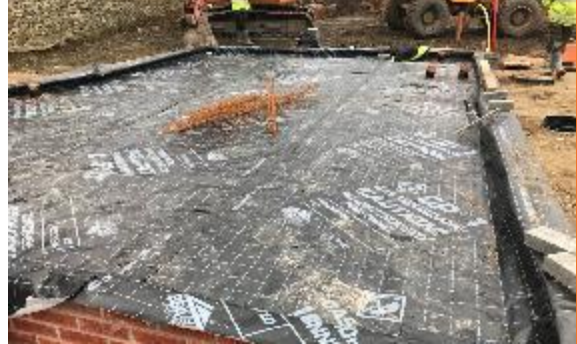
**Plot - 1**

**General Condition of Membrane-Good Condition**

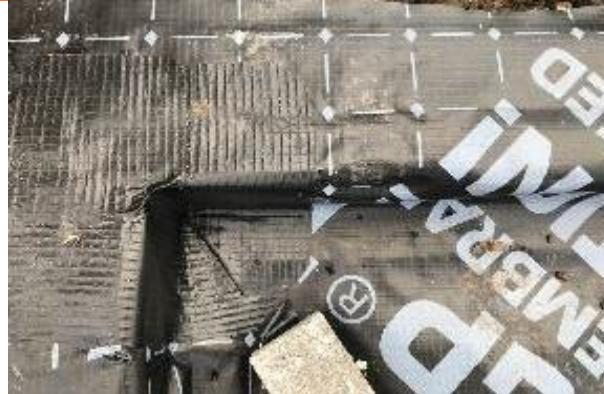
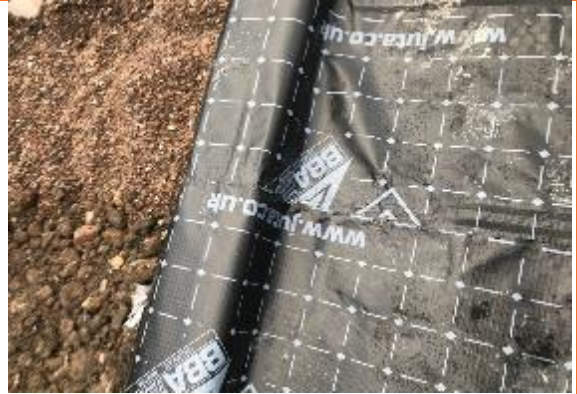
**Verification of Joints and Seals-Good Condition**

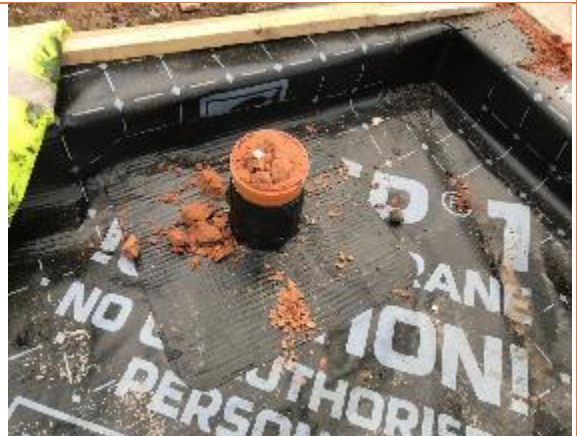
**Verification of Service Penetrations-Good Condition**

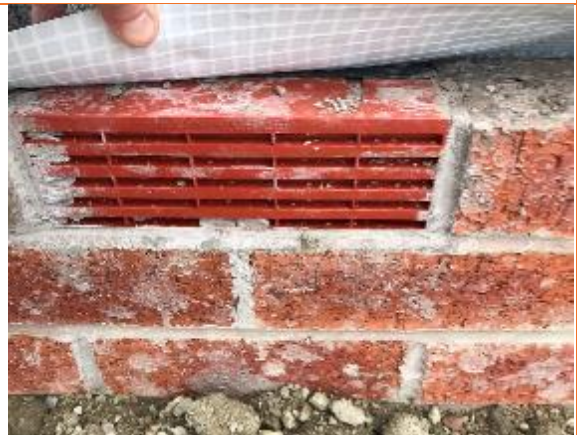
**Verification of Ventilation-Good Condition**

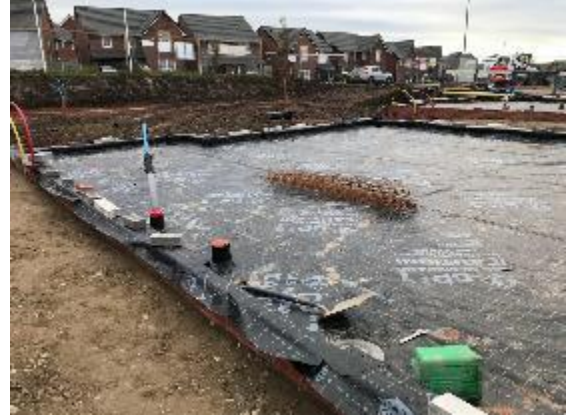
**Plot - 2**

**General Condition of Membrane-Good Condition**

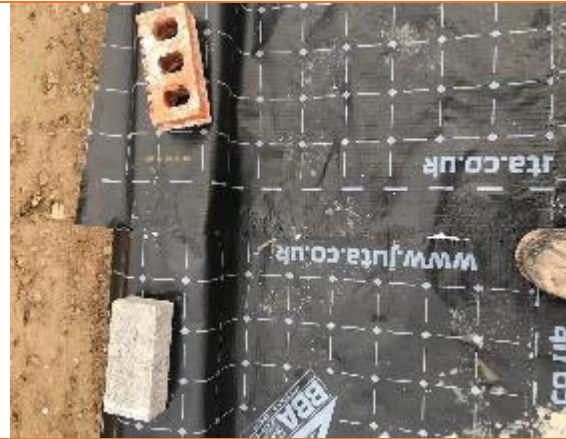
**Verification of Joints and Seals-Good Condition**

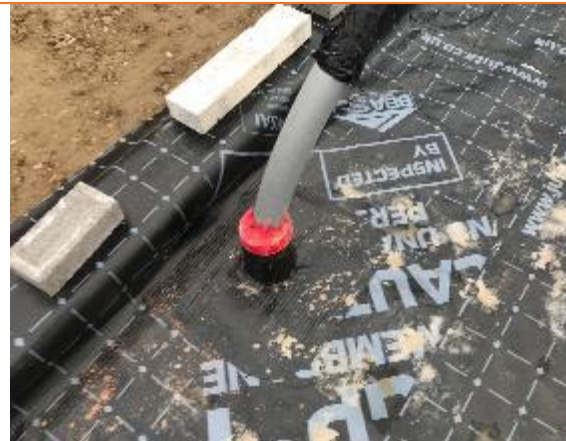
**Verification of Service Penetrations-Good Condition**

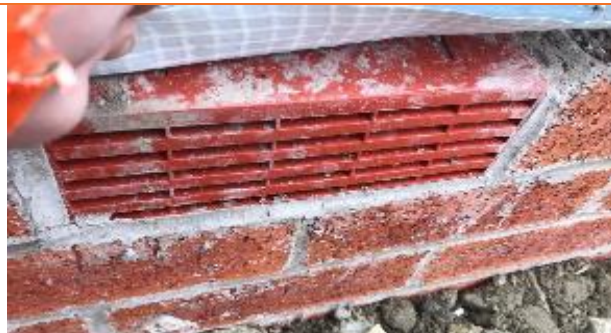
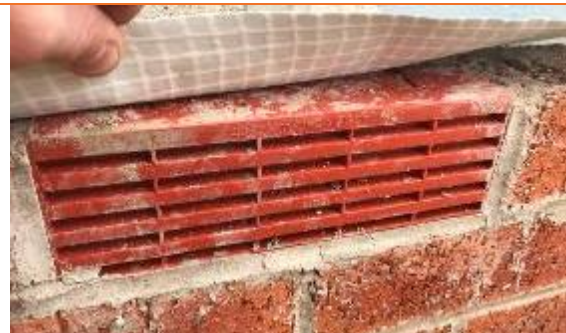
**Verification of Ventilation-Good Condition**

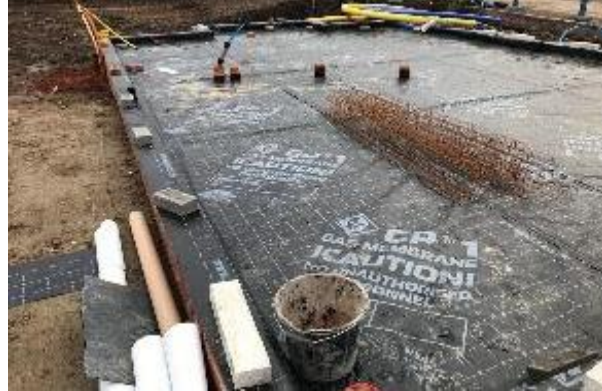
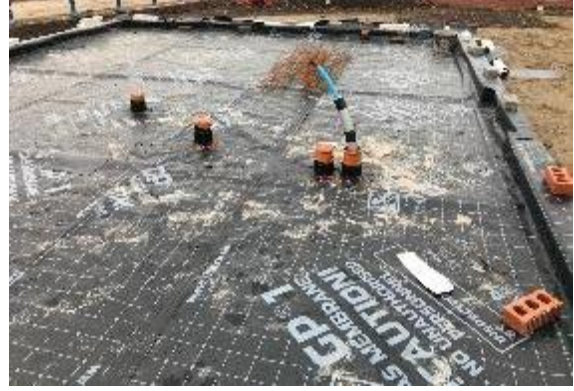
**Plot - 3**

**General Condition of Membrane-Good Condition**

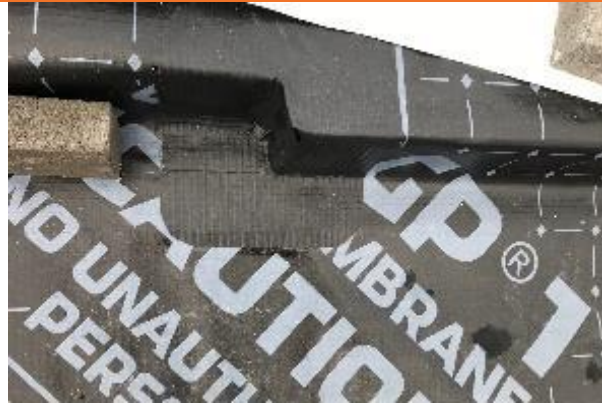
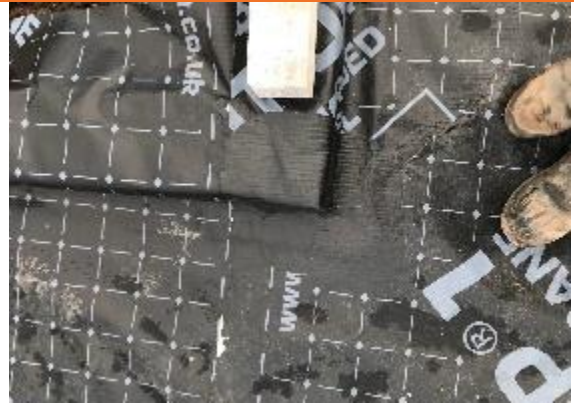
**Verification of Joints and Seals-Good Condition**

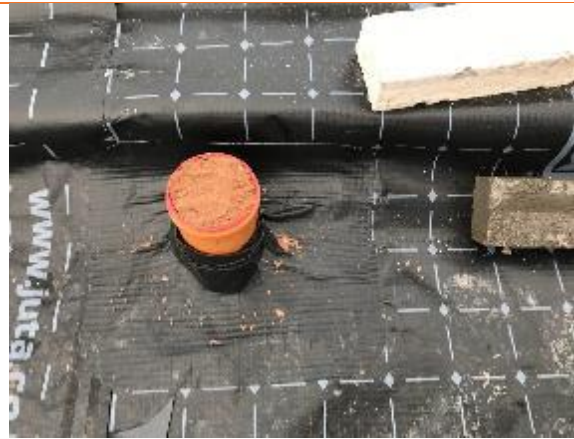
**Verification of Service Penetrations-Good Condition**

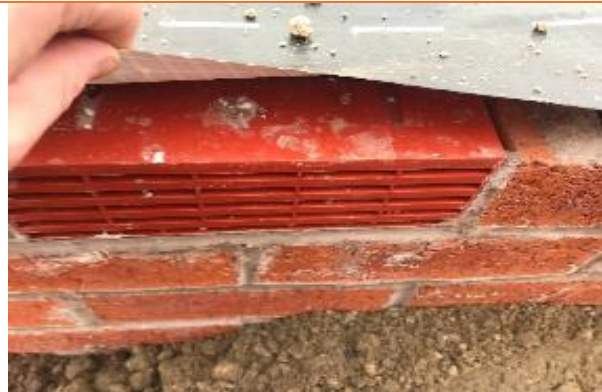
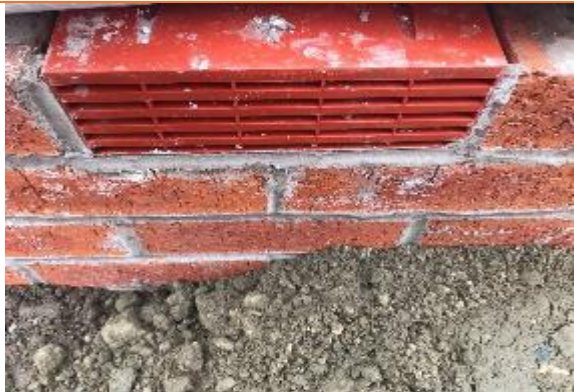
**Verification of Ventilation-Good Condition**

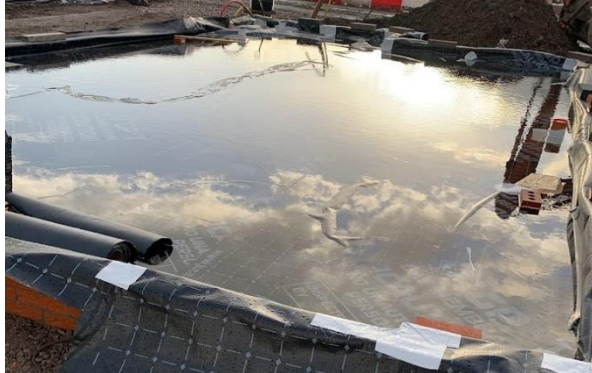
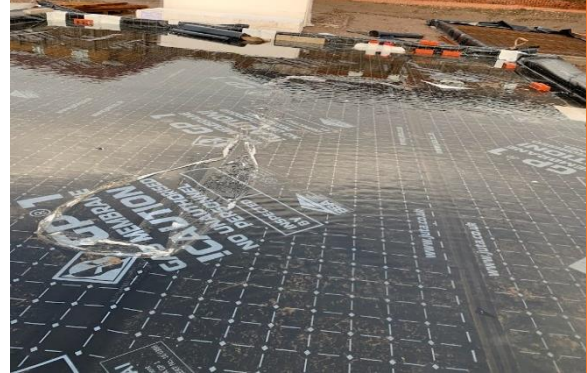
**Plot - 4**

**General Condition of Membrane-Good Condition**

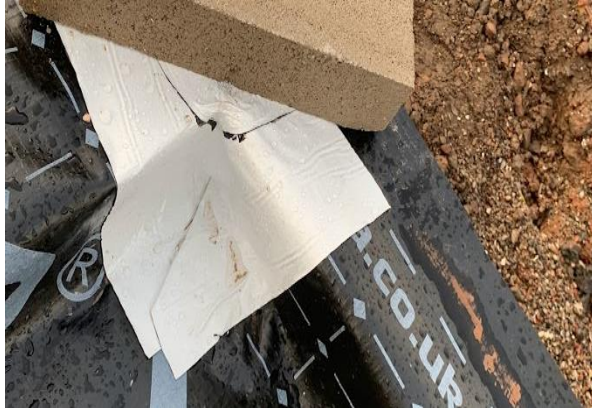
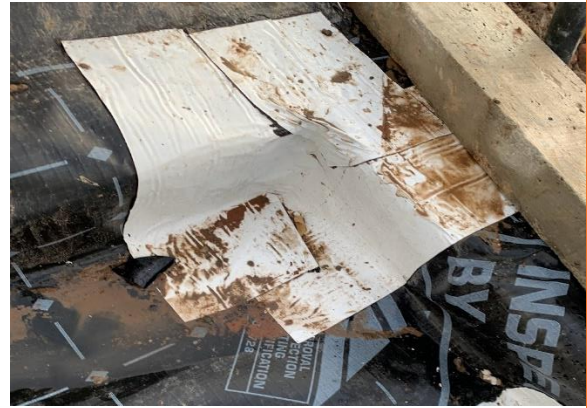
**Verification of Joints and Seals-Good Condition**

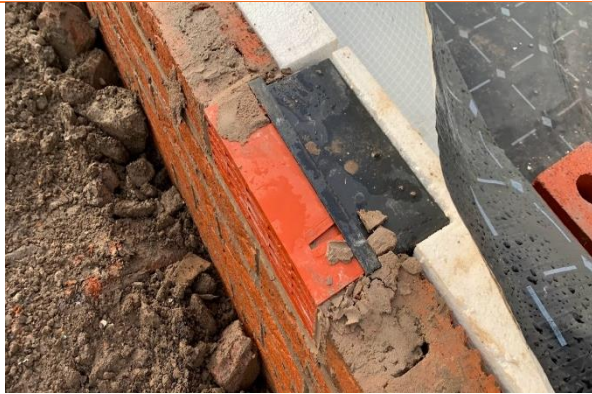
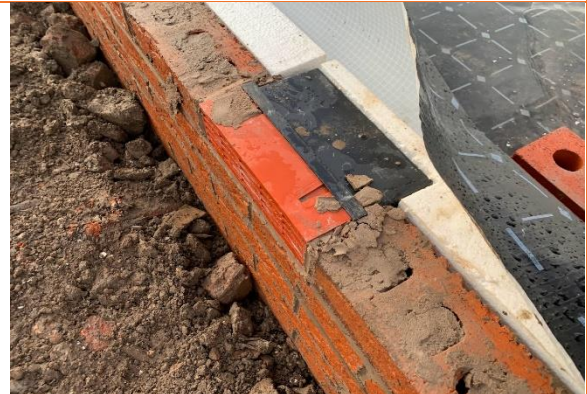
**Verification of Ventilation-Good Condition**

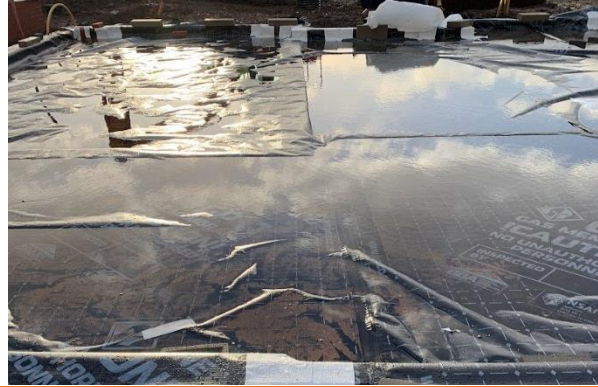
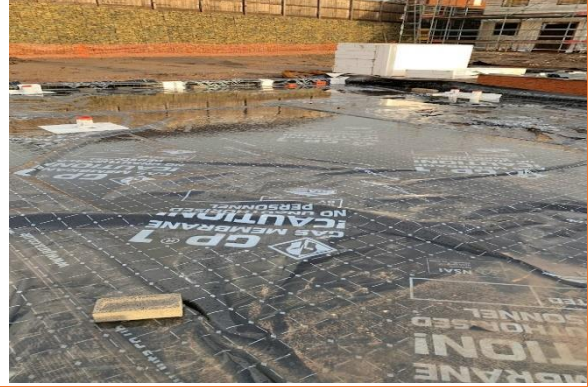
**Plot - 5**

**General Condition of Membrane-Good Condition**

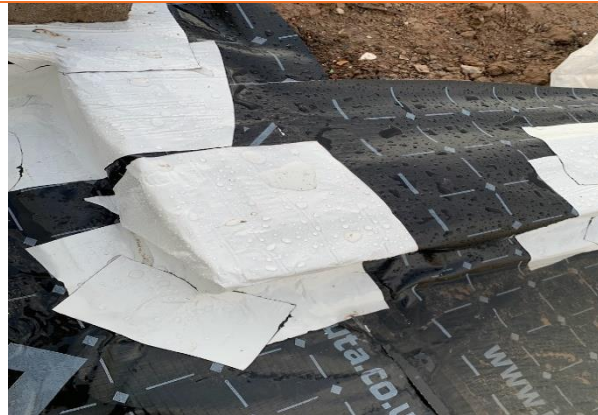
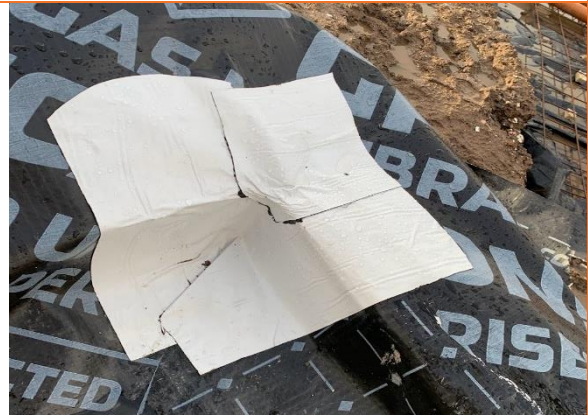
**Verification of Joints and Seals-Good Condition**

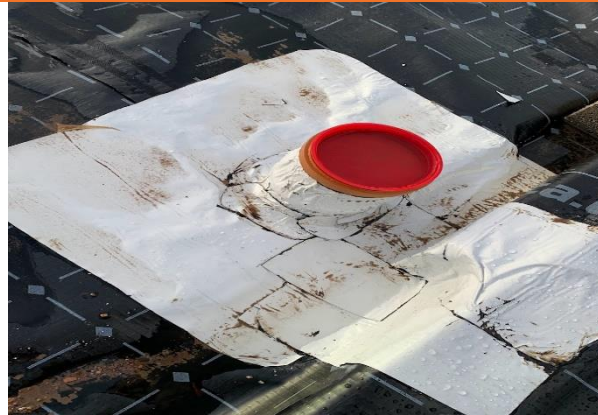
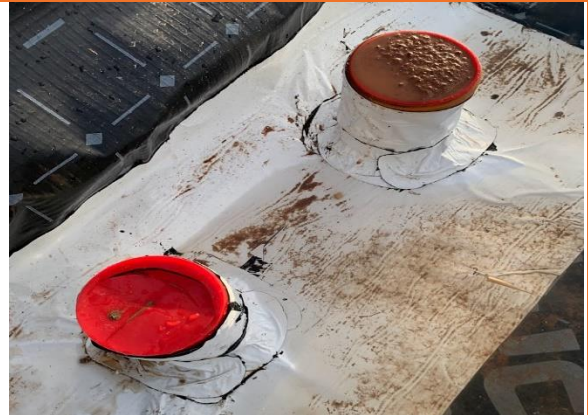
**Verification of Service Penetrations-Good Condition**

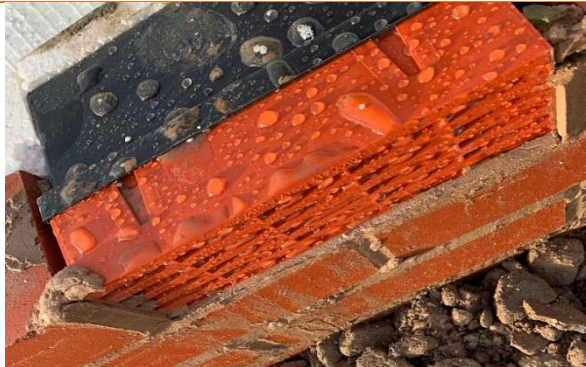
**Verification of Ventilation-Good Condition**

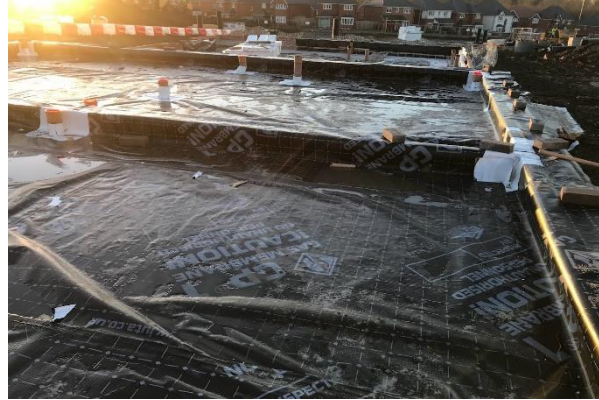
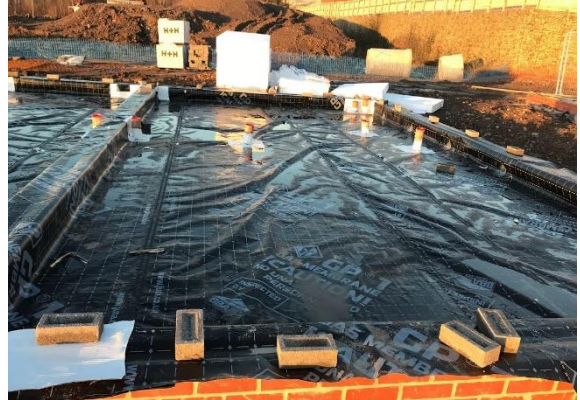
**Plot - 7**

**General Condition of Membrane-Good Condition**

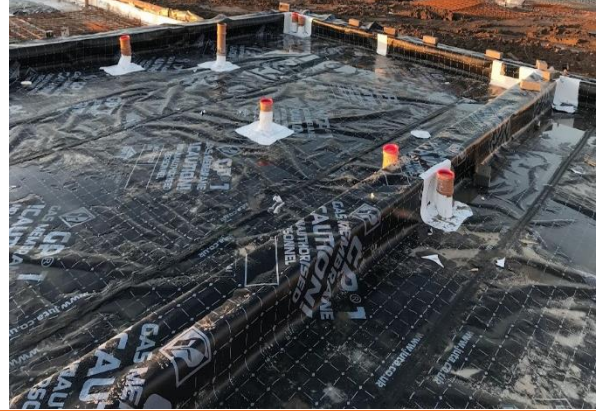
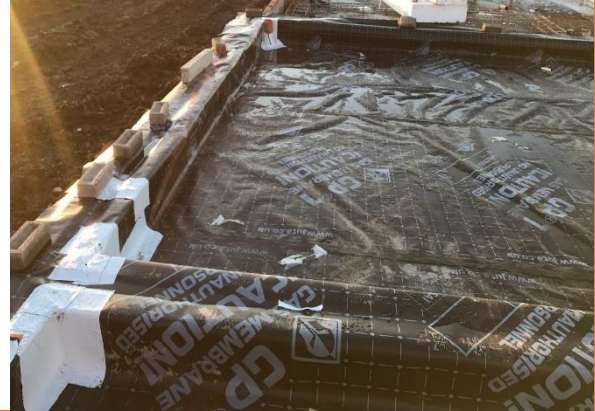
**Plot - 8**

**General Condition of Membrane-Good Condition**

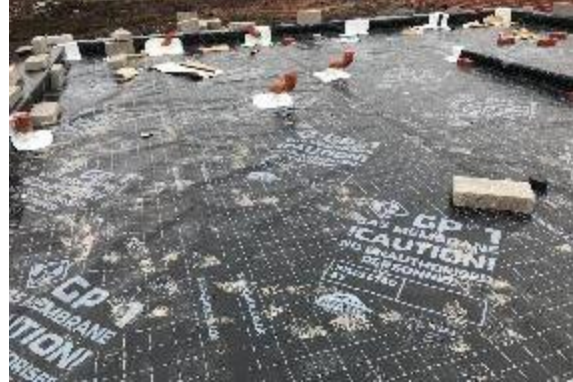
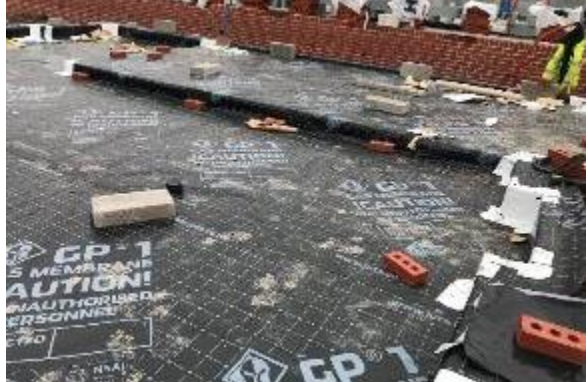
**Plot - 9**

**General Condition of Membrane-Good Condition**

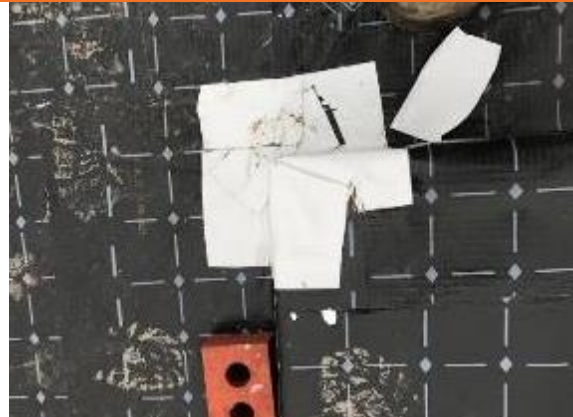
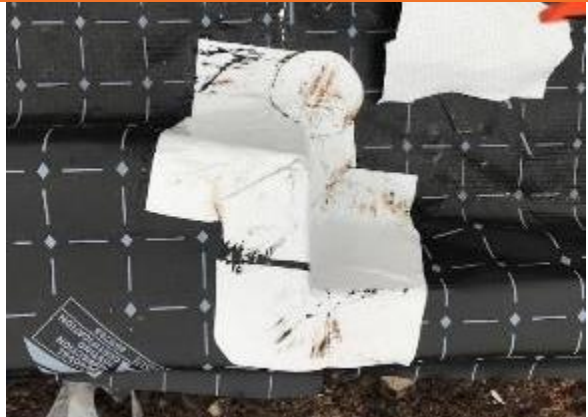
**Verification of Joints and Seals-Good Condition**

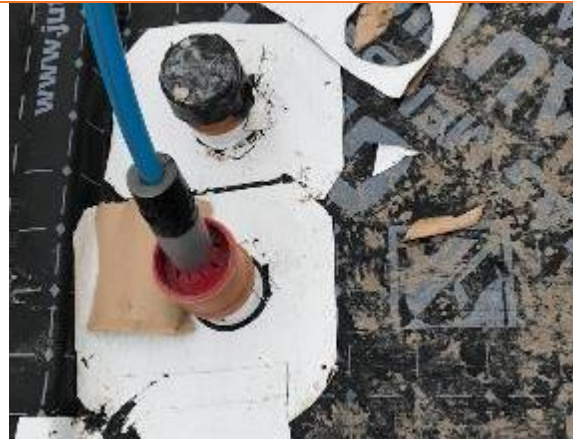
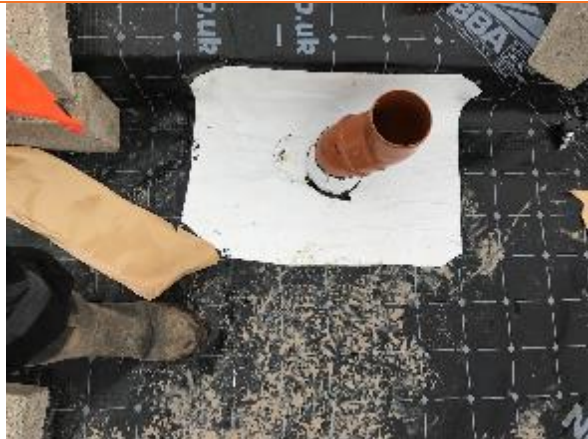
**Verification of Service Penetrations-Good Condition**

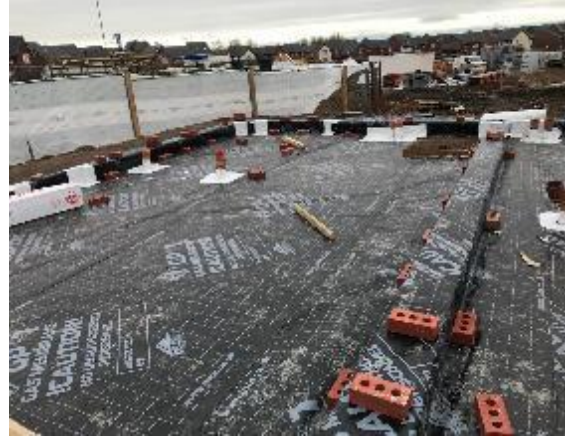
**Plot - 16**

**General Condition of Membrane-Good Condition**

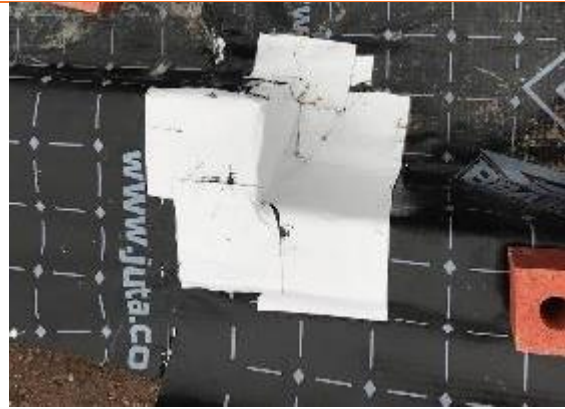
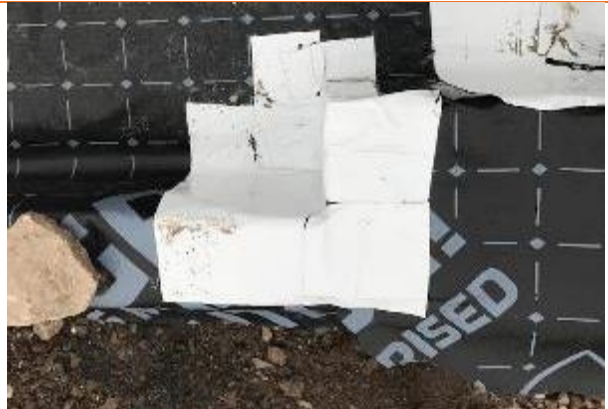
**Verification of Joints and Seals-Good Condition**

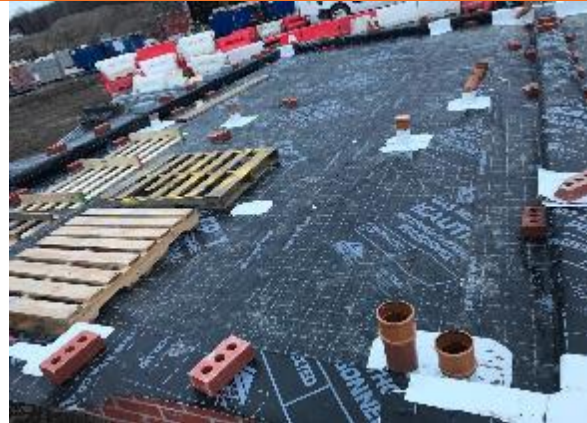
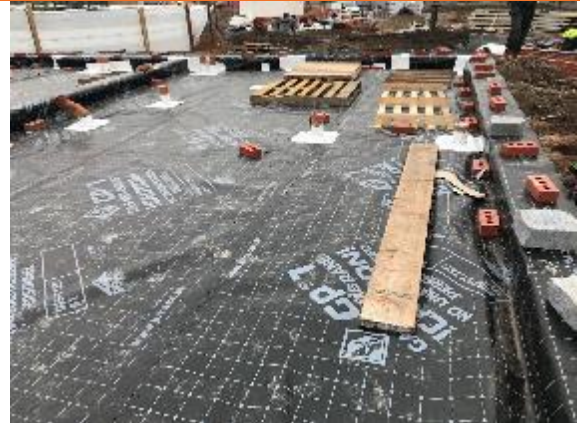
**Plot - 17**

**General Condition of Membrane-Good Condition**

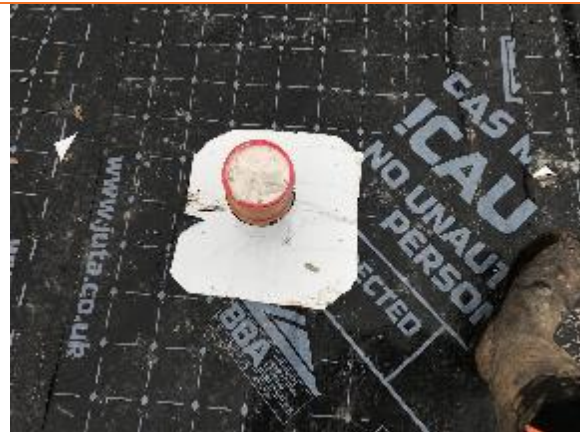
**Verification of Service Penetrations-Good Condition**

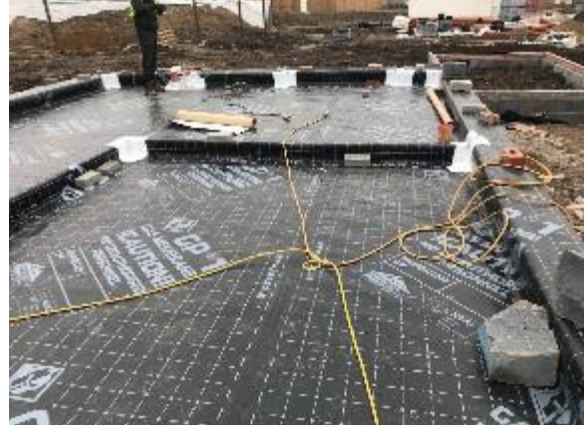
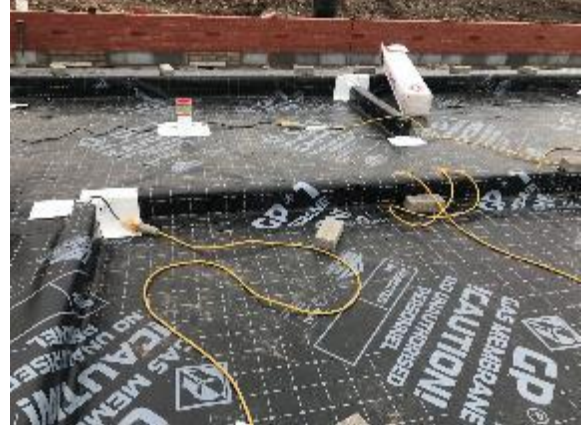
**Plot - 18**

**General Condition of Membrane-Good Condition**

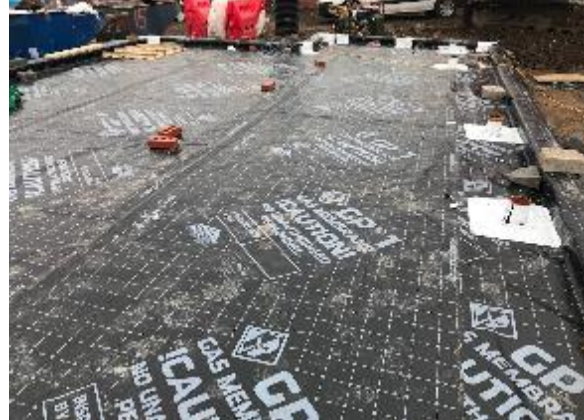
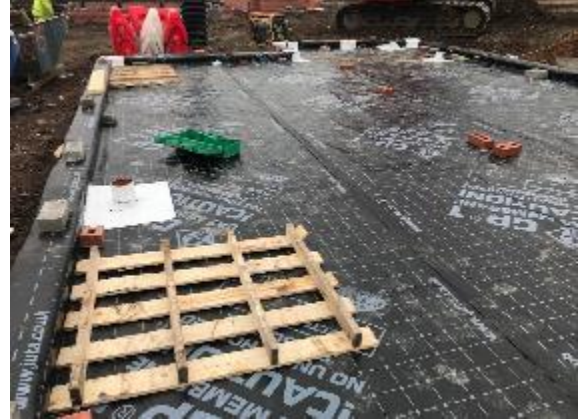
**Plot - 19**

**General Condition of Membrane-Good Condition**

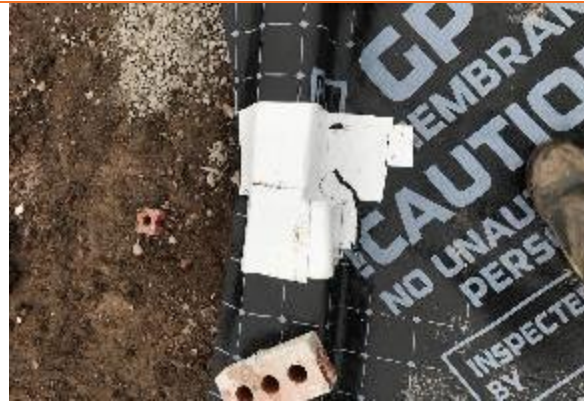
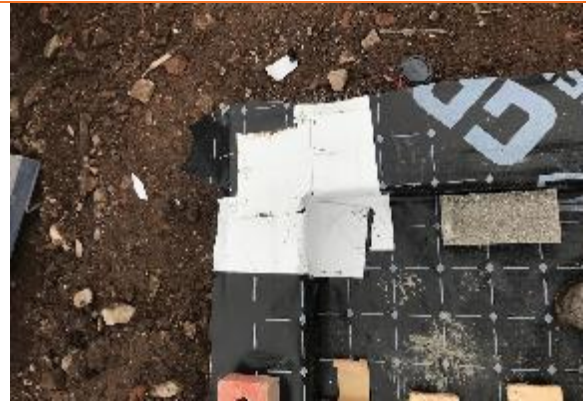
**Verification of Joints and Seals-Good Condition**

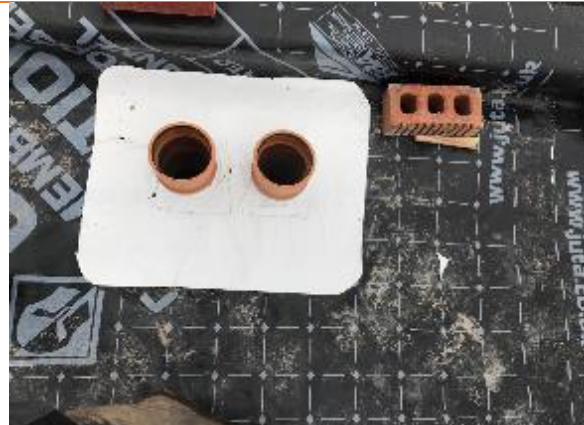
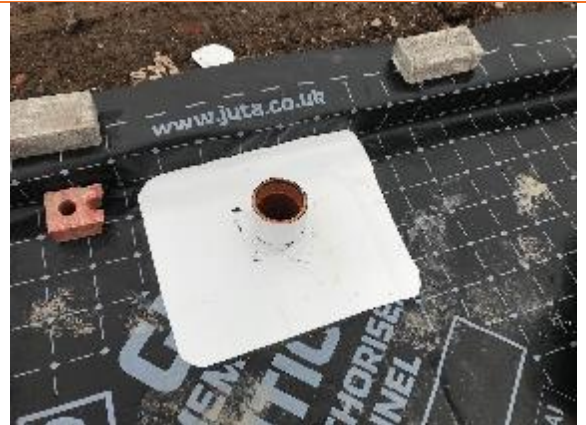
**Verification of Service Penetrations-Good Condition**

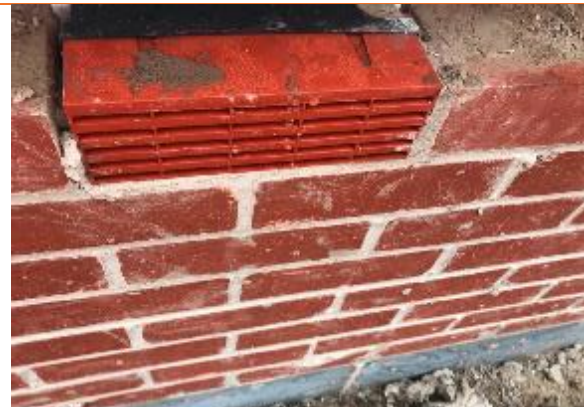
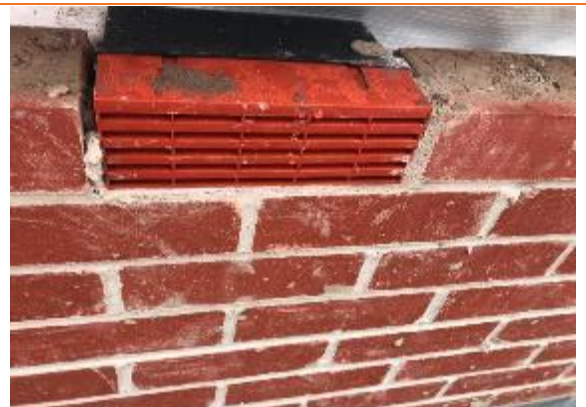
**Verification of Ventilation- Good Condition**

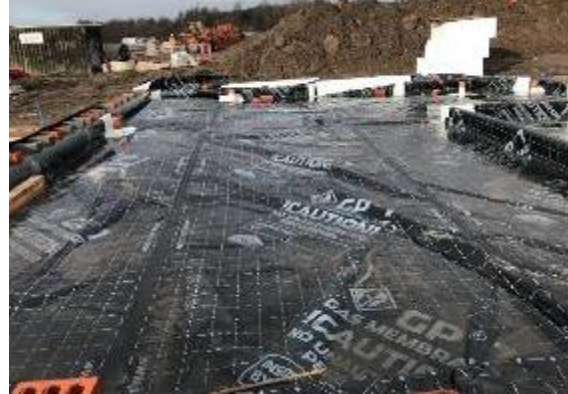
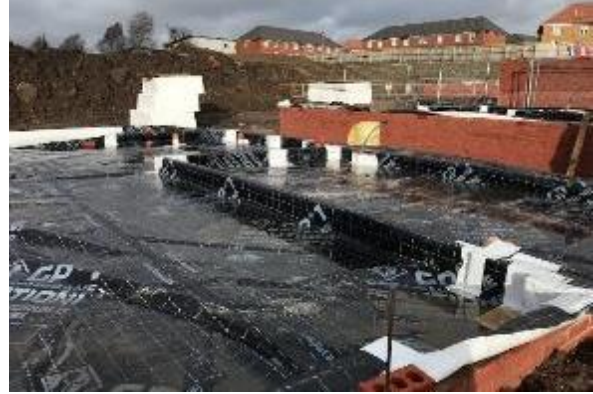
**Plot - 10**

**General Condition of Membrane-Good Condition**

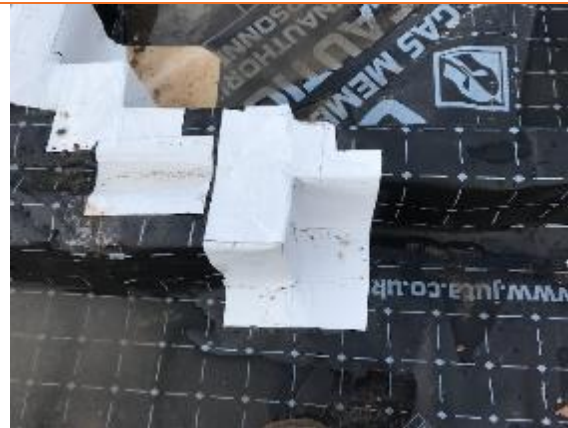
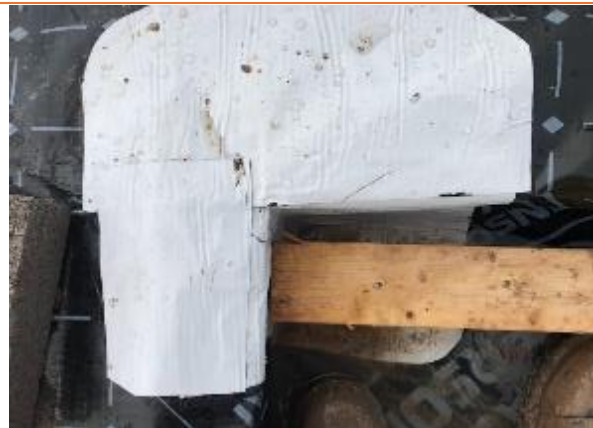
**Verification of Joints and Seals-Good Condition**

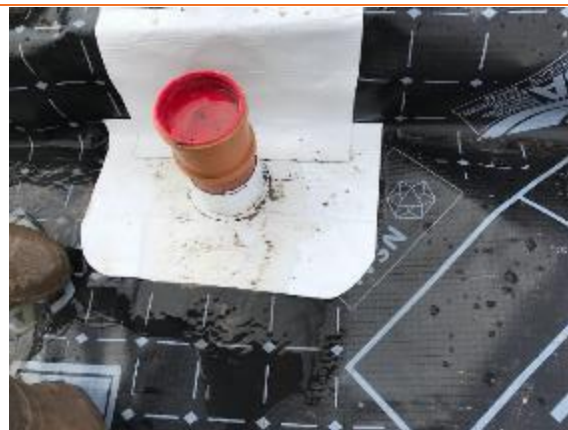
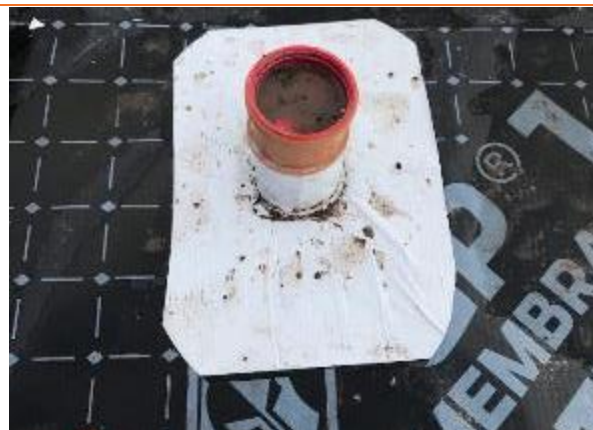
**Verification of Service Penetrations-Good Condition**

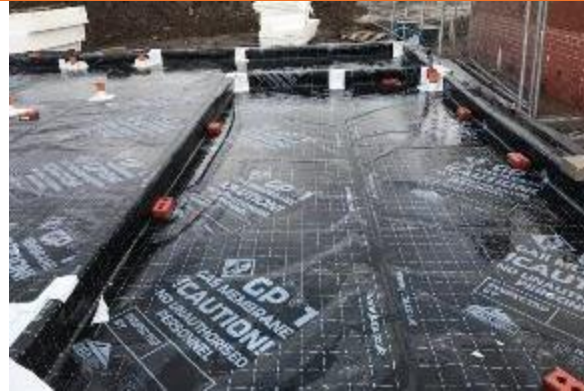
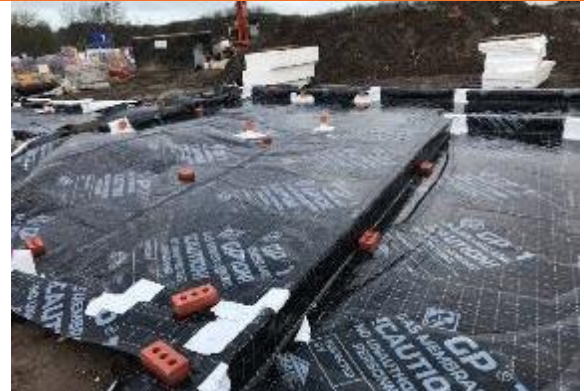
Plot - 11

General Condition of Membrane-Good Condition

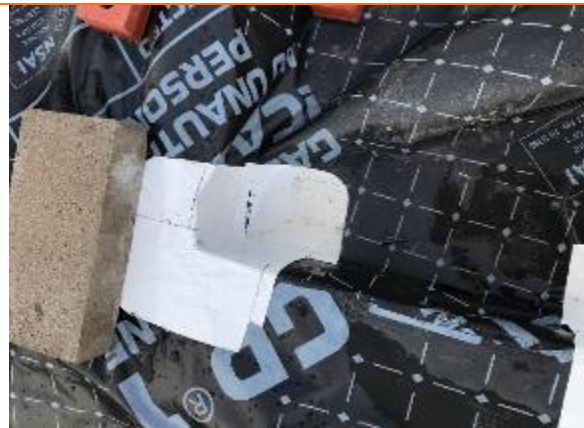
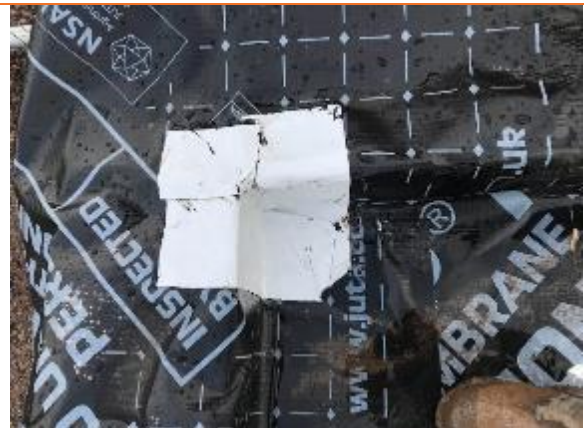
Verification of Joints and Seals-Good Condition

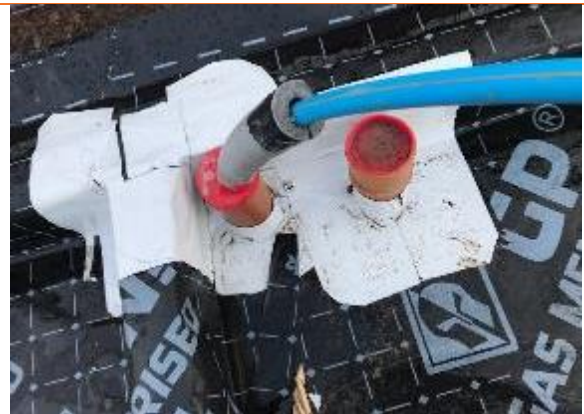
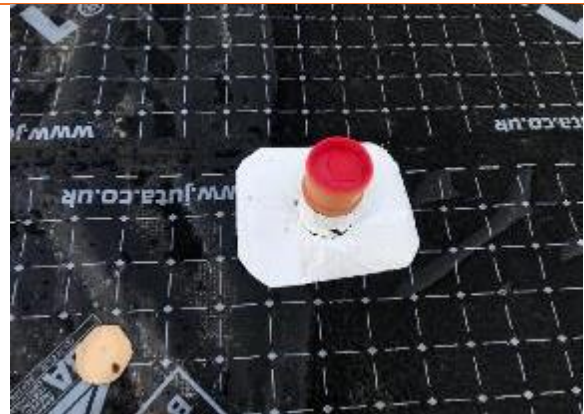
Verification of Service Penetrations-Good Condition

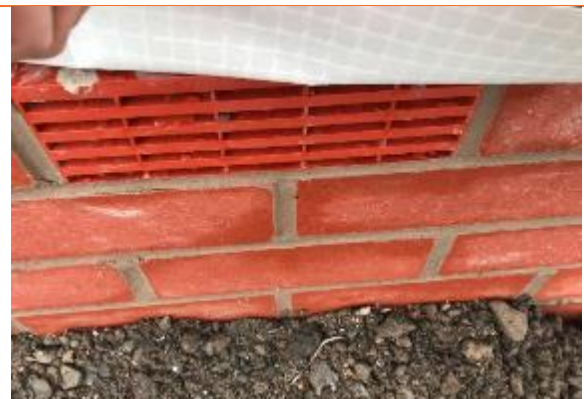
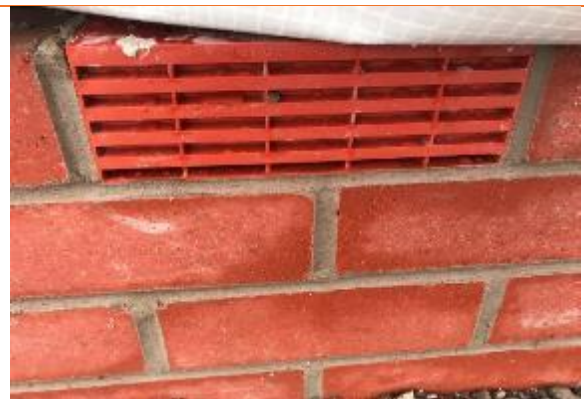
Verification of Service Penetrations-Good Condition

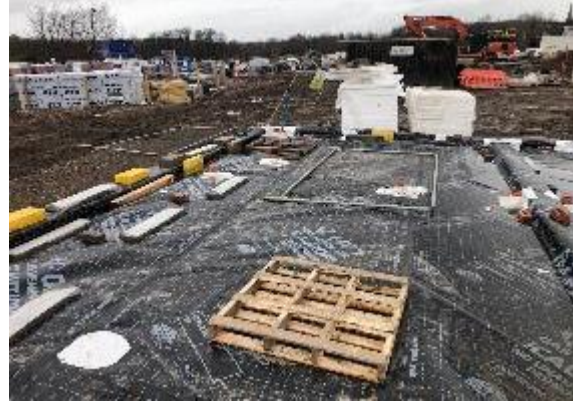
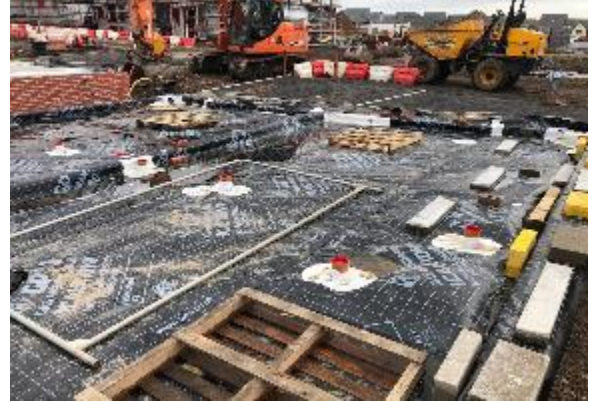
**Plot - 12**

**General Condition of Membrane-Good Condition**

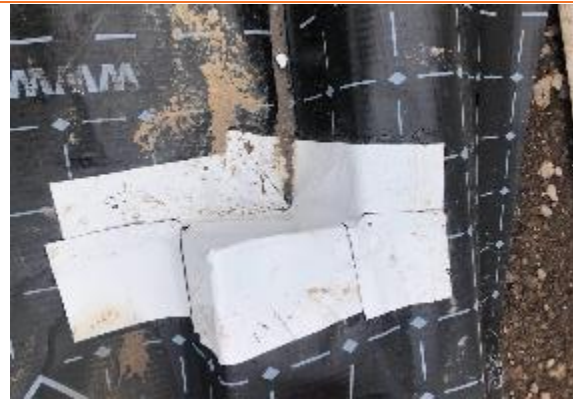
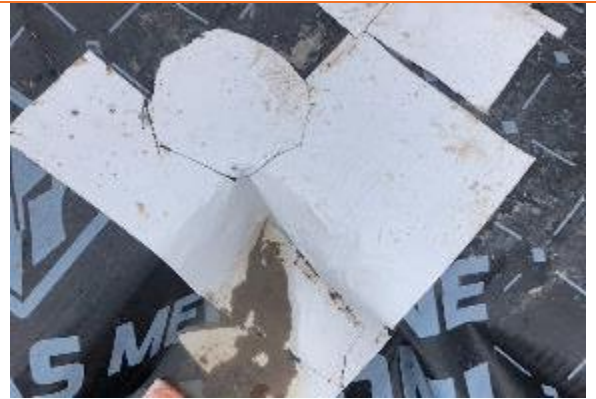
**Verification of Joints and Seals-Good Condition**

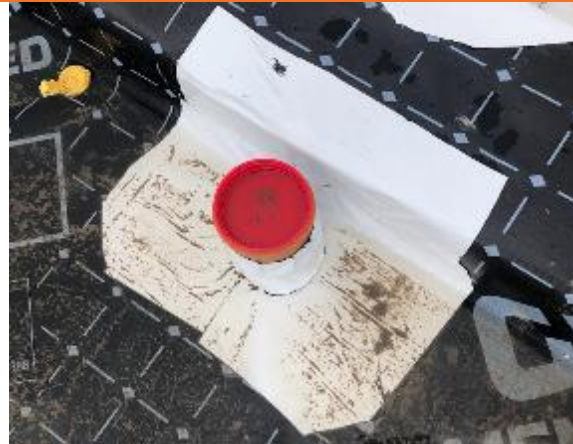
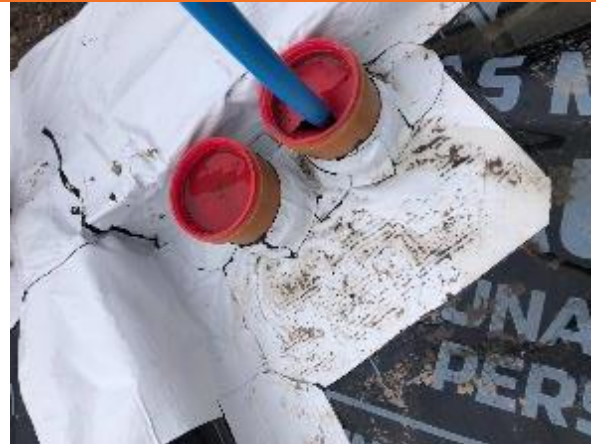
**Verification of Service Penetrations-Good Condition**

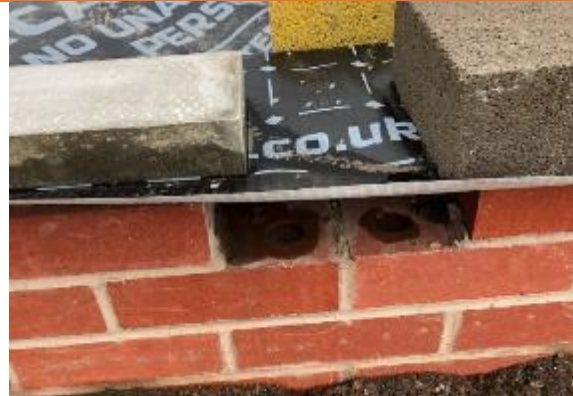
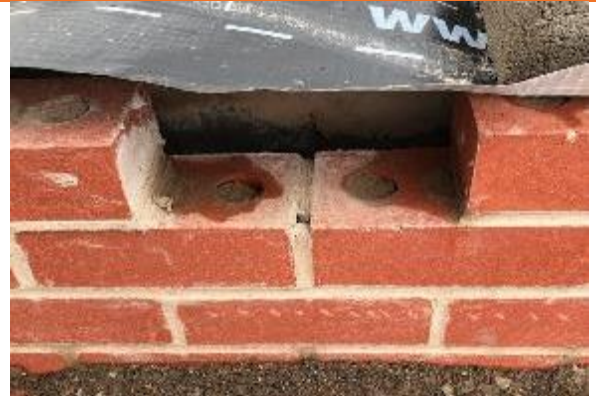
**Verification of Service Penetrations-Good Condition**

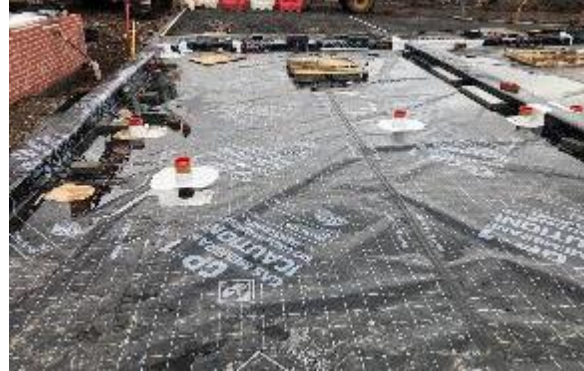
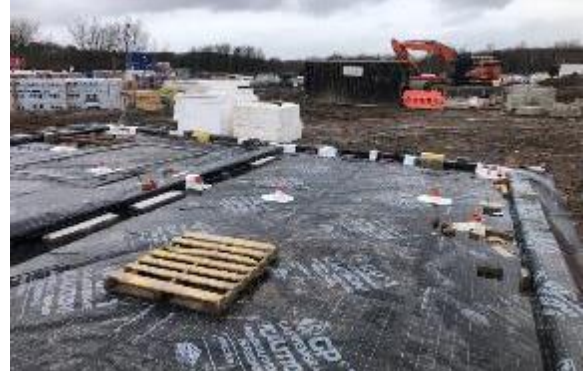
**Plot - 13**

**General Condition of Membrane-Good Condition**

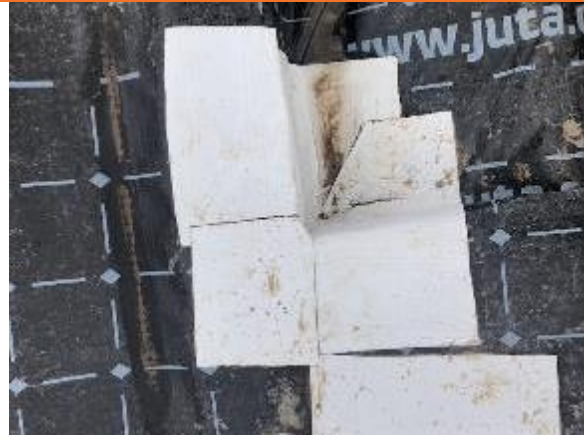
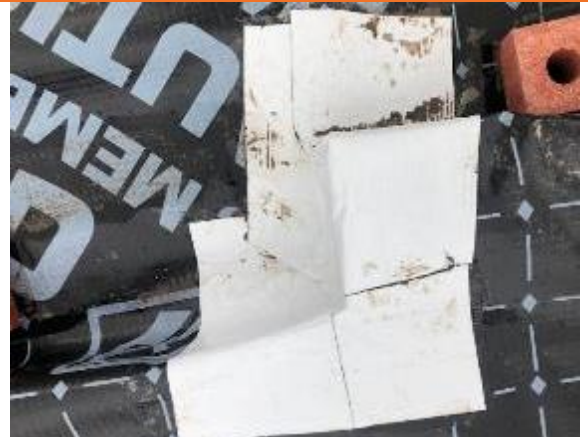
**Verification of Joints and Seals-Good Condition**

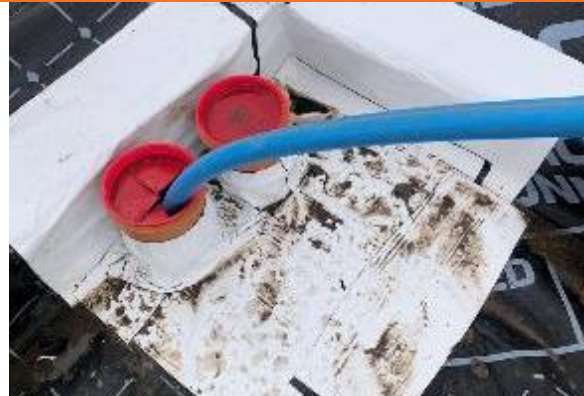
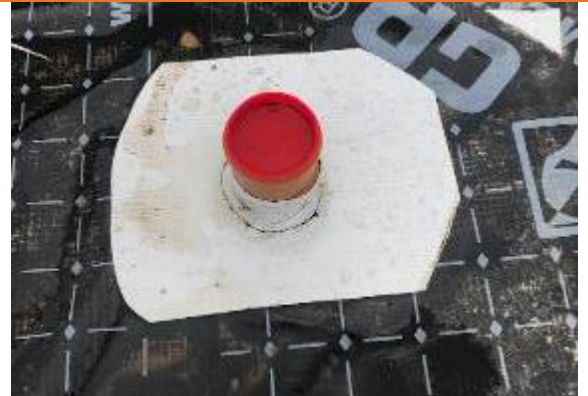
**Verification of Service Penetrations-Good Condition**

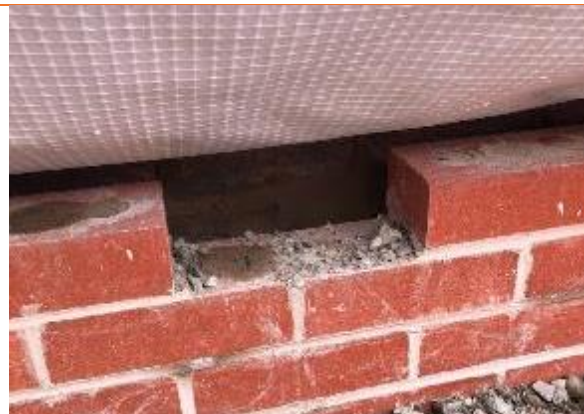
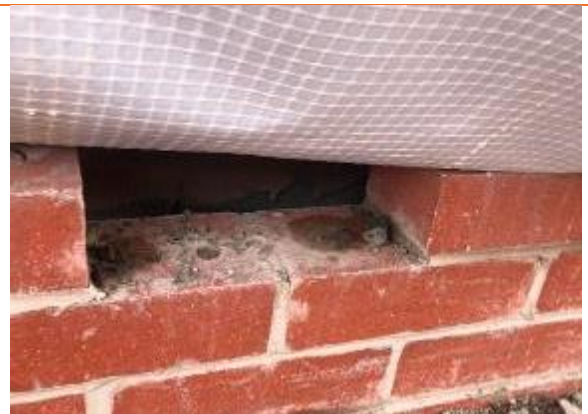
**Verification of Service Penetrations-Good Condition**

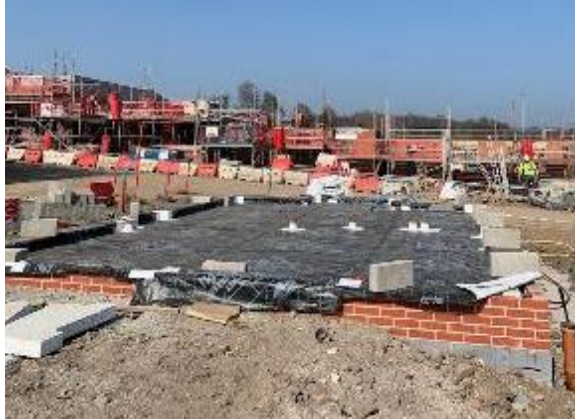
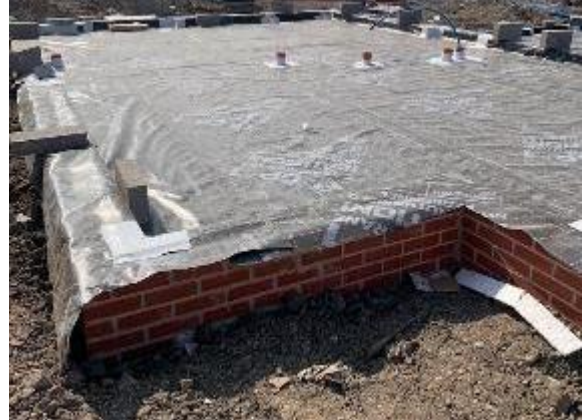
**Plot - 34**

**General Condition of Membrane-Good Condition**

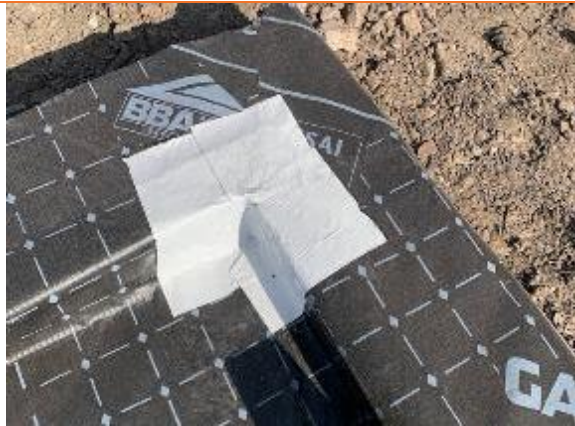
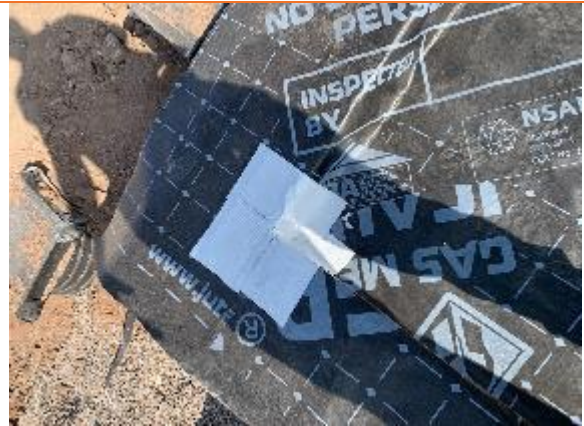
**Verification of Joints and Seals-Good Condition**

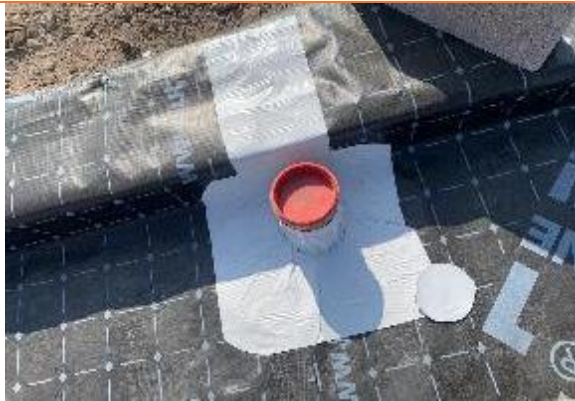
**Verification of Service Penetrations-Good Condition**

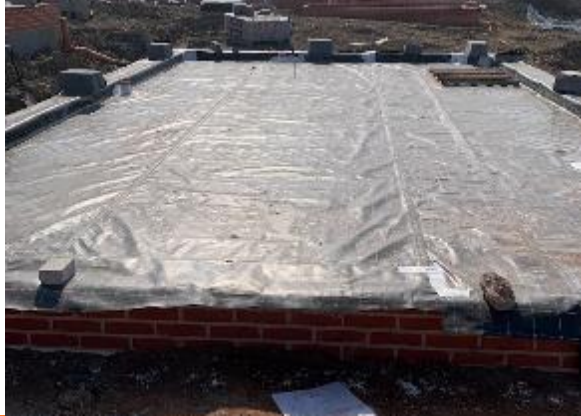
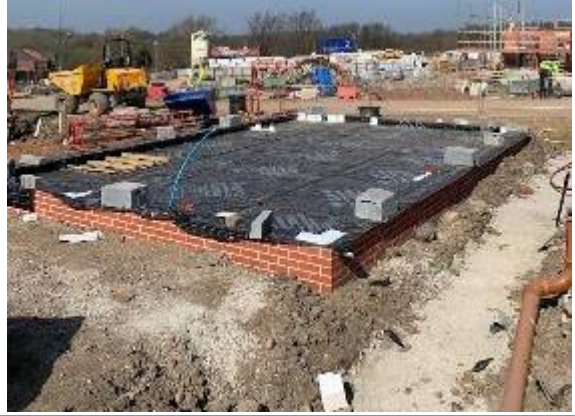
**Plot - 35**

**General Condition of Membrane-Good Condition**
