# Validation Completion Report

Site: Sonnet Gate, Prescott

Reference:15-292-R1

Date: July 2025

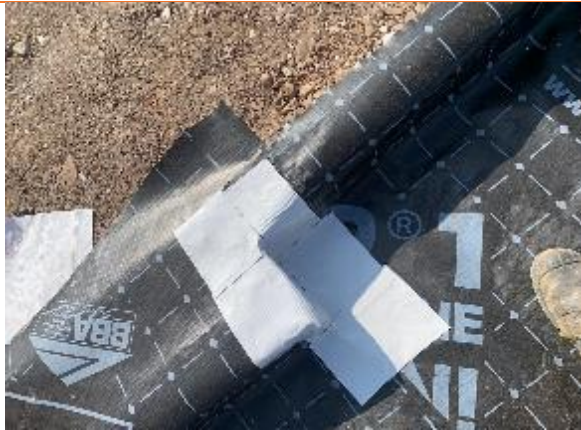
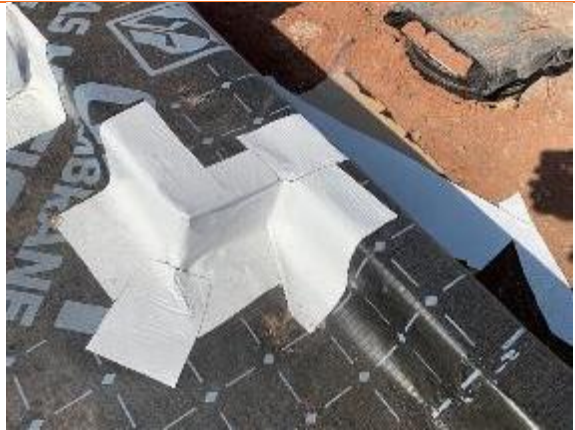
**Plot - 35**

**Verification of Joints and Seals-Good Condition**

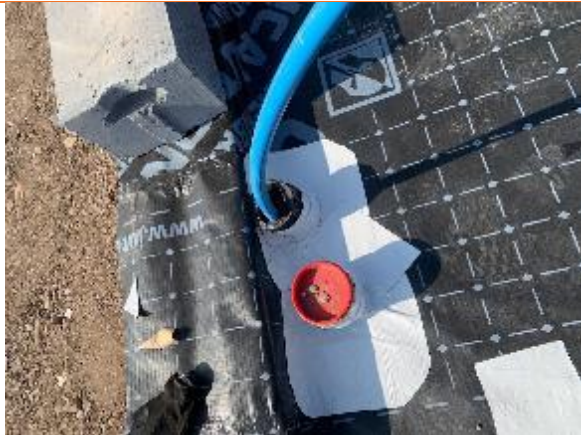
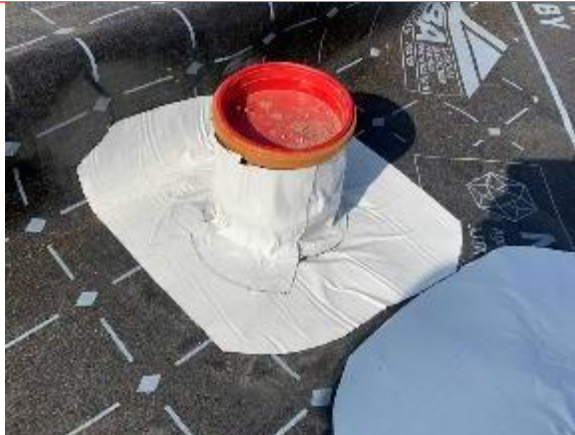
**Verification of Service Penetrations-Good Condition**

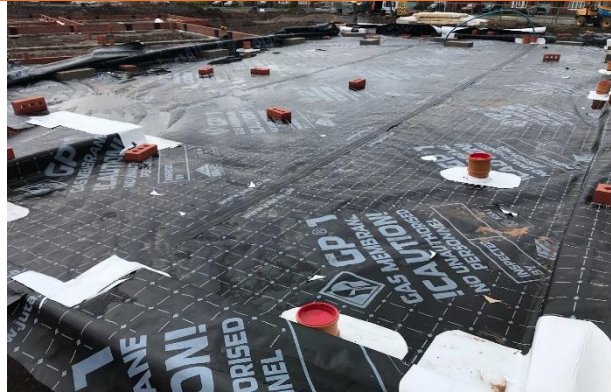
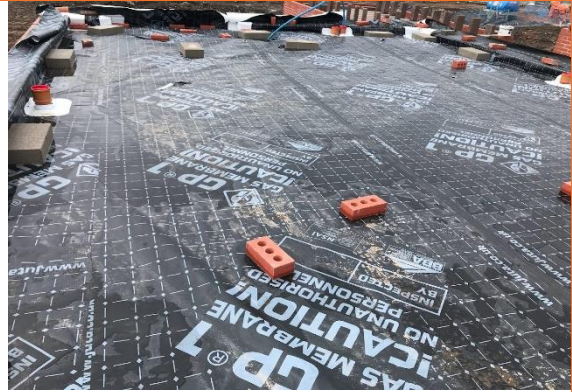
Plot - 32

General Condition of Membrane-Good Condition

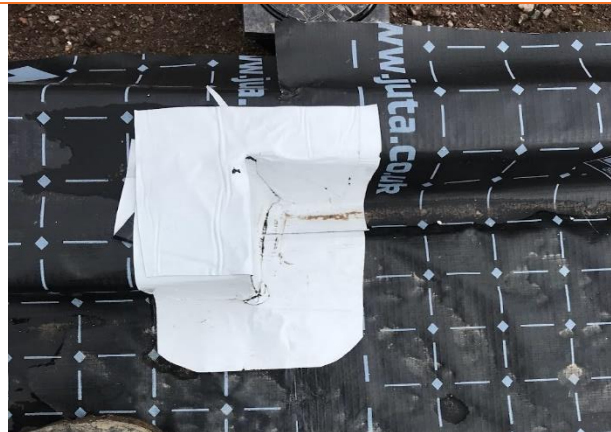
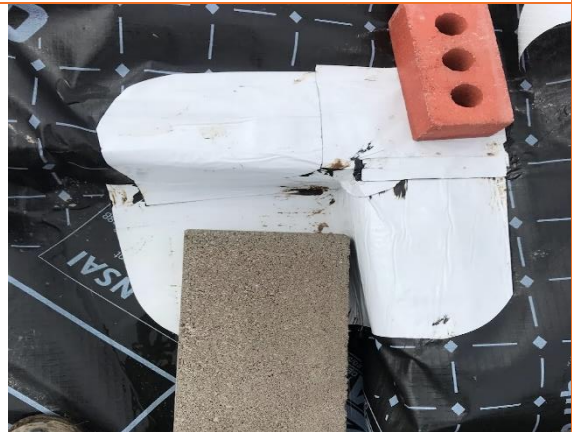
Verification of Joints and Seals-Good Condition

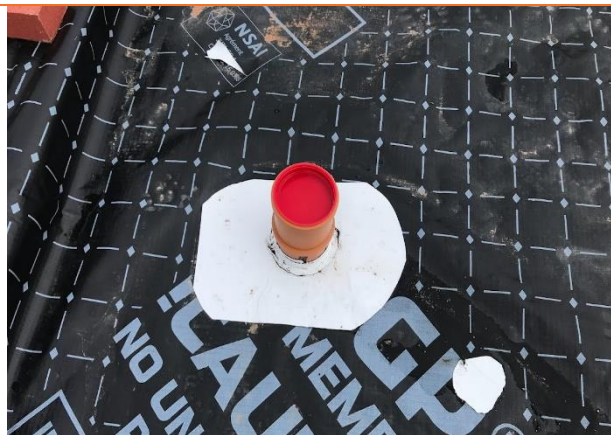
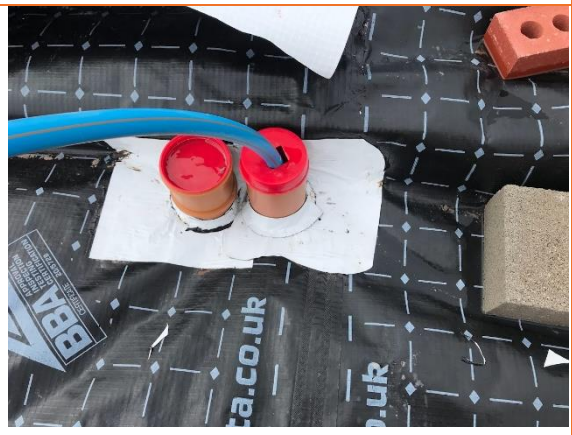
Verification of Service Penetrations-Good Condition

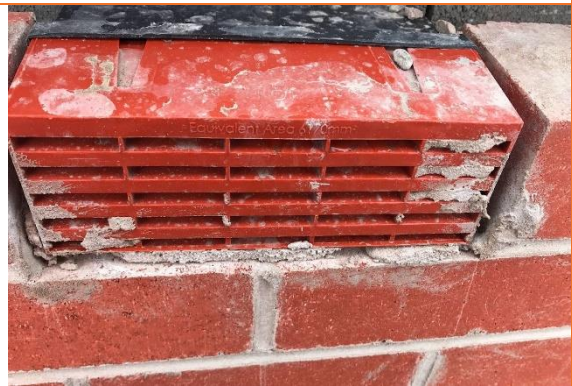
Verification of Service Penetrations-Good Condition

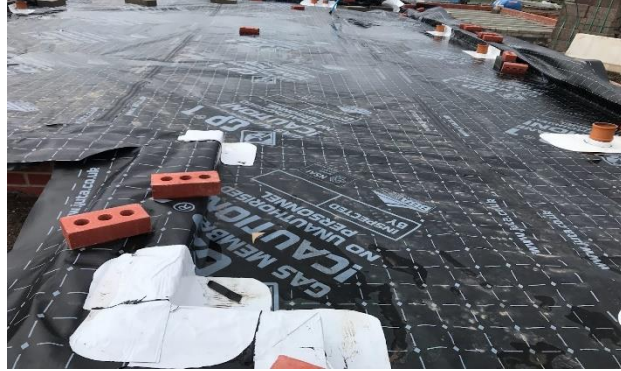
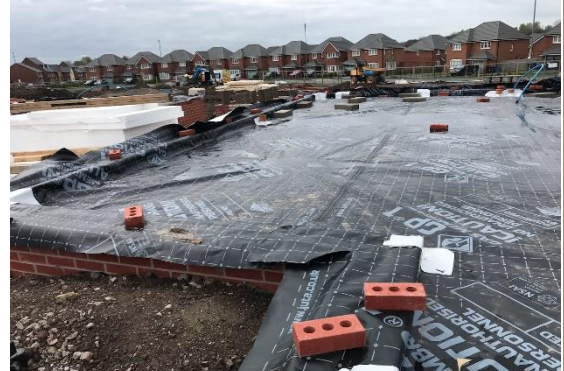
**Plot - 33**

**General Condition of Membrane-Good Condition**

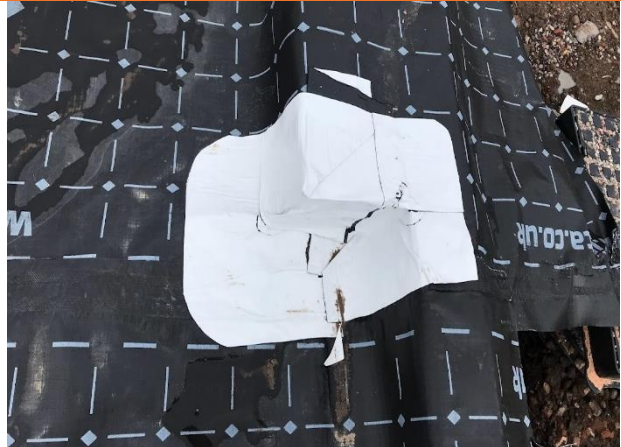
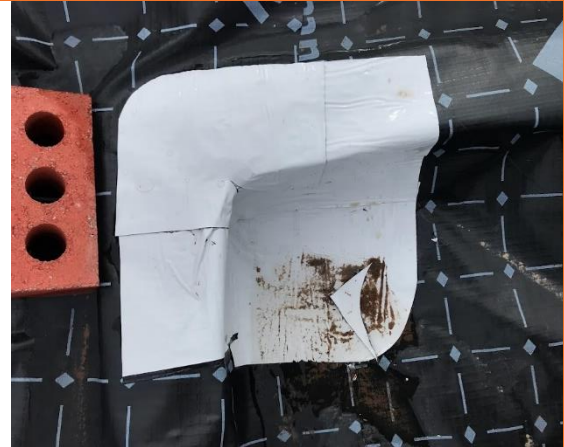
**Verification of Joints and Seals-Good Condition**

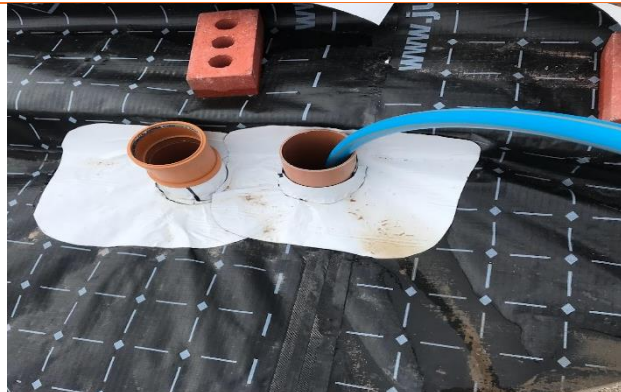
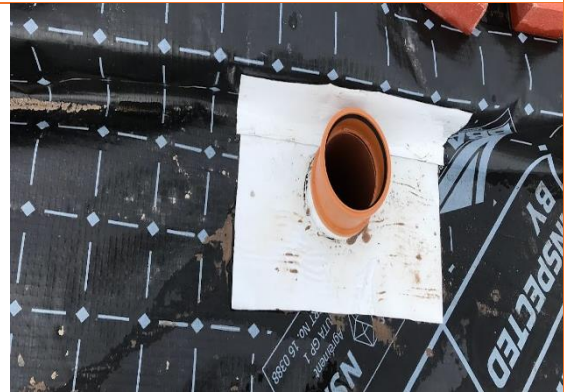
**Verification of Service Penetrations-Good Condition**

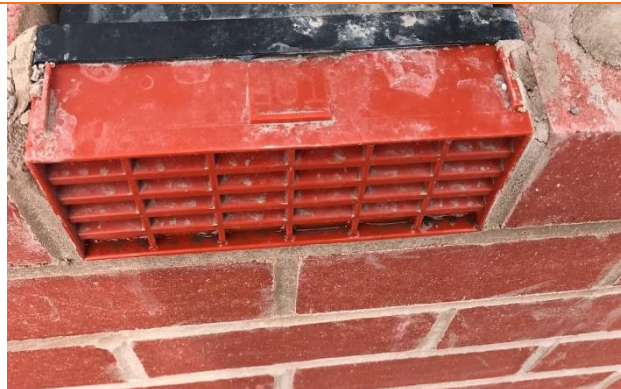
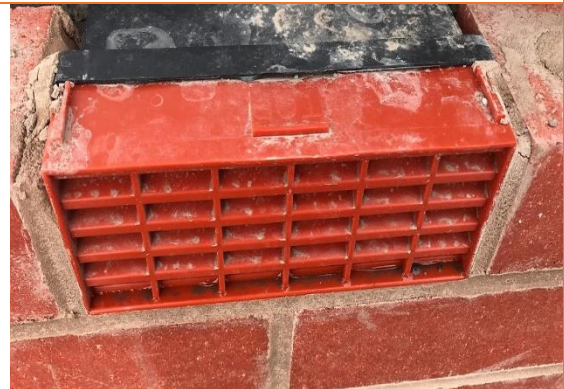
**Verification of Service Penetrations-Good Condition**

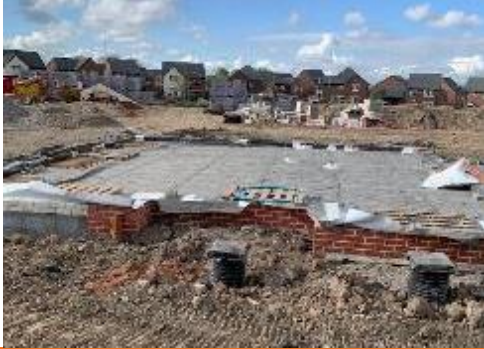
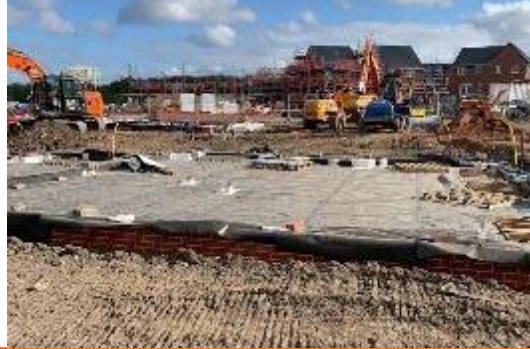
**Plot - 27**

**General Condition of Membrane-Good Condition**

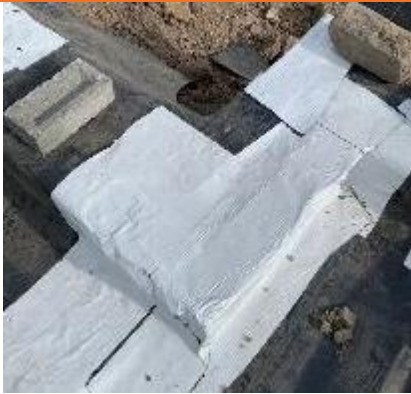
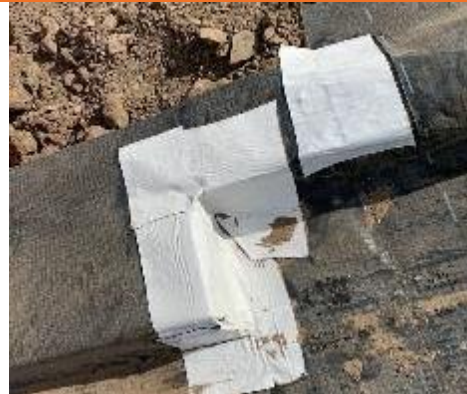
**Verification of Joints and Seals-Good Condition**

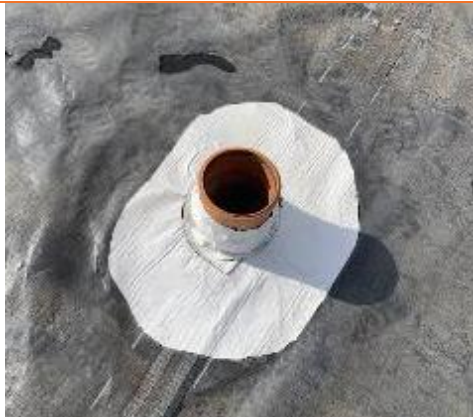
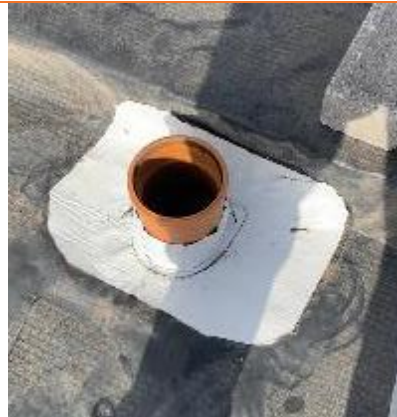
**Verification of Service Penetrations-Good Condition**

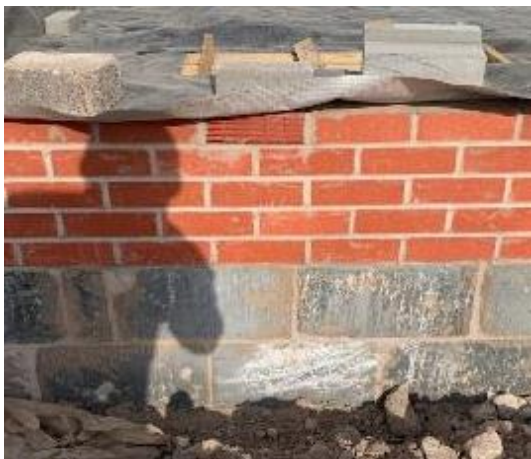
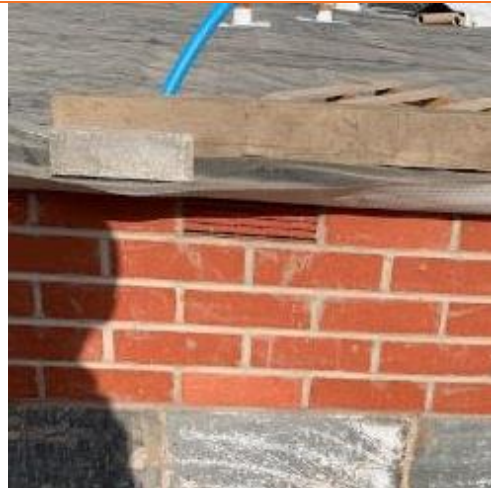
**Verification of Service Penetrations-Good Condition**

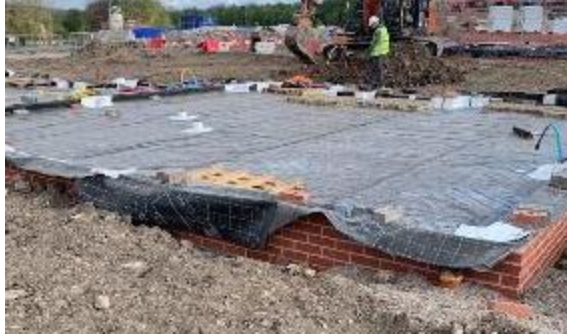
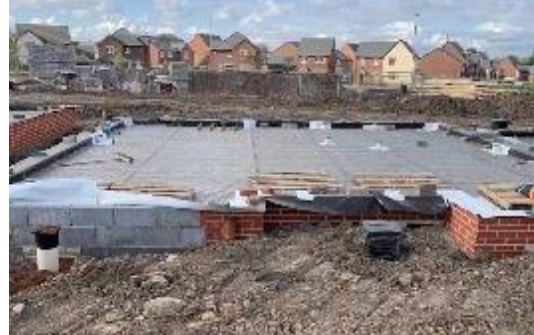
**Plot - 28**

**General Condition of Membrane-Good Condition**

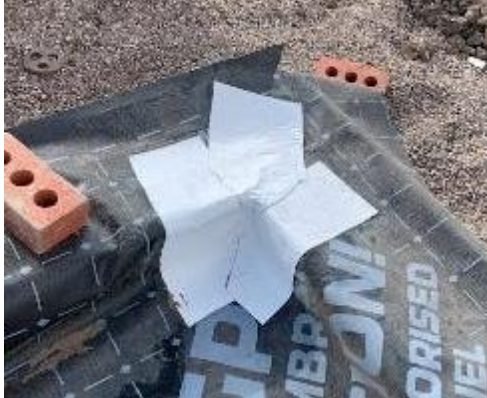
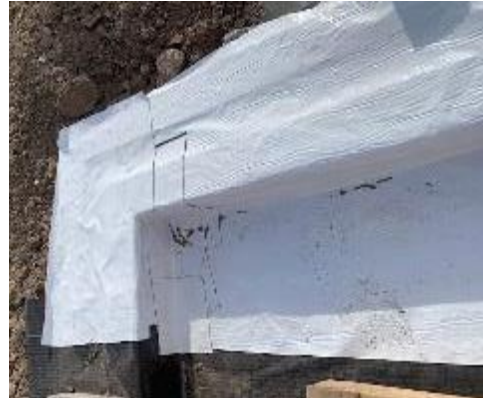
**Verification of Joints and Seals-Good Condition**

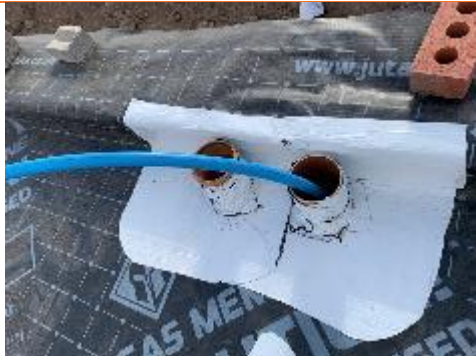
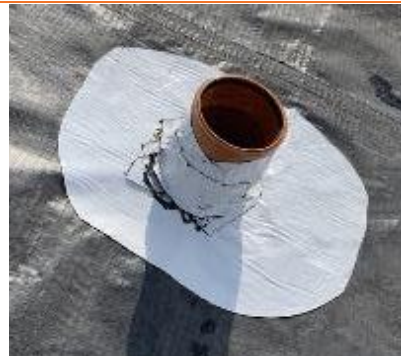
**Verification of Service Penetrations-Good Condition**

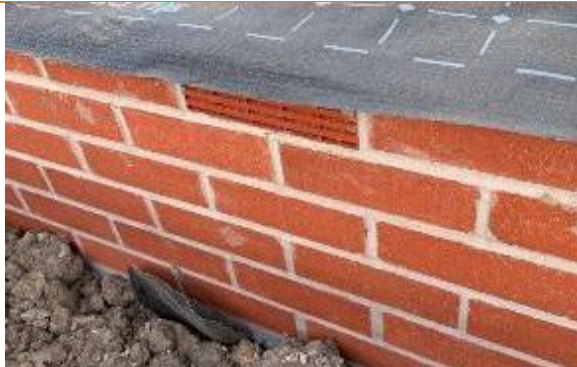
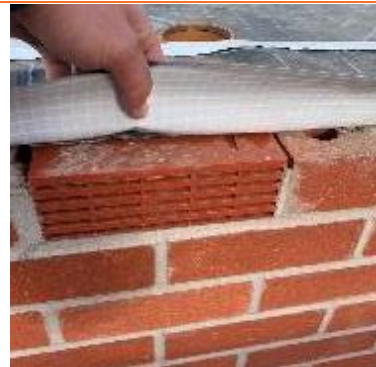
**Verification of Service Penetrations-Good Condition**

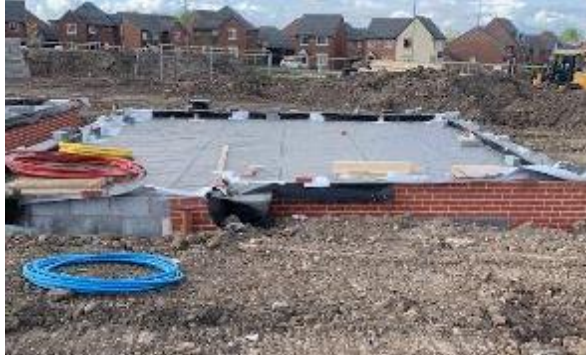
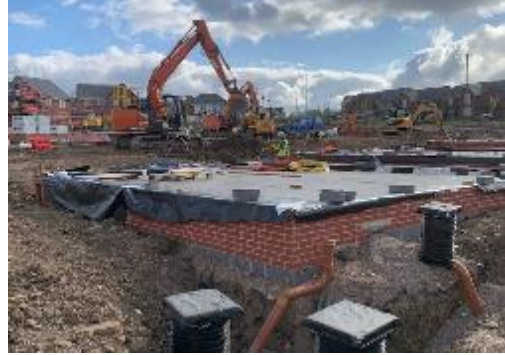
**Plot - 29**

**General Condition of Membrane-Good Condition**

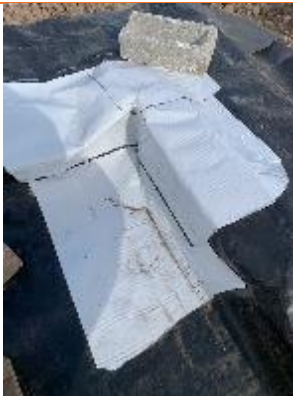
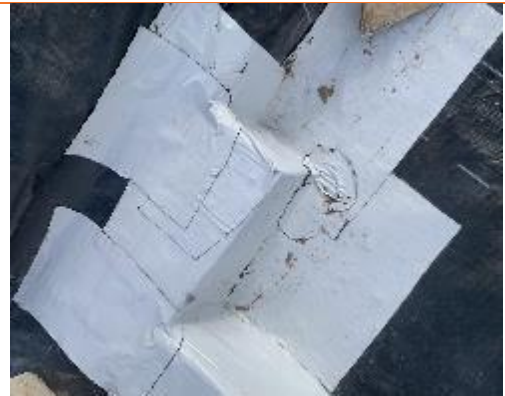
**Verification of Joints and Seals-Good Condition**

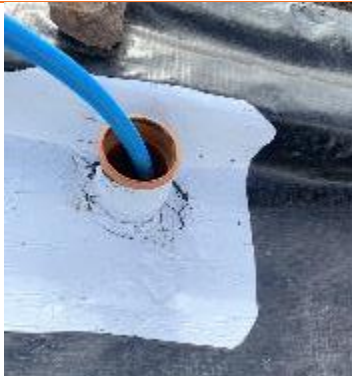
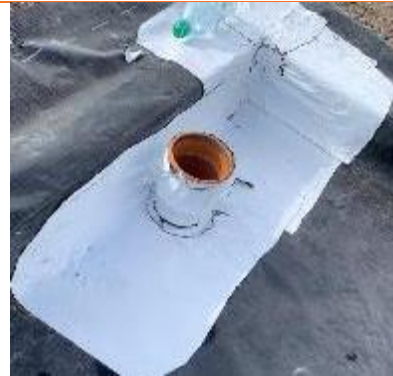
**Verification of Service Penetrations-Good Condition**

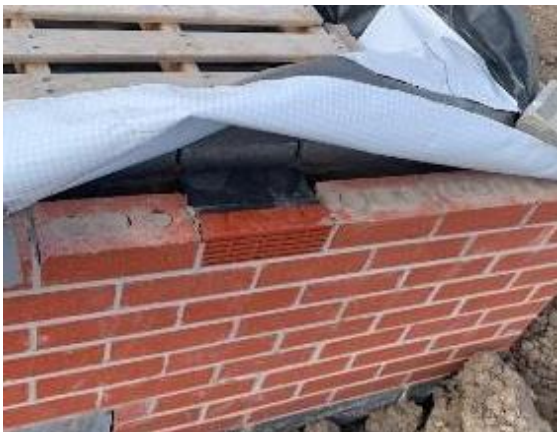
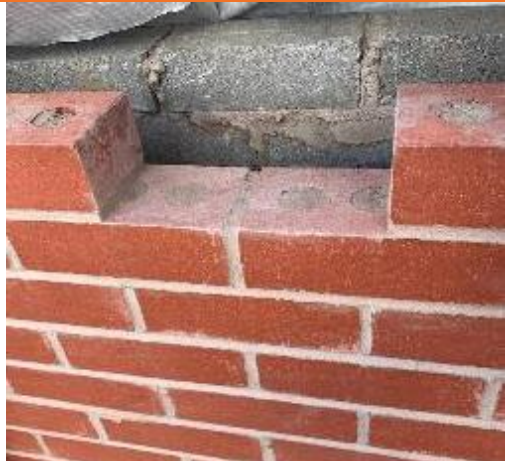
**Verification of Service Penetrations-Good Condition**

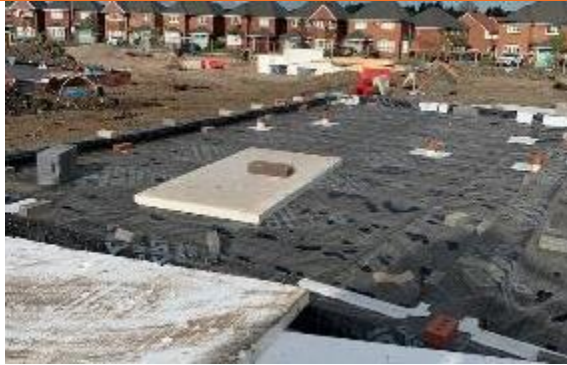
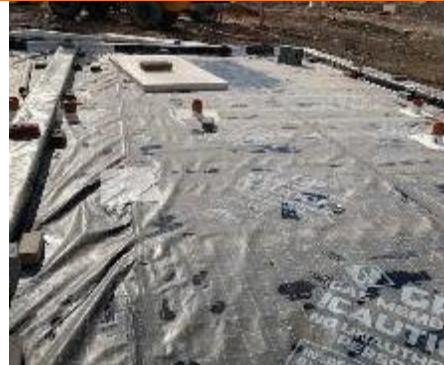
Plot - 30

General Condition of Membrane-Good Condition

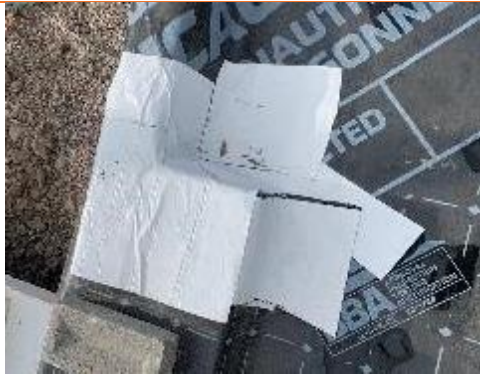
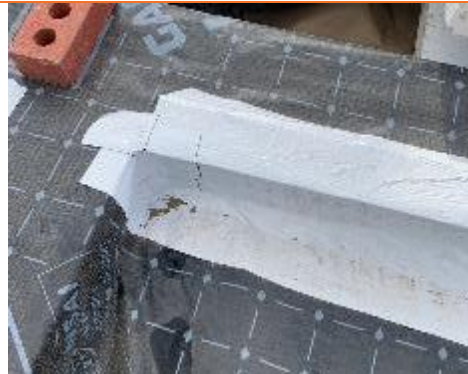
Verification of Joints and Seals-Good Condition

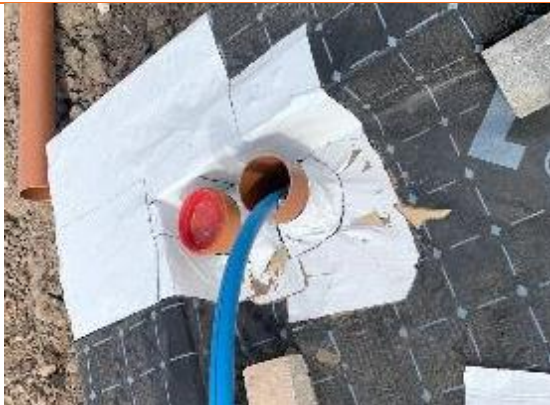
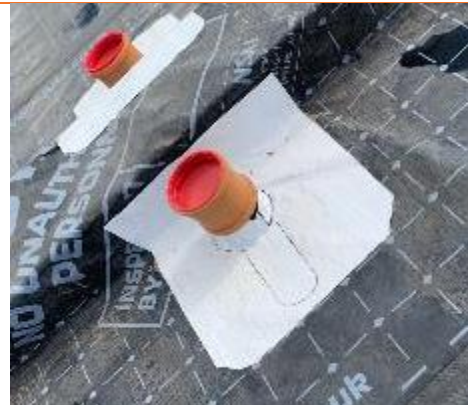
Verification of Service Penetrations-Good Condition

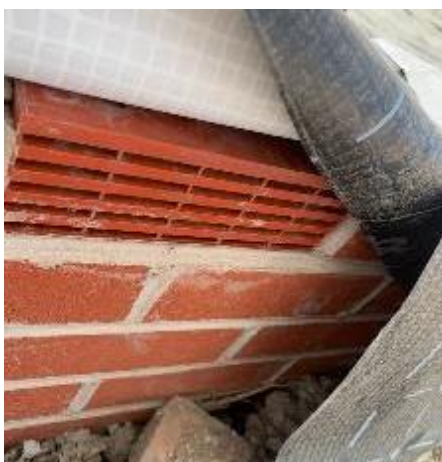
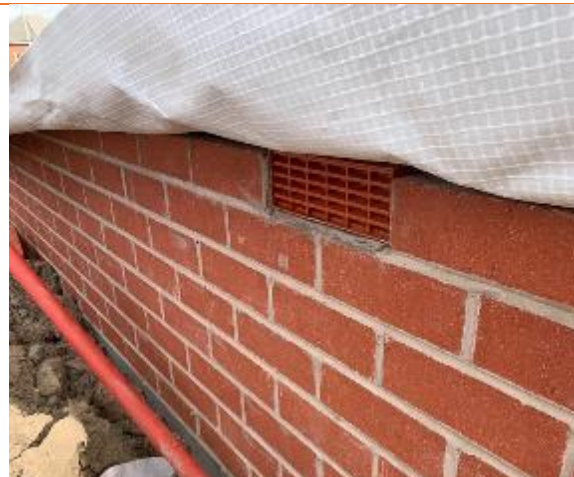
Verification of Service Penetrations-Good Condition

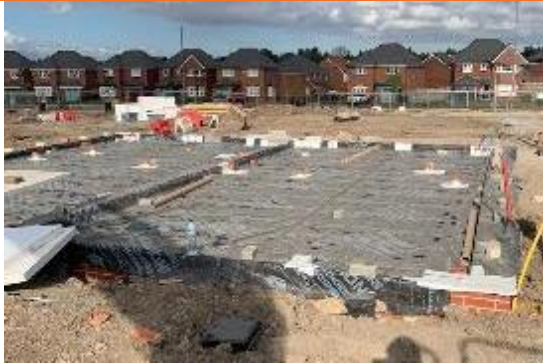
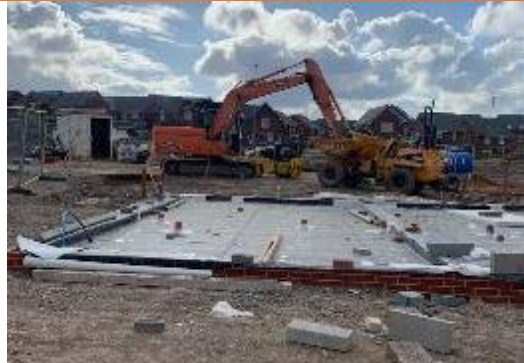
**Plot - 31**

**General Condition of Membrane-Good Condition**

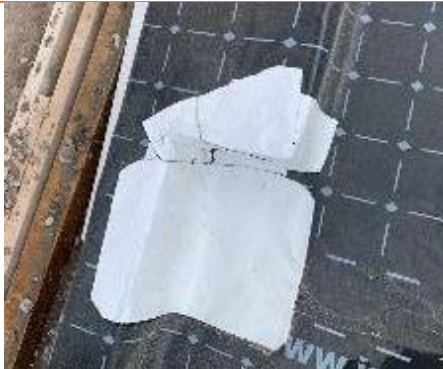
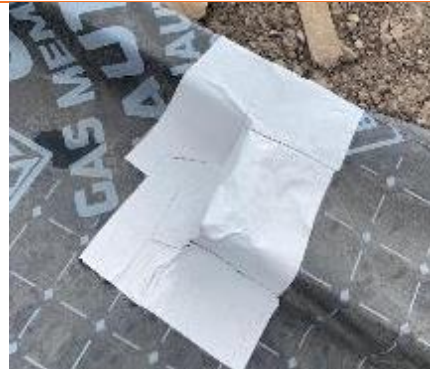
**Verification of Joints and Seals-Good Condition**

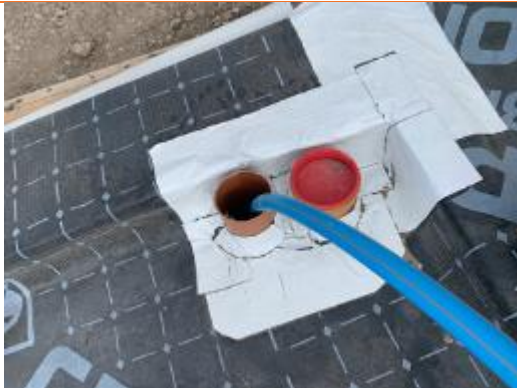
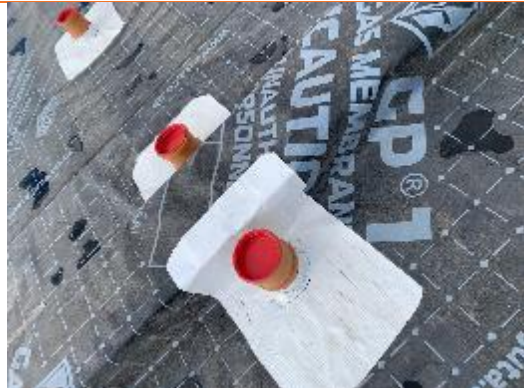
**Verification of Service Penetrations-Good Condition**

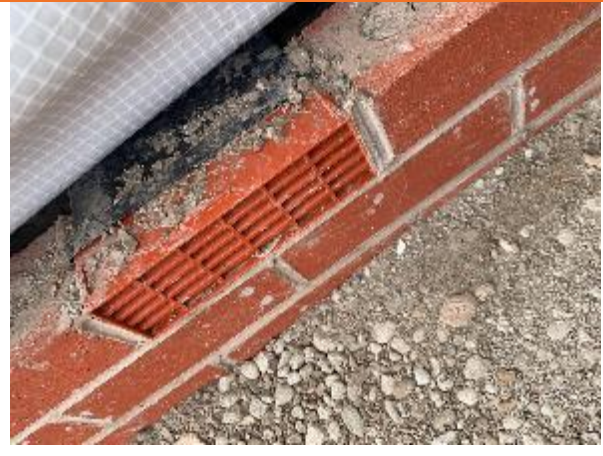
**Verification of Service Penetrations-Good Condition**

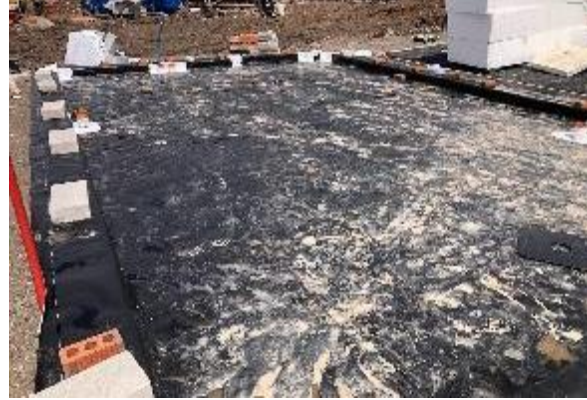
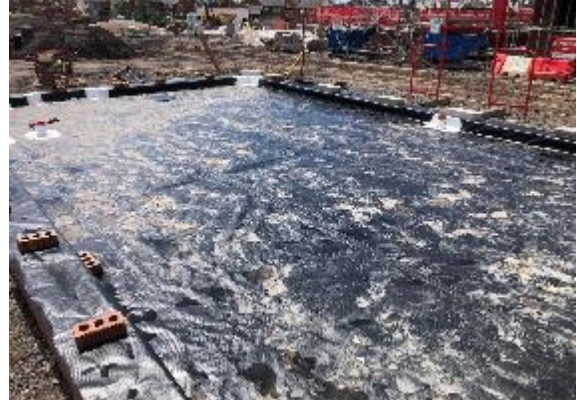
**Plot - 20**

**General Condition of Membrane-Good Condition**

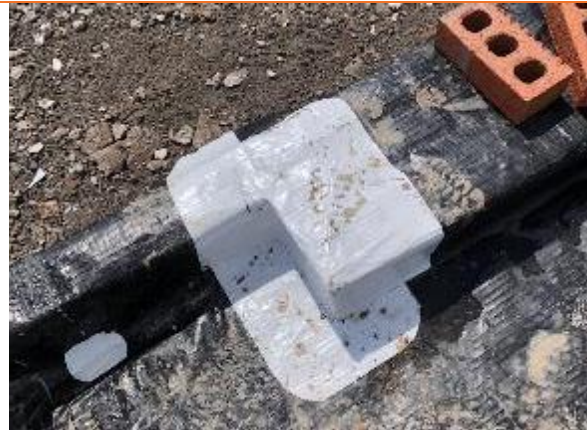
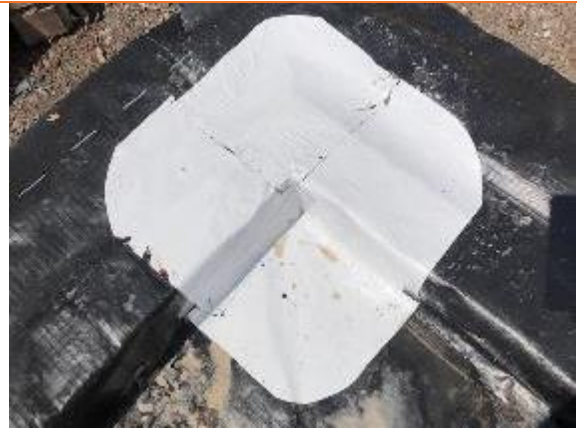
**Verification of Joints and Seals-Good Condition**

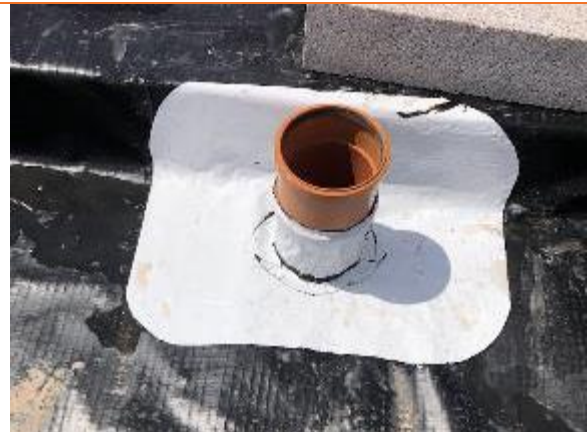
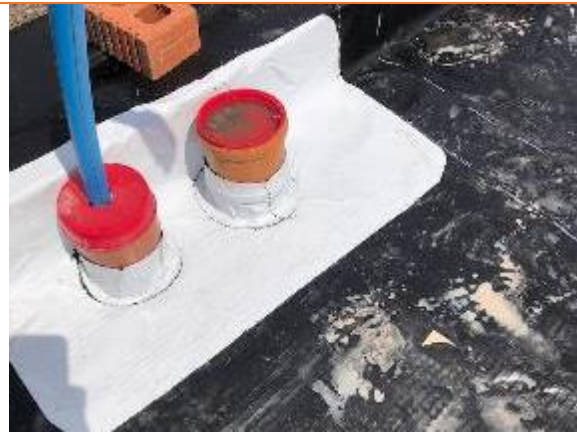
**Verification of Service Penetrations-Good Condition**

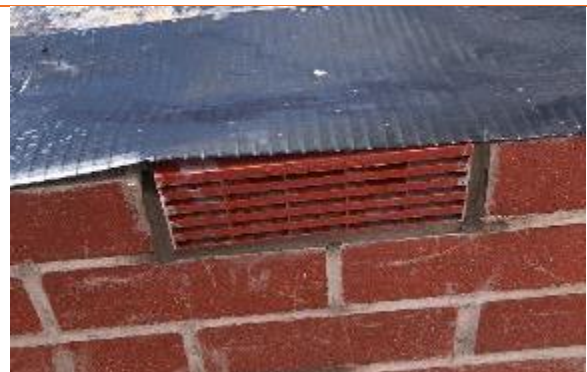
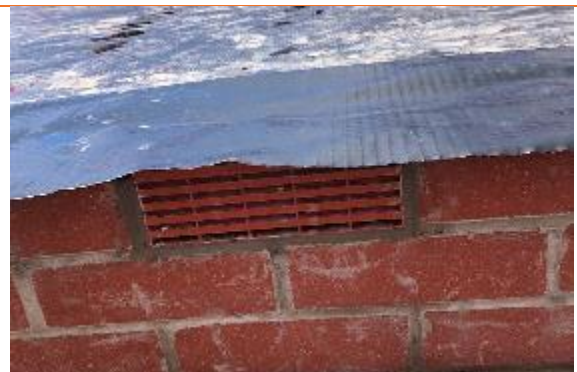
**Verification of Service Penetrations-Good Condition**

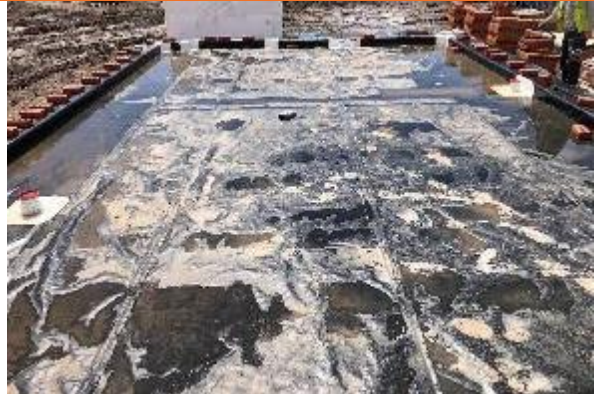
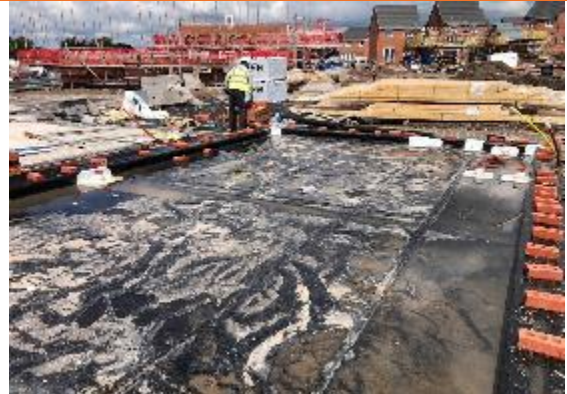
**Plot - 26**

**General Condition of Membrane-Good Condition**

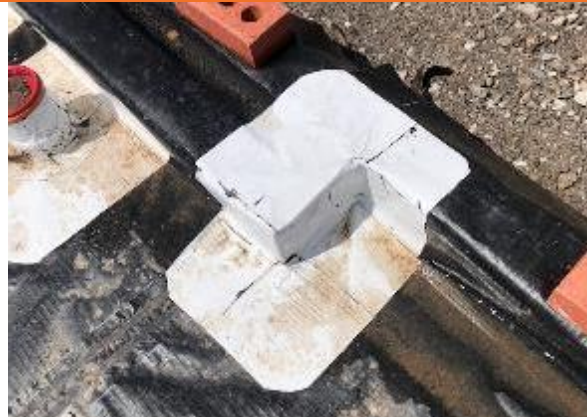
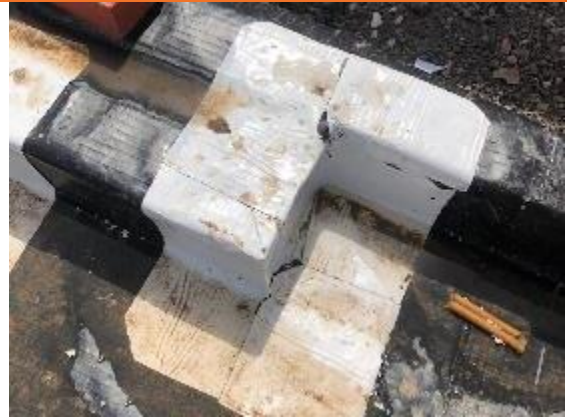
**Verification of Joints and Seals-Good Condition**

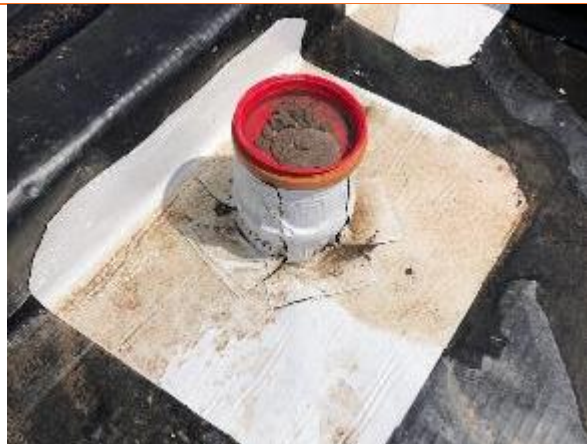
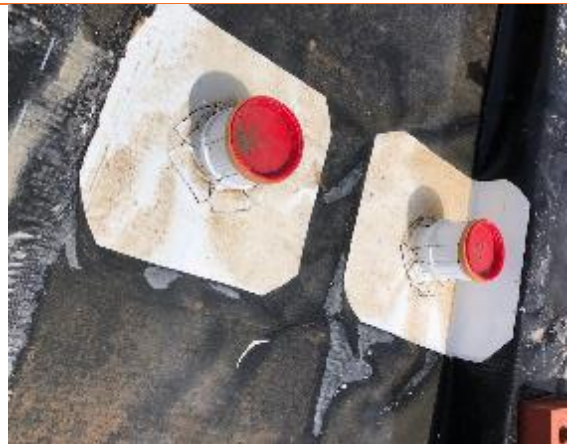
**Verification of Service Penetrations-Good Condition**

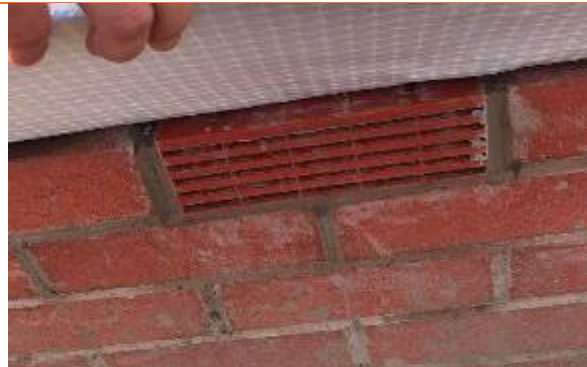
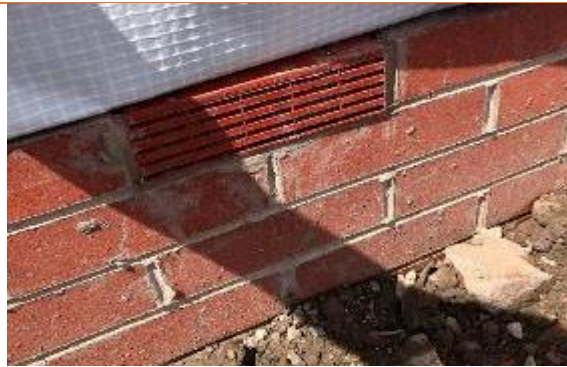
**Verification of Service Penetrations-Good Condition**

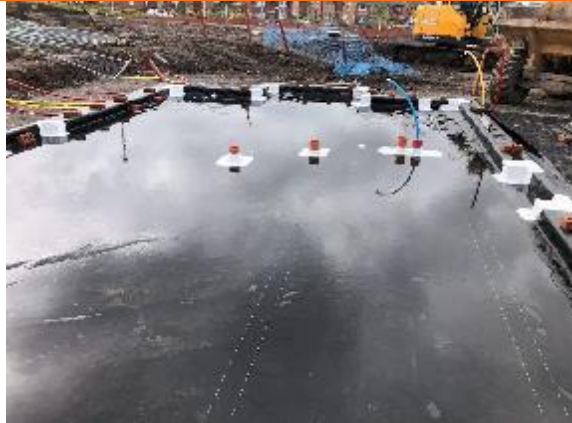
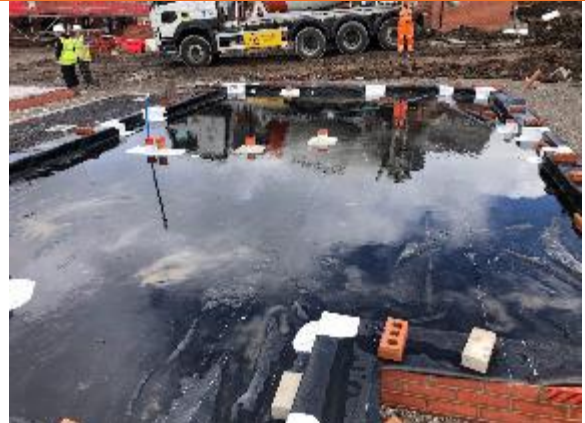
**Plot - 21**

**General Condition of Membrane-Good Condition**

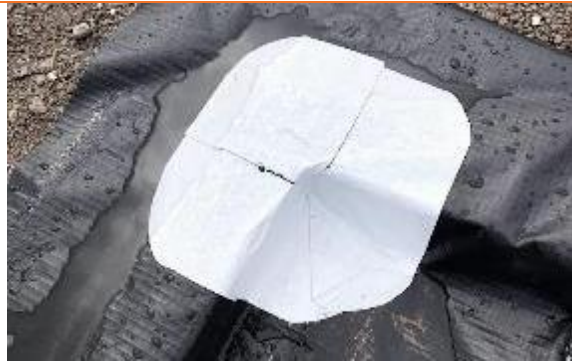
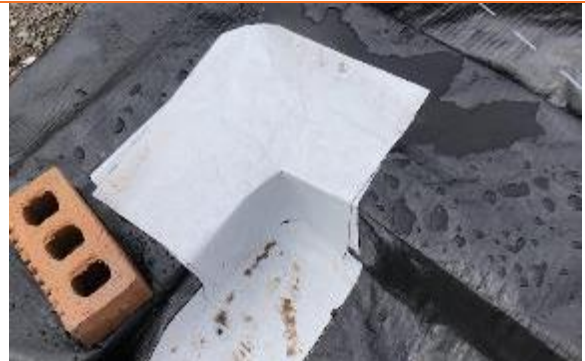
**Verification of Joints and Seals-Good Condition**

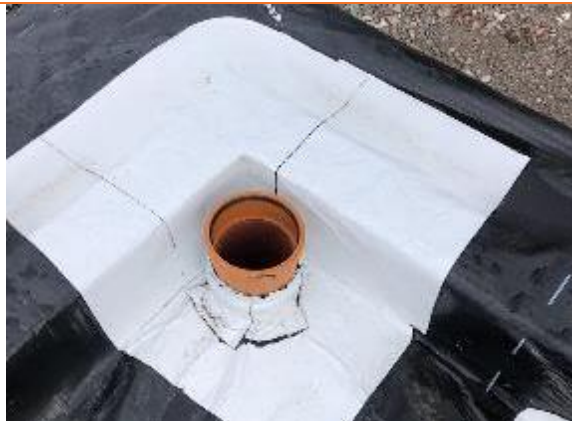
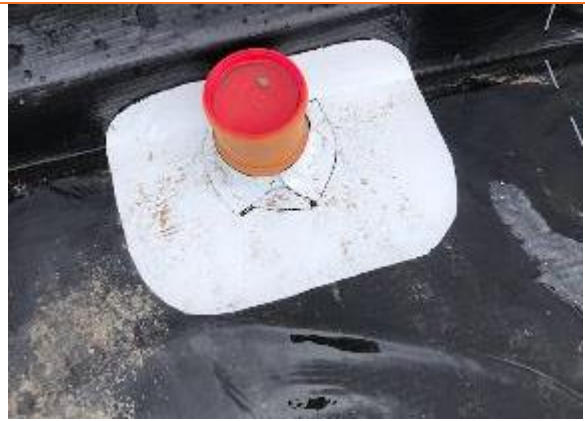
**Verification of Service Penetrations-Good Condition**

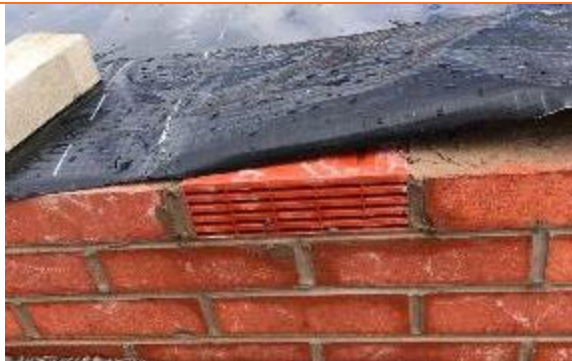
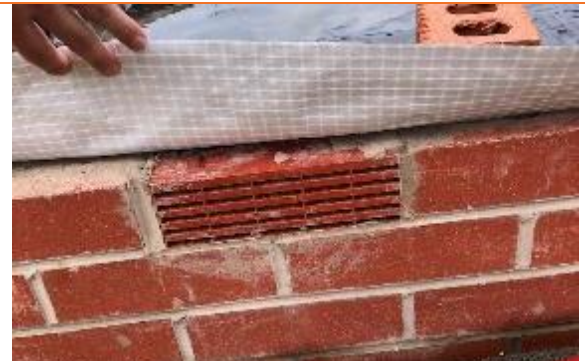
**Verification of Service Penetrations-Good Condition**

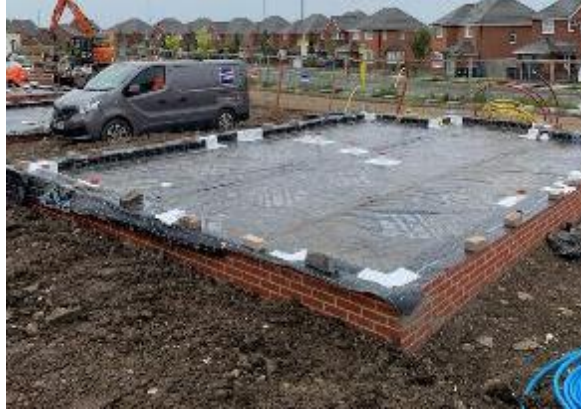
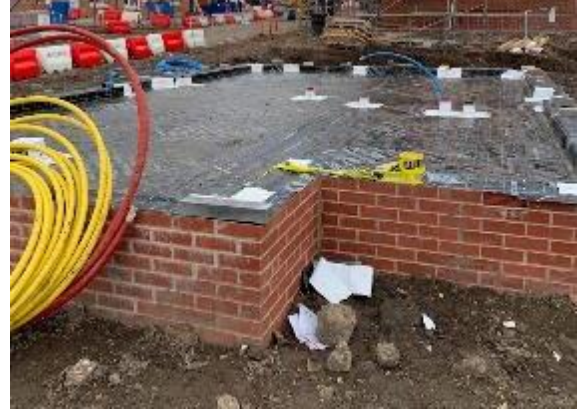
**Plot - 36**

**General Condition of Membrane-Good Condition**

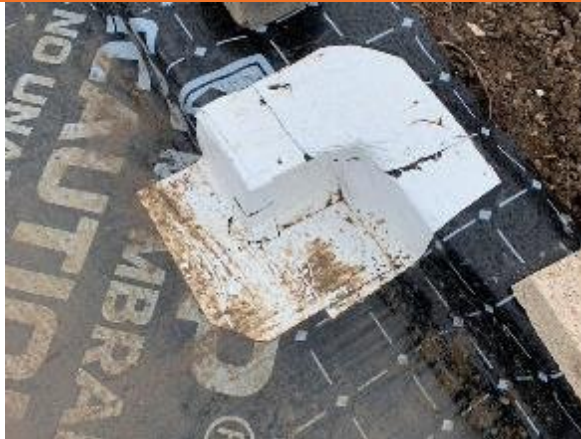
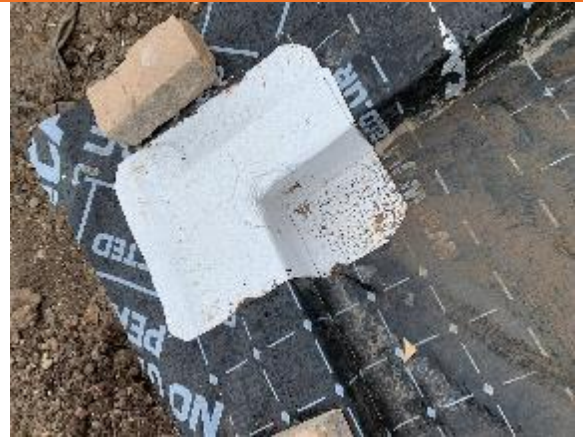
**Verification of Joints and Seals-Good Condition**

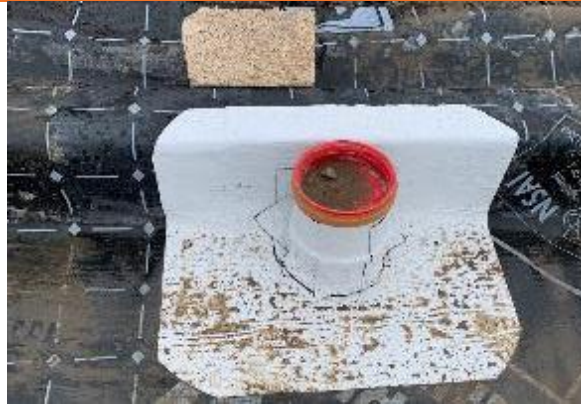
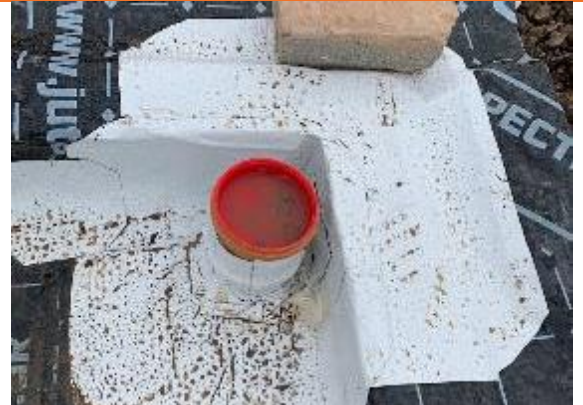
**Verification of Service Penetrations-Good Condition**

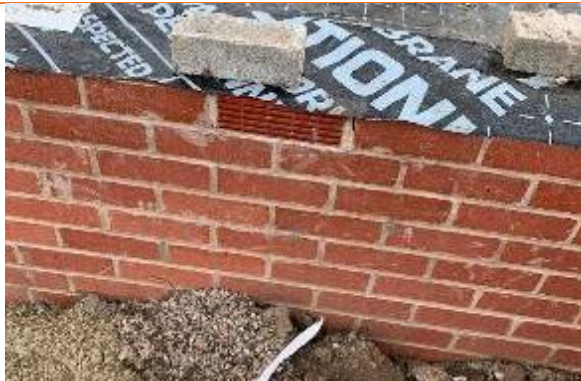
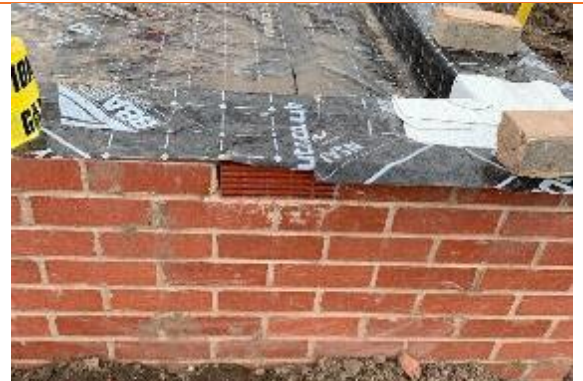
**Verification of Service Penetrations-Good Condition**

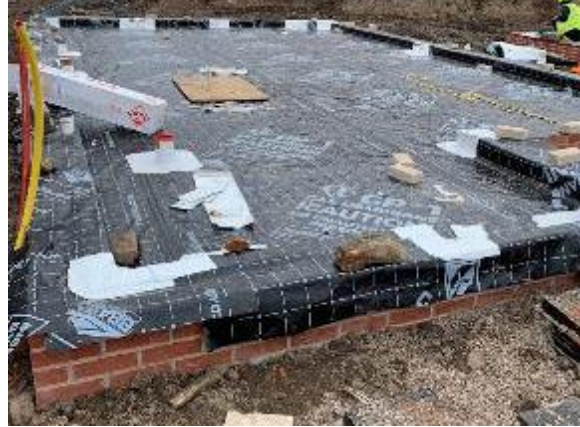
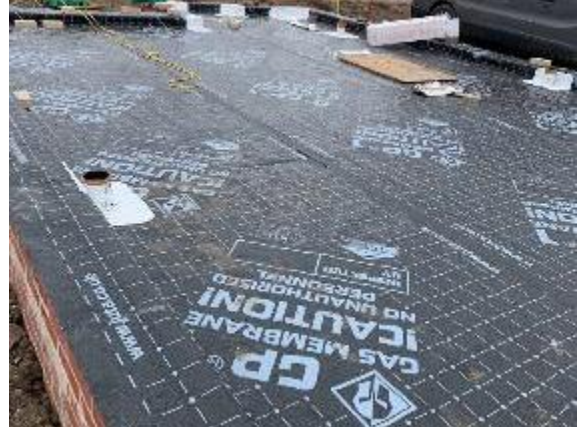
Plot - 37

General Condition of Membrane-Good Condition

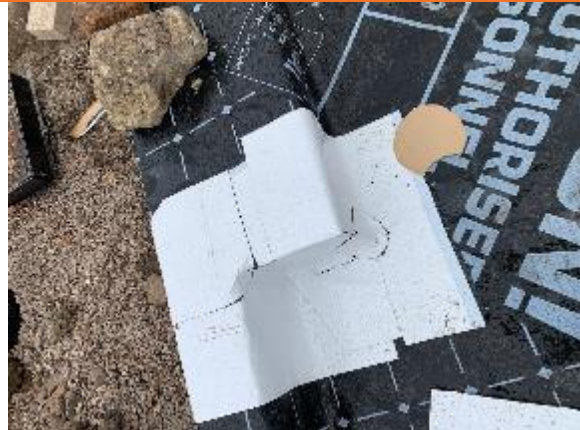
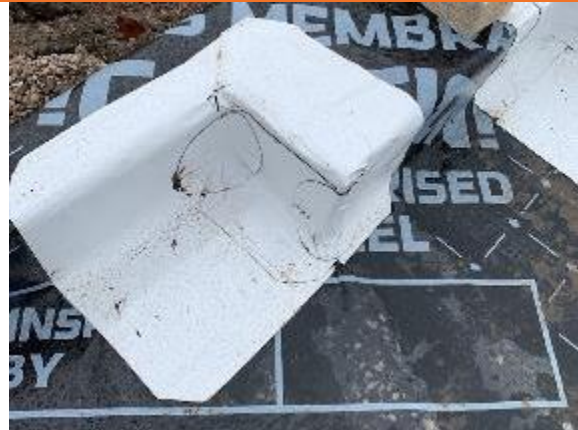
Verification of Joints and Seals-Good Condition

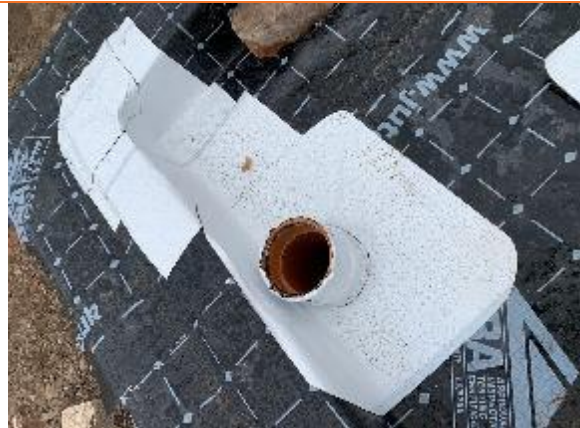
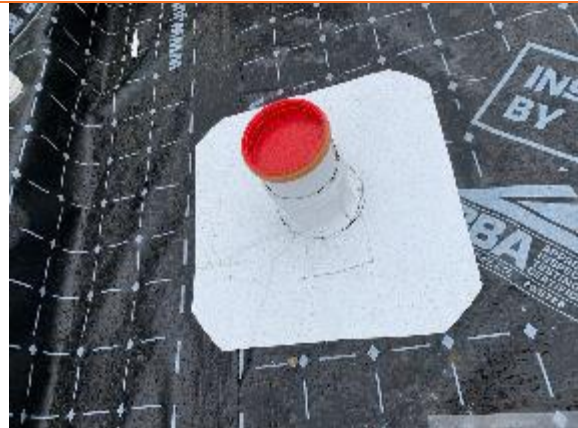
Verification of Service Penetrations-Good Condition

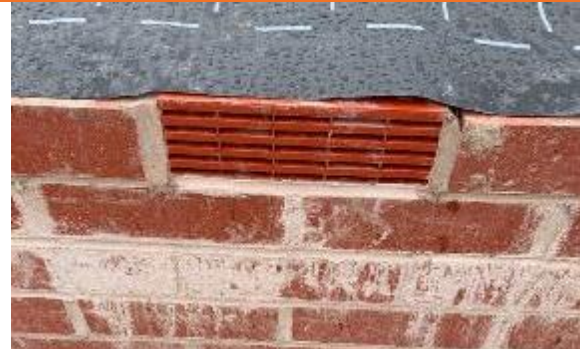
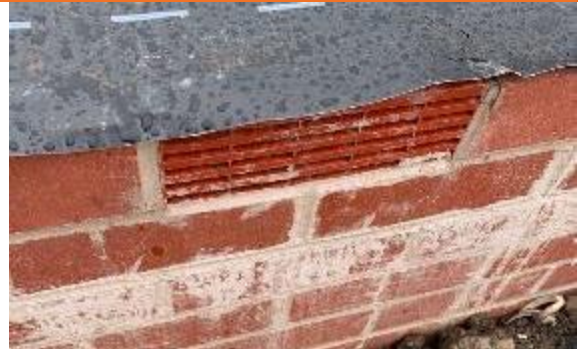
Verification of Service Penetrations-Good Condition

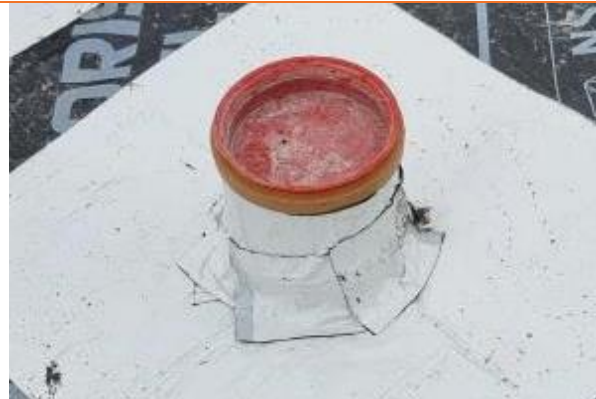
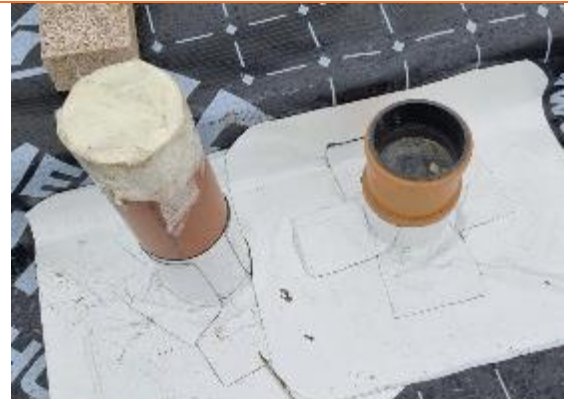
**Plot - 38**

**Verification of Service Penetrations-Good Condition**

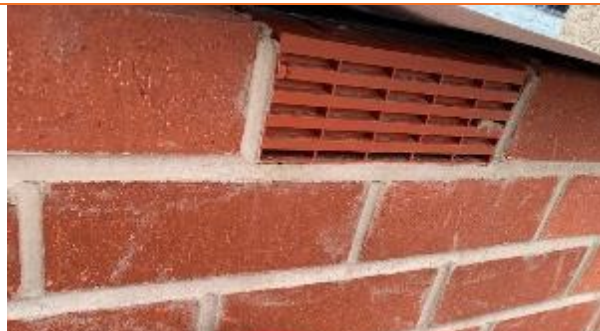
**Verification of Service Penetrations-Good Condition**
