# Validation Completion Report

Site: Sonnet Gate, Prescott

Reference:15-292-R1

Date: July 2025

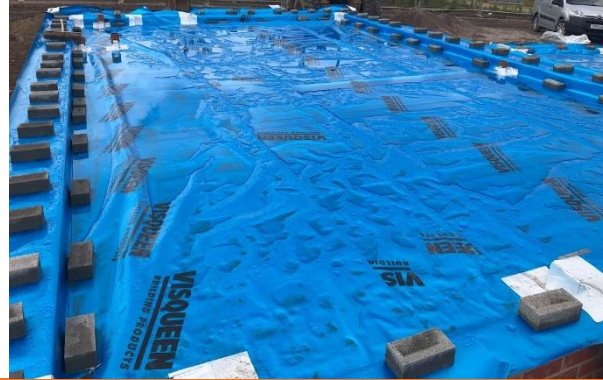
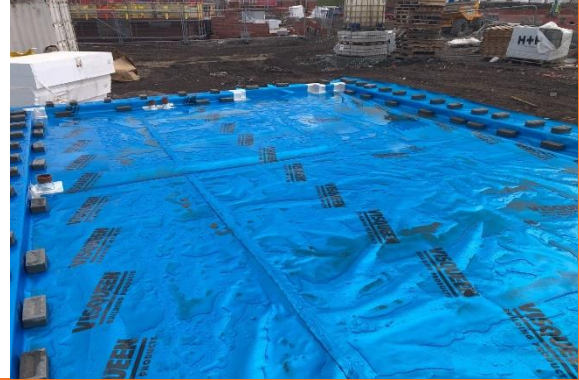
**Plot - 47**

**General Condition of Membrane-Good Condition**

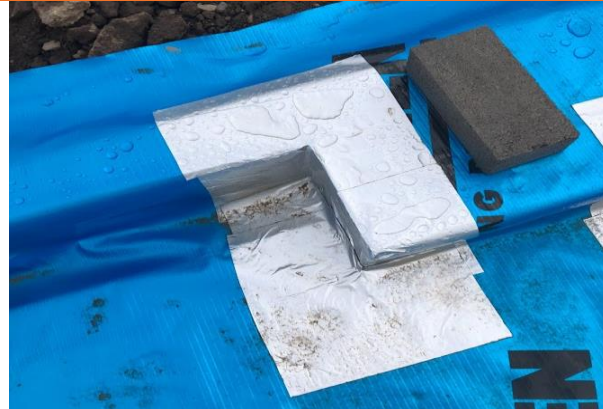
**Verification of Joints and Seals-Good Condition**

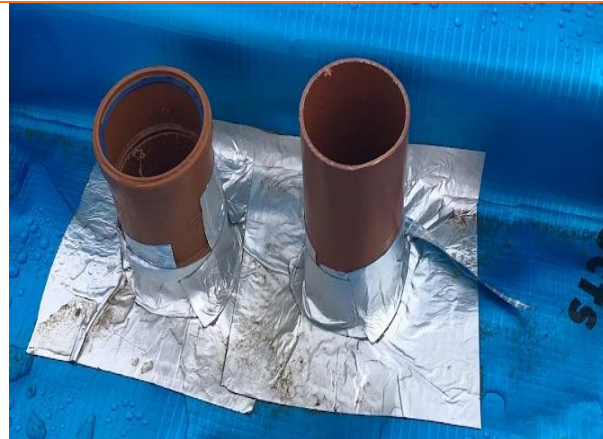
**Verification of Service Penetrations-Good Condition**

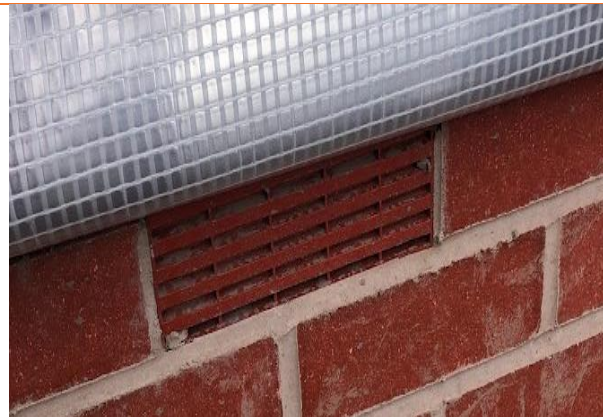
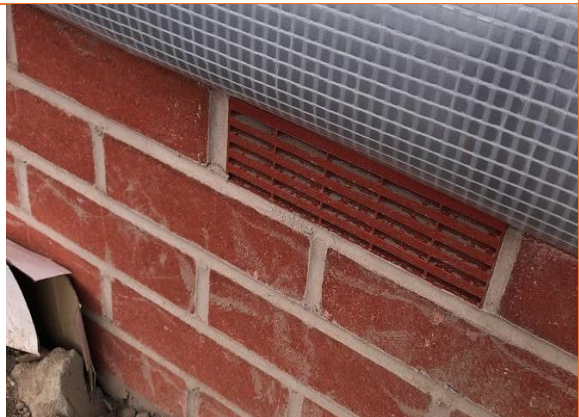
**Verification of Service Penetrations-Good Condition**

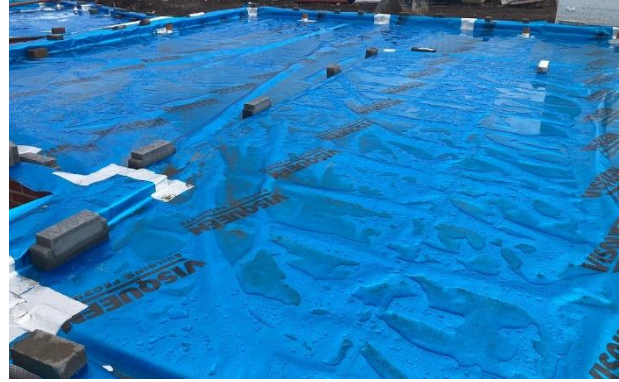
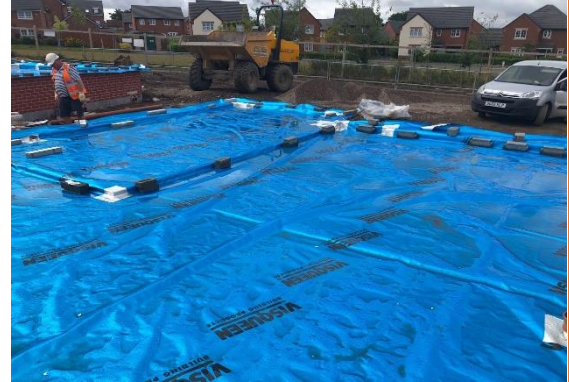
**Plot – 48**

**General Condition of Membrane-Good Condition**

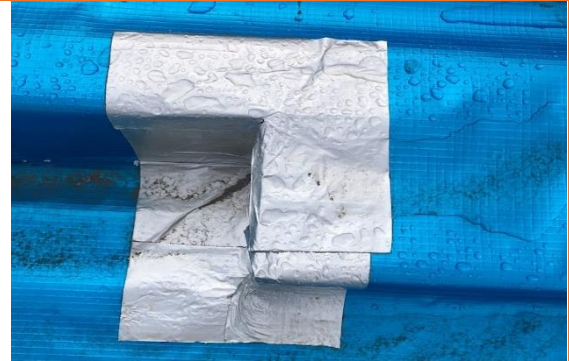
**Verification of Joints and Seals-Good Condition**

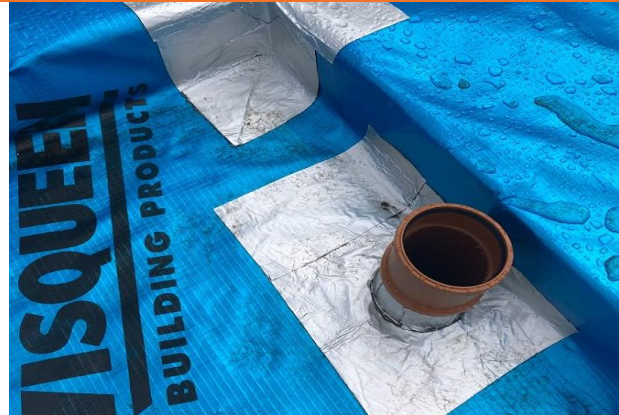
**Verification of Service Penetrations-Good Condition**

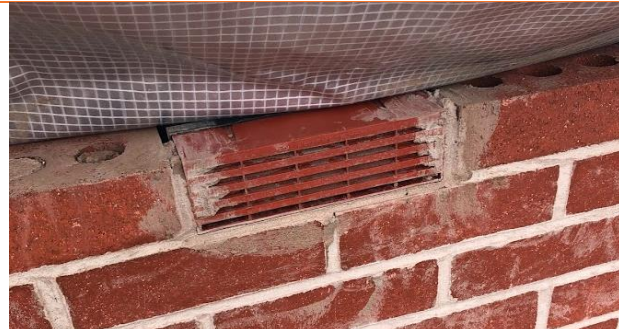
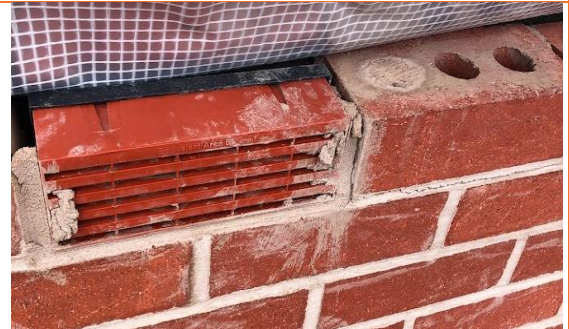
**Verification of Service Penetrations-Good Condition**

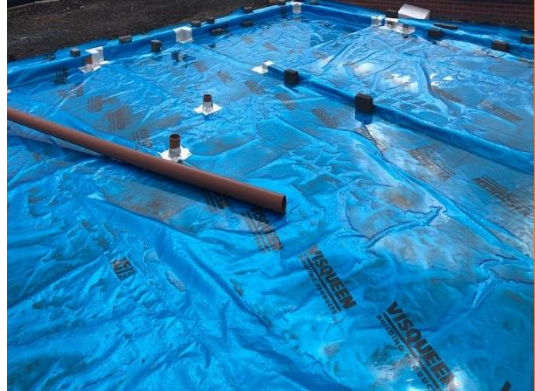
**Plot - 49**

**General Condition of Membrane-Good Condition**

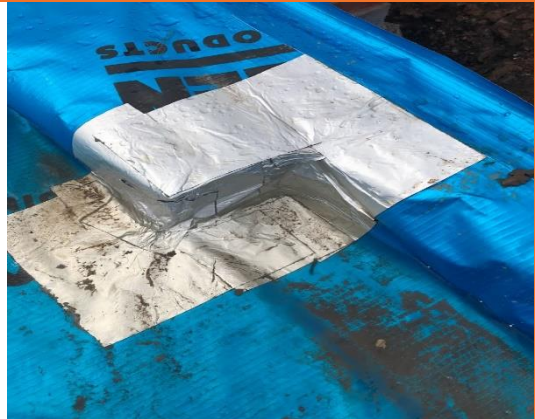
**Verification of Joints and Seals-Good Condition**

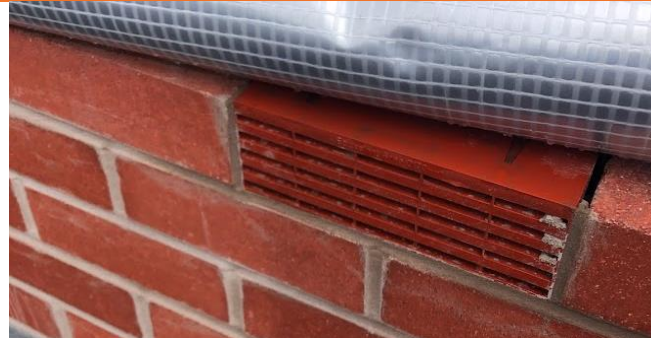
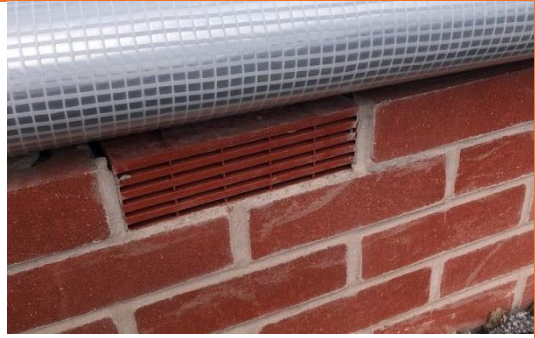
**Verification of Service Penetrations-Good Condition**

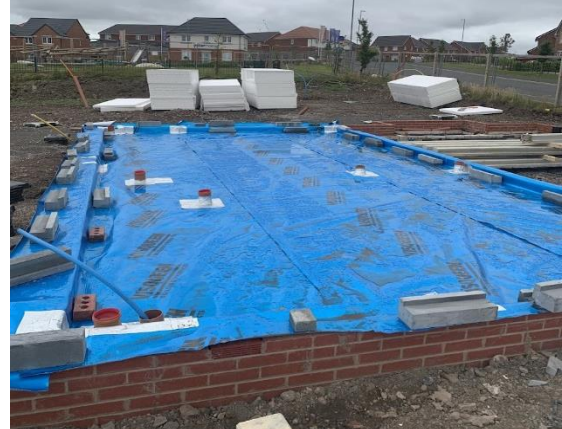
**Plot - 23**

**General Condition of Membrane-Good Condition**

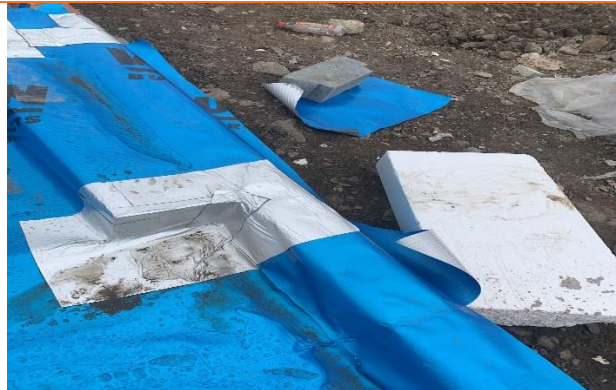
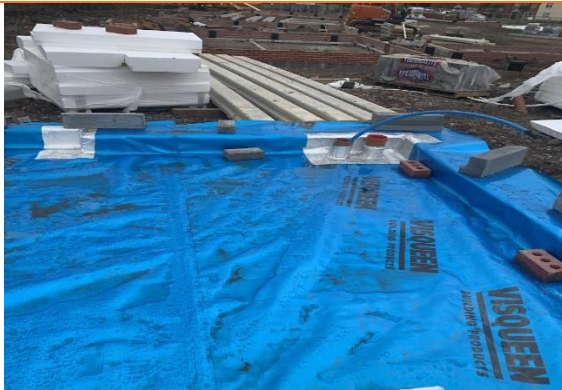
**Verification of Joints and Seals-Good Condition**

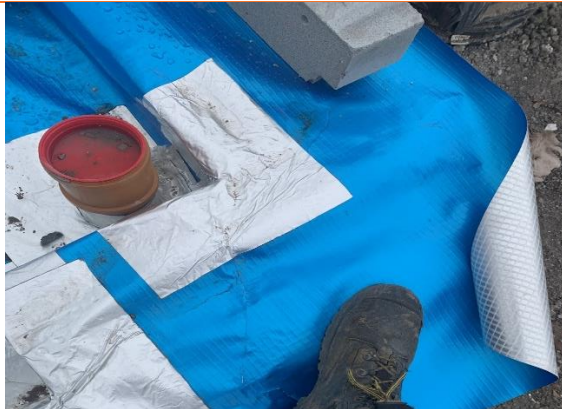
**Verification of Service Penetrations-Good Condition**

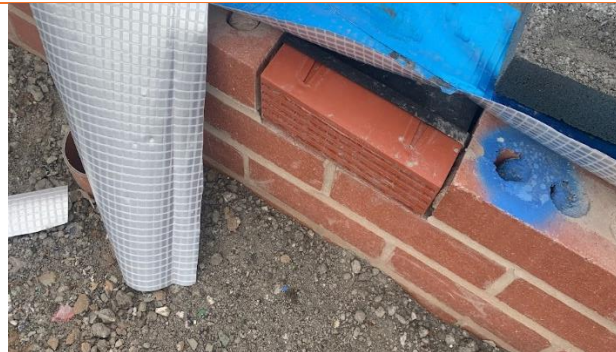
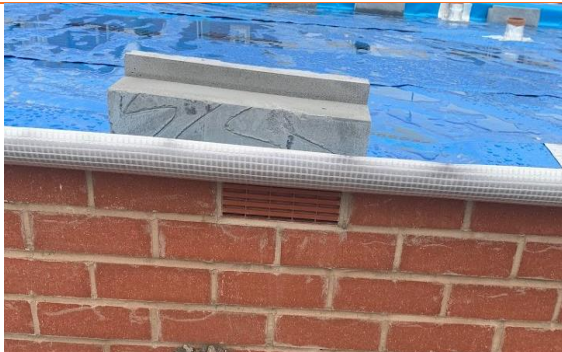
**Verification of Service Penetrations-Good Condition**

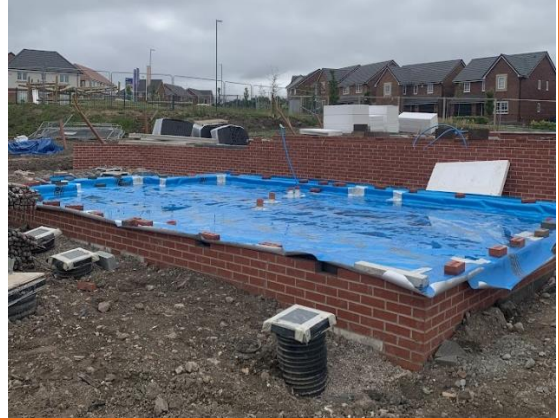
**Plot – 25**

**General Condition of Membrane-Good Condition**

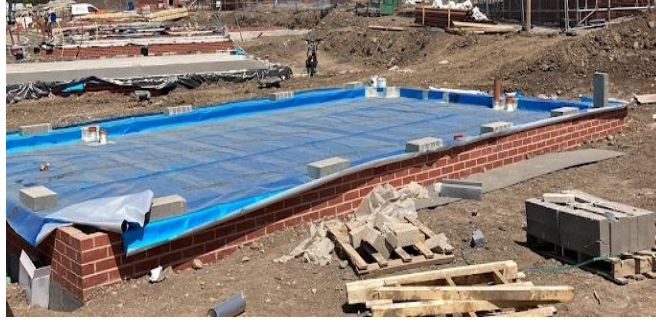
**Plot - 44**

**General Condition of Membrane-Good Condition**

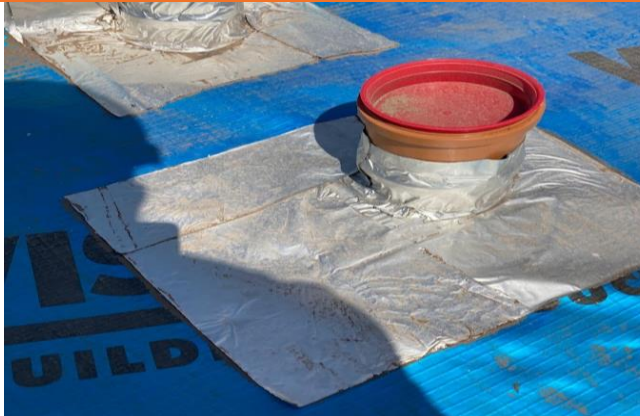
**Verification of Service Penetrations-Good Condition**

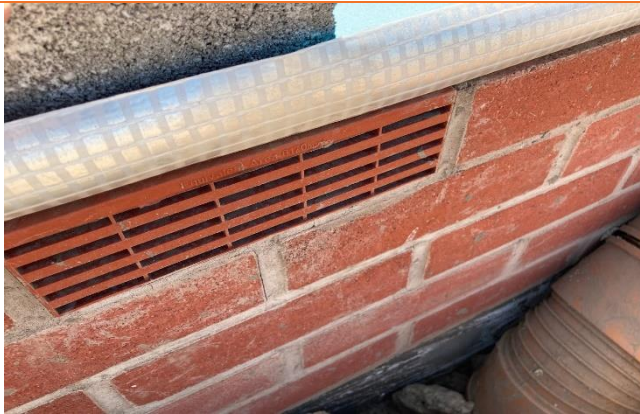
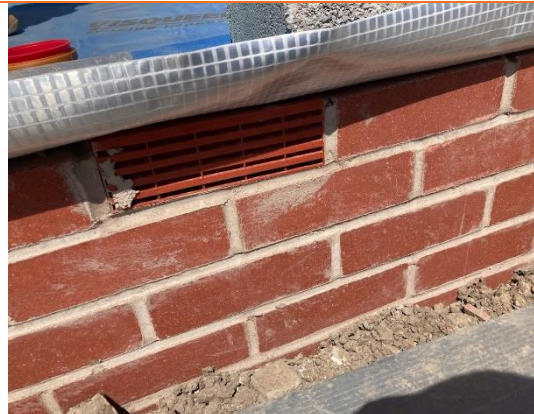
**Verification of Service Penetrations-Good Condition**

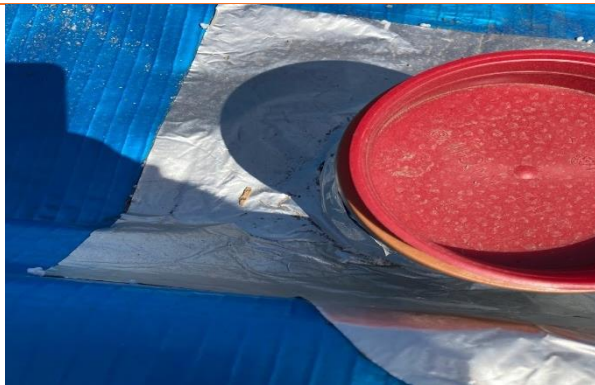
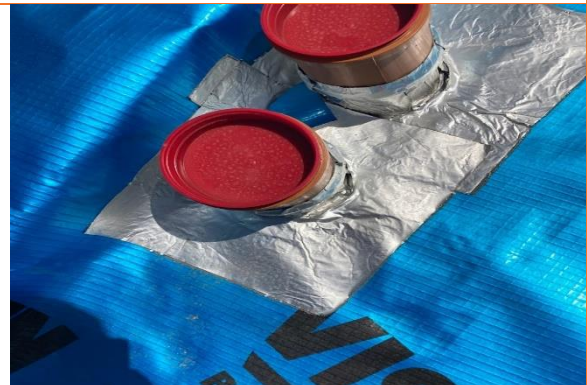
**Plot – 45**

**Verification of Service Penetrations-Good Condition**

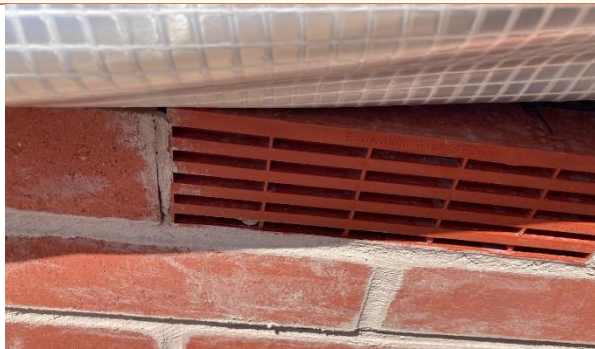
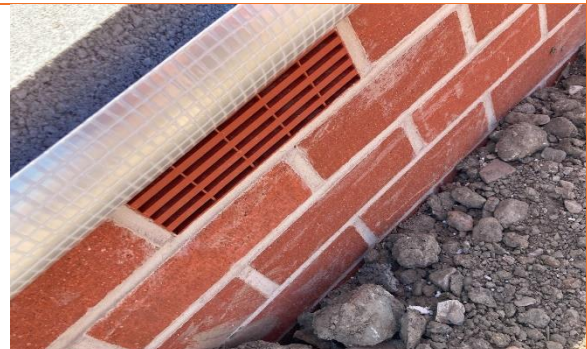
**Verification of Service Penetrations-Good Condition**
