**e3p** Gas Protection Validation Site Record

## GAS MEMBRANE VALIDATION

| <b>Site Name:</b> Parcel C, Prescott | <b>Project Number:</b> 15-292 |
| <b>Company:</b> Miller Homes | <b>Date:</b> 21-07-2022 |

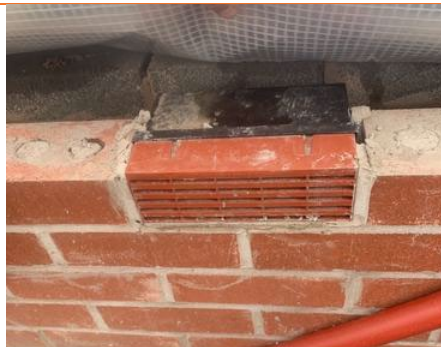
**Verification of Service Penetrations-Good Condition**
